BANK FAILURE AND EROSION ON THE OHIO RIVER

D.J. HAGERTY¹, M.F. SPOOR² and C.R. ULLRICH¹

ABSTRACT

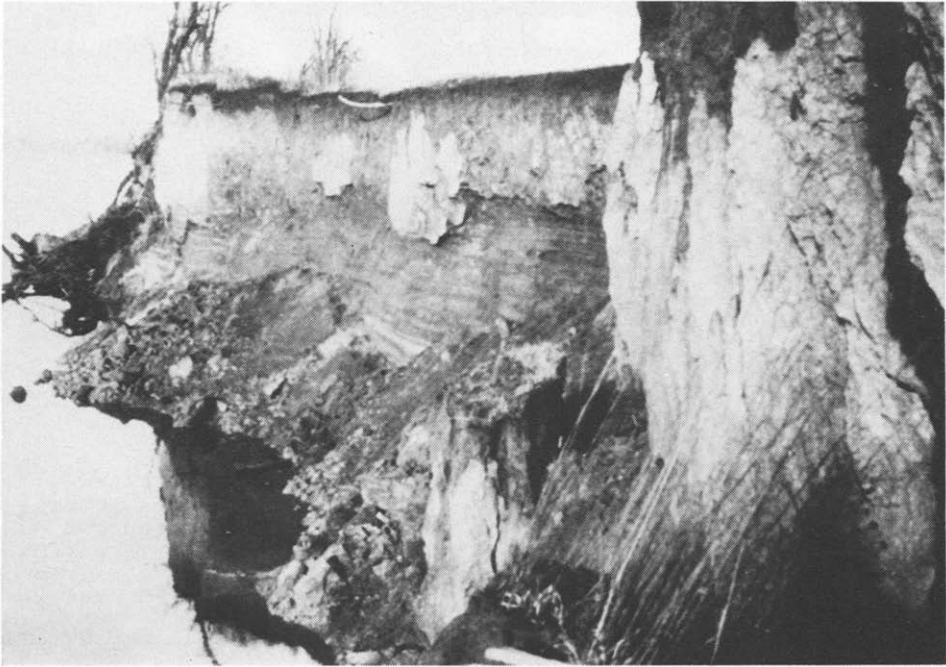
A site where bank failure and erosion or removal of debris has occurred during the period of these studies from late 1976 to 1980 is shown in Fig.1. It is not correct to consider any one site "typical" of conditions along the Ohio River because the banks are variable in sequence and character of the soils, in geometry and location relative to the channel and thalweg of the stream, in topography and drainage conditions immediately landward of the banks and along the valley slopes, in the use of the land adjacent to the banks and within the floodplain, and in many other factors. However, many of the bank characteristics shown in Fig.1 are to be seen at many locations along the entire Ohio River. An upper, near-vertical portion of the bank, including soils with significant apparent cohesion, was found. Thin layers of granular soils underlie the cohesive soils. Between the water's edge and the thin basal lenses of granular soil, cohesive soil debris fallen from the upper bank zones has accumulated. Removal of the thin granular layers undercuts the upper cohesive soils, which then develop tension cracks; eventually slabs of material fall off

Fig.1. Left descending bank, Ohio River, 448 km (278 miles) downstream from Pittsburgh, 13 December 1977.

The bank failure and erosion configurations shown in Fig.1 have historical relevance and are similar to bank conditions along much of the Ohio River and tributary streams at the present time. A search was conducted in public archives, agency files, and private collections, for photographs and other information on Ohio River bank conditions, particularly erosion thereof, from the time that the Ohio River Valley was first settled, to the present. Paintings and illustrations were found which depicted bank geometries as early as 1786. Numerous references to bank failure and erosion on the Ohio River as early as 1820 were found in the literature. Many historical photographs showed bare, apparently failed and eroded banks, much like those in Figs.1 and 2. Many of these photographs were taken prior to the construction of Ohio River navigation dams, with water levels in the photographs, in many instances, well below those maintained by the current system of dams. These historical photographs often show gently sloping lower bank areas at low-flow conditions, below the kind of bank conditions shown in Figs.1 and 2. A great number of paintings and illustrations of referenced locations were found showing similar conditions.

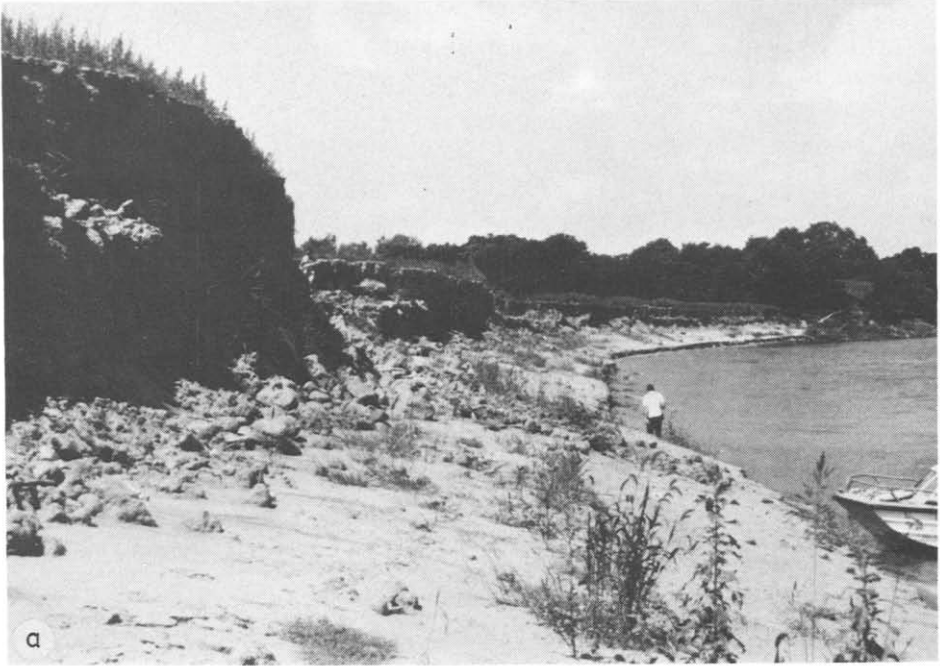
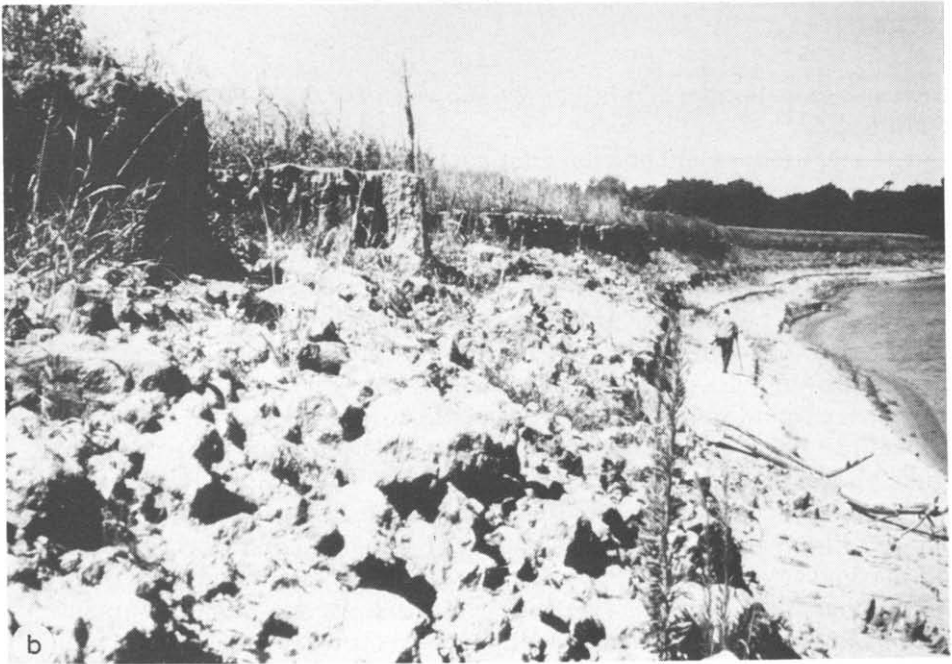
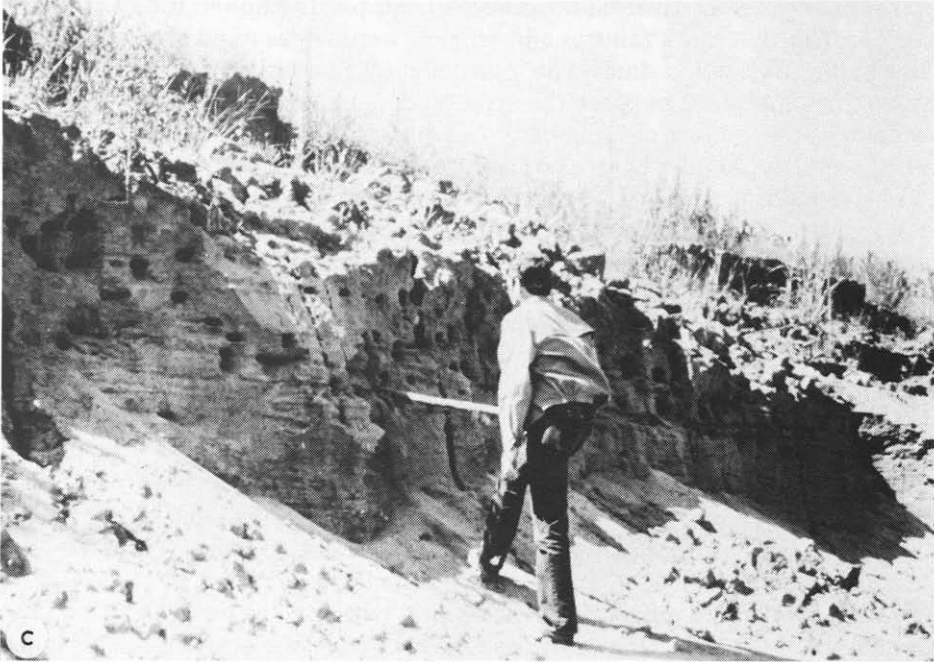
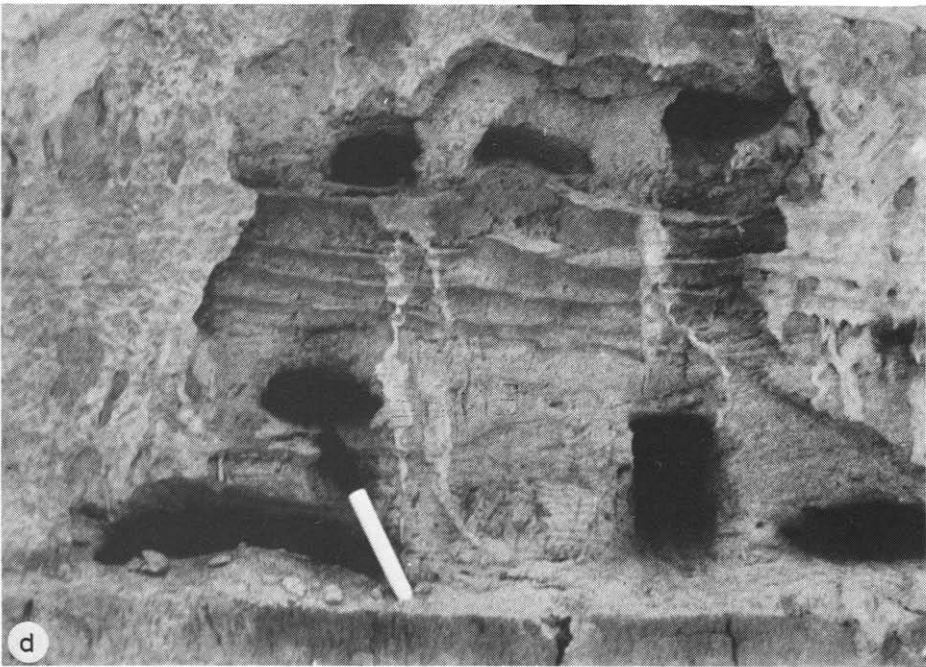
the bank face. Similar conditions are shown in Fig.2 for a site on the lower Ohio River.

Fig.2. Left descending bank, Ohio River, 1320 km (820 miles) downstream from Pittsburgh, August 1978.

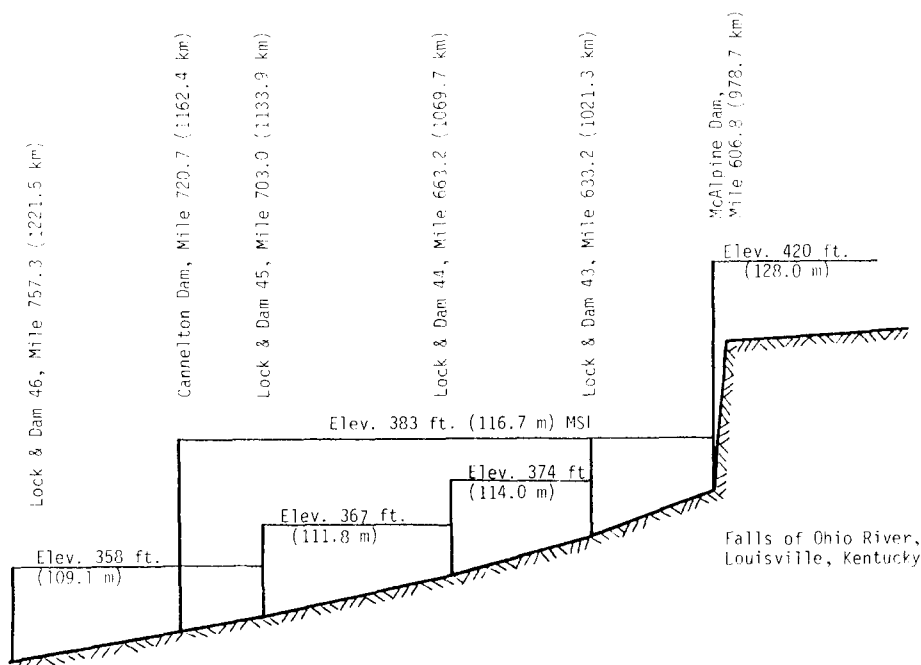
With the recent construction of larger dams and locks, retained water levels were raised in some areas. The new Cannelton Dam, for example, raised normal pool water level 7.6 m (25 ft.) above the levels maintained by old Dam 46, 4.9 m (16 ft.) above the levels maintained by old Dam 45 and 2.8 m (9 ft.) above the levels maintained by old Dam 44, without change to the slackwater pool elevations maintained by old Dam 43 (see Fig.3). Similar situations existed for all the newer higher dams. This type of situation provided a means to test the allegations that raising the river elevations had accelerated or intensified bank erosion. If these allegations were correct, the river banks within the reaches where pool raises were greatest should exhibit more widespread and severe failures and erosion than the banks in portions of the stream where pool raises were less, or where no change occurred as in the case of the Dam 43

Fig. 3. Diagram showing replacement of old Ohio River Dams 43, 44, and 45 by Cannelton Dam.

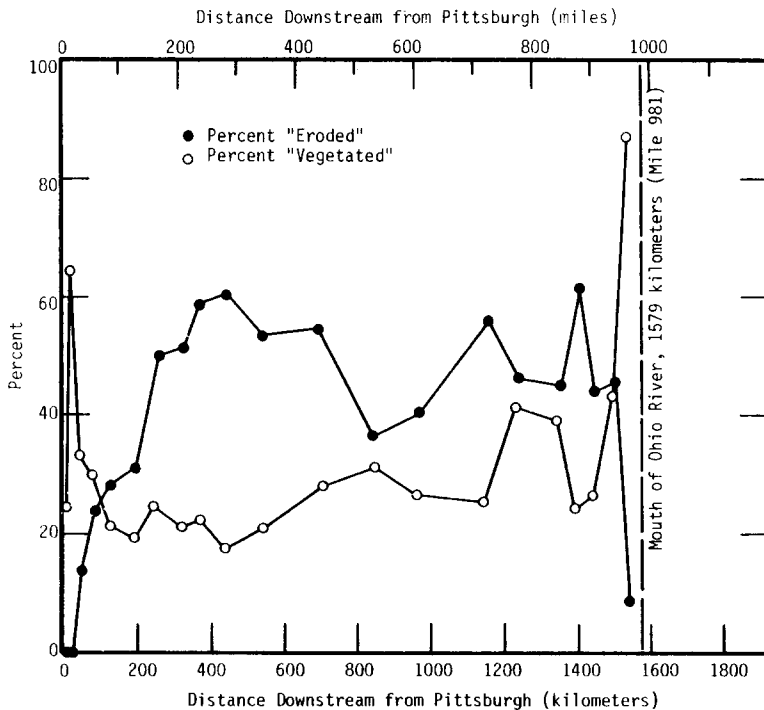
Data shown in Fig. 4 and Table III, indicate the evaluations obtained during examination of the 1580-km (981-mile) reach of the Ohio River in July—August 1978. These data do not fully describe the complex mechanism interrelationships which trigger bank failure and erosion. Rather, these reconnaissance data were used to evaluate hypotheses *suggested by others* to explain mechanisms of bank erosion. Thus, if pool raise as a result of construction of new dams had produced significant additional bank erosion, very recently

Fig. 4. Bank conditions in Ohio River navigation dam pools versus distance downstream from Pittsburgh, July–August 1978.

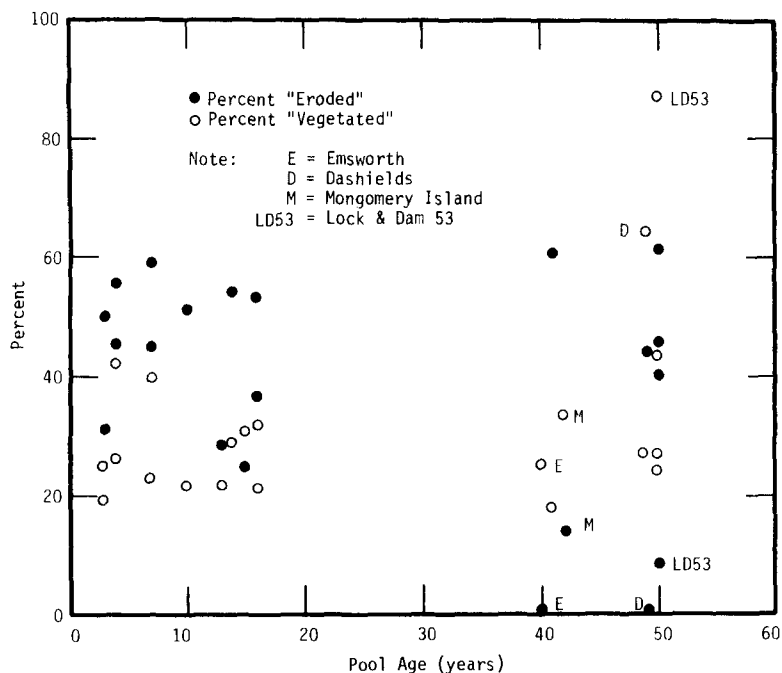
retained pools could be expected to show less severe and widespread erosion than older pools. However, no such correlation between age of pool and apparent severity of erosion could be found (see Fig.5). If pool raise were a significant causative factor in bank erosion, a correlation could be anticipated between magnitude of pool raise (from old dam slackwater pool to new dam slackwater pool) and extent and severity of bank failure and erosion; no such correlation was found (see Fig.6).

Fig.5. Bank conditions in Ohio River navigation dam pools versus pool age, July—August 1978.

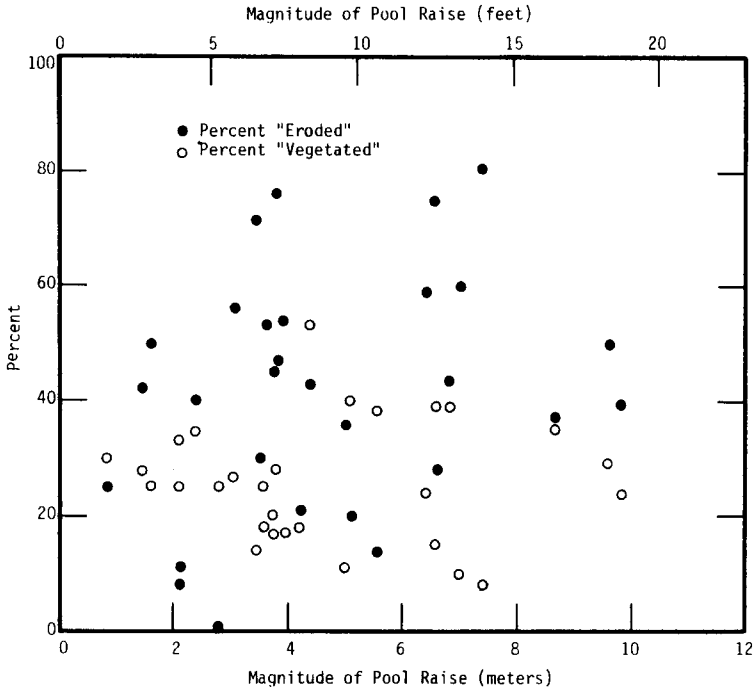
Fig. 6. Bank conditions in Ohio River navigation dam pools versus magnitude of pool raise, July—August 1978.

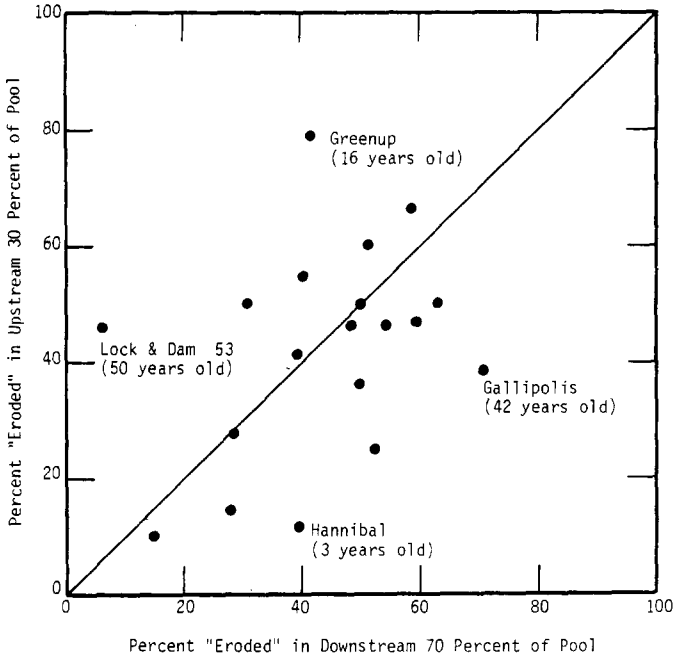
Fig.7. Bank conditions in upstream 30% of Ohio River navigation dam pools versus bank conditions in downstream 70% of pools, July–August 1978.

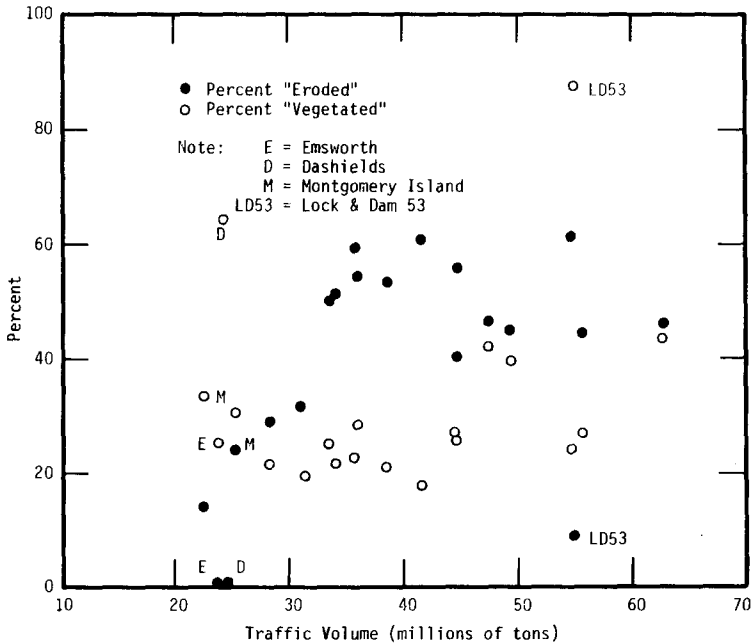
Apparent severity of erosion is shown as a function of traffic volume in Fig.8. In this figure there appears to be an increase in erosion with increase in traffic volume, up to a volume of about 30 million tons per year. However, this relation does not suggest a significant correlation between traffic volume and erosion because of the following circumstances.

(b) There is no increase in apparent severity of erosion with increase in traffic level above 30 million tons per year up to 57 million tons per year.

It must be mentioned also that the data in Fig. 8 reflect the fact that the Dam 53 pool is subject to backwater conditions from the Mississippi River and during the reconnaissance of that reach, near normal pool conditions were not encountered.

Fig.8. Bank conditions in Ohio River navigation dam pools versus traffic volume, July–August 1978.

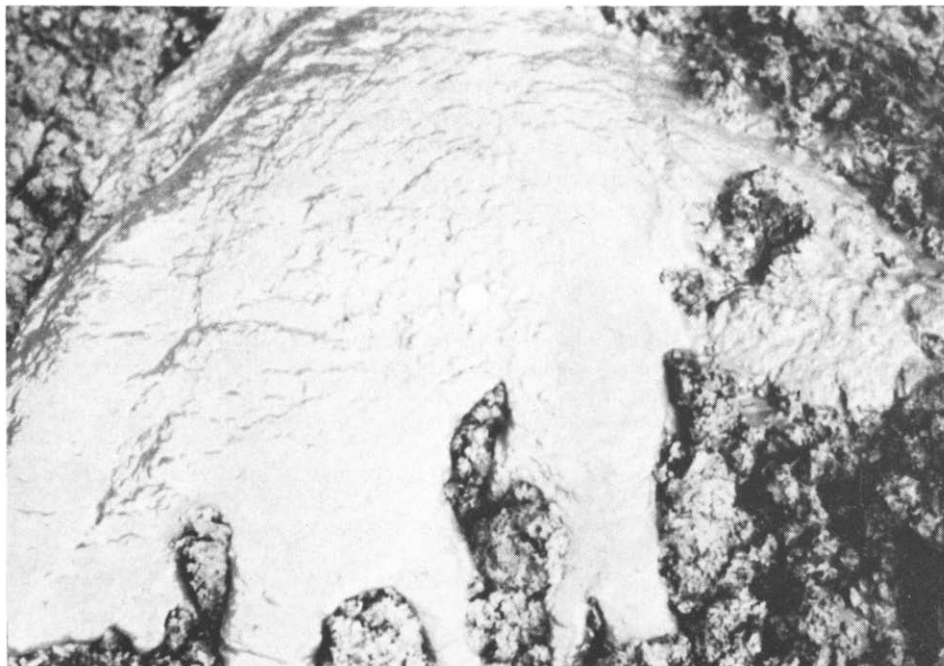
These detailed investigations disclosed landslides at several sites triggered by periods of greater-than-average precipitation. These landslides included colluvium (weathered rock and residual soil on slopes) and Pleistocene lake-bed deposits. At sites located on floodplain alluvium, erosion mechanisms were related to the character of the alluvial soils. As shown in Fig.1, the alluvial soils in the banks and terraces of the Ohio River occur as lenses and layers of varying thickness. Commonly, the texture of the lenses varies from sandy to silty or even clayey. The coarse-grained soil lenses are much more pervious (by several orders of magnitude) than the fine-grained soils. Thus, water flows preferentially in the sandy layers and lenses. When water flows out of the sandy layers it can remove these materials grain by grain, until more cohesive overlying layers are undermined and fail, as shown in Fig.1. The authors observed this process occurring at many sites. This internal erosion mechanism is most significant during periods of above-average annual precipitation such as the early 1970's, and could be more significant as a result of changes in drainage or land use which increase infiltration behind river banks. This mechanism was seen at a representative site in December 1977. Approximately 5 cm (2 inches) of rain had fallen on the site on 5-6 December; the temperature then had dropped and the last of the precipitation had fallen as a light dusting of snow. The river rose to flood crest on 9 December when the banks were frozen and stable. On 14 December 1977, temperatures rose above freezing. Soil-and-water was observed flowing out of the bank when the site was visited on 15 December. A close view of the flowing soil is shown in Fig.9.

Although this mechanism of erosion had been described long ago by other investigators (Thomas and Watt, 1918), the significance and areal extent of the mechanism had not been defined. This mechanism of erosion was noted by the authors within alluvial soils seasonally throughout the entire length of the Ohio River. Conditions on the left descending bank of the Ohio, 1320 km (820 miles) downstream from Pittsburgh, have been shown in Fig.2. The holes in the bank and the flow patterns in soil debris indicate the occurrence of this mechanism of "internal" erosion.

Fig.9. Soil and water flowing out of right descending bank, Ohio River, 662 km (411 miles) downstream from Pittsburgh, December 1977.
