Roughness Characteristics of Natural Channels

By HARRY H. BARNES, JR.

U.S. GEOLOGICAL SURVEY WATER-SUPPLY PAPER 1849

Color photographs and descriptive data for 50 stream channels for which roughness coefficients have been determined

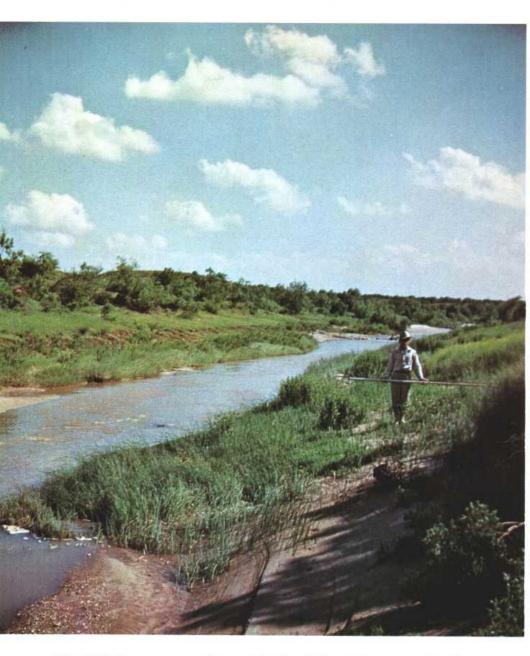
No. 511 downstream along right bank from above section 2, Champlin Creek near Colorado City, Tex.

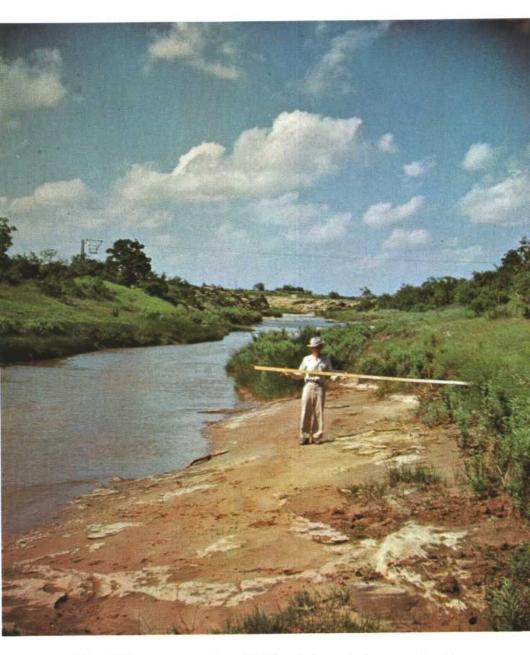
No. 512 upstream along left bank from below section 4, Champlin Creek near Colorado City, Tex.

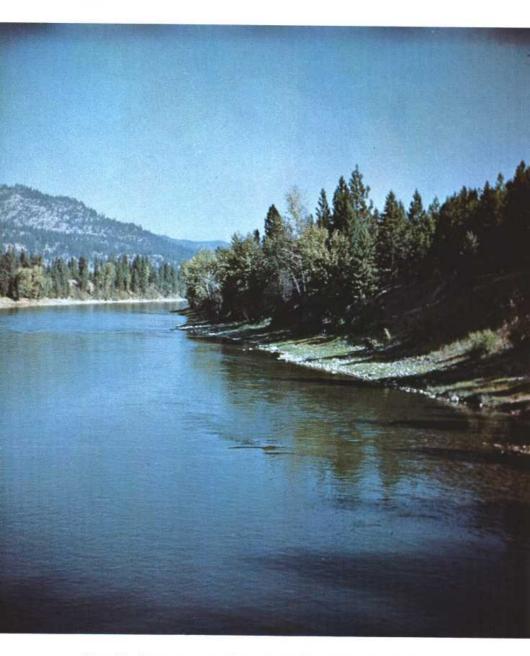
No. 22 downstream along right bank from section 2, Clark Fork at St. Regis, Mont.

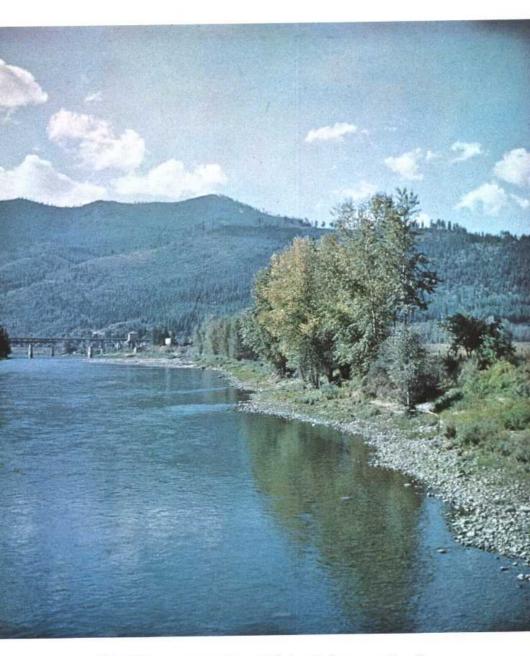
No. 23 upstream along left bank from section 2, Clark Fork at St. Regis, Mont.

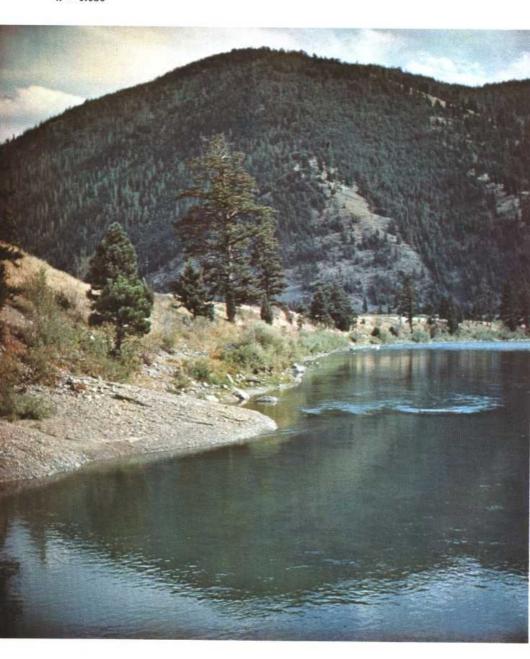
No. 18 downstream along left bank from above section 3, Clark Fork above Missoula, Mont.

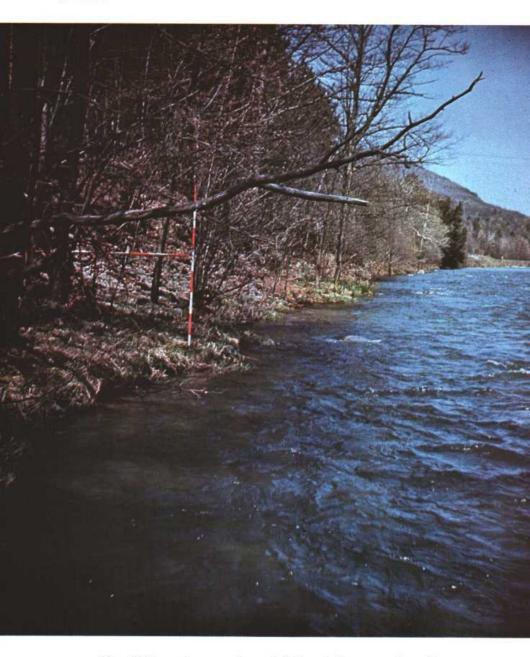
No. 354 upstream along left bank from section 2, Esopus Creek at Coldbrook, N.Y.

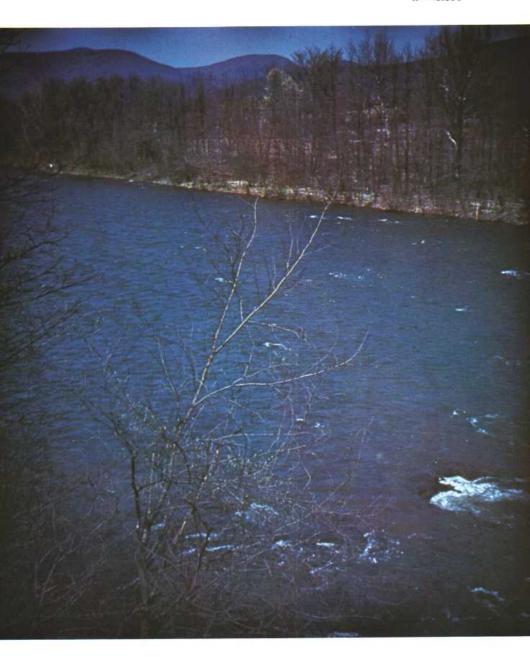
No. 357 upstream from right end of bridge below reach, Esopus Creek at Coldbrook, N.Y. (at Highway 28–A).

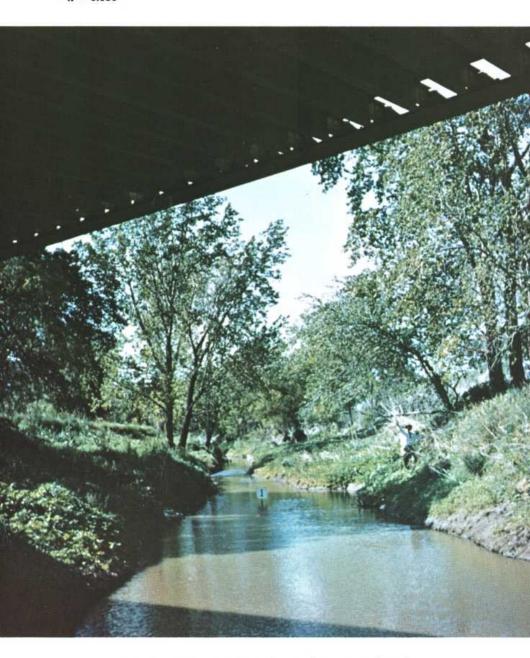
No. 824 downstream from above section 1, Salt Creek at Roca, Nebr.

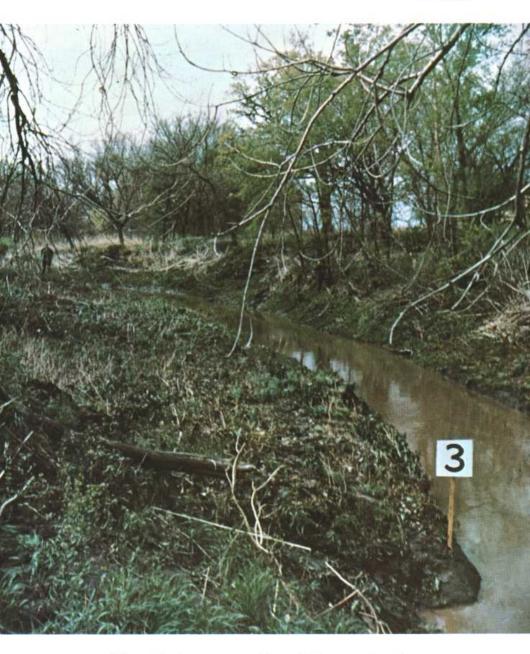
No. 825 downstream from below section 2, Salt Creek at Roca, Nebr.

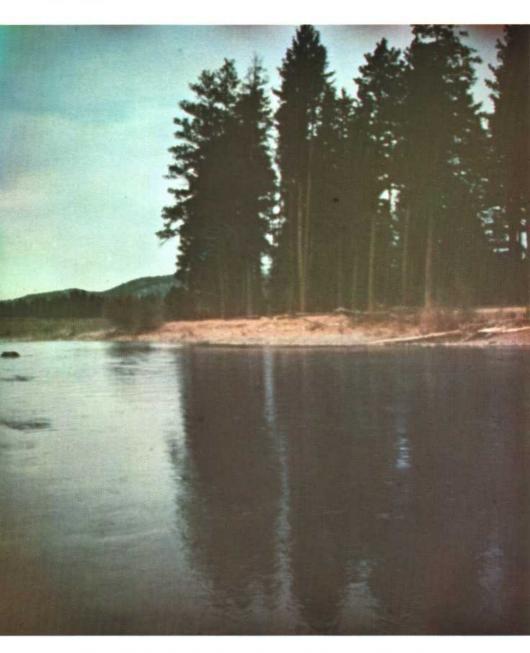
No. 1 downstream from left bank above section 1, Blackfoot River near Ovanda, Mont.

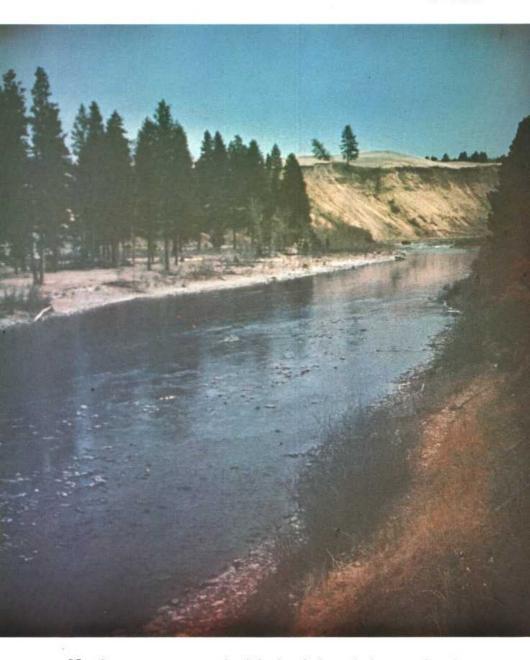
No. 3 upstream towards right bank from below section 2, Blackfoot River near Ovanda, Mont.

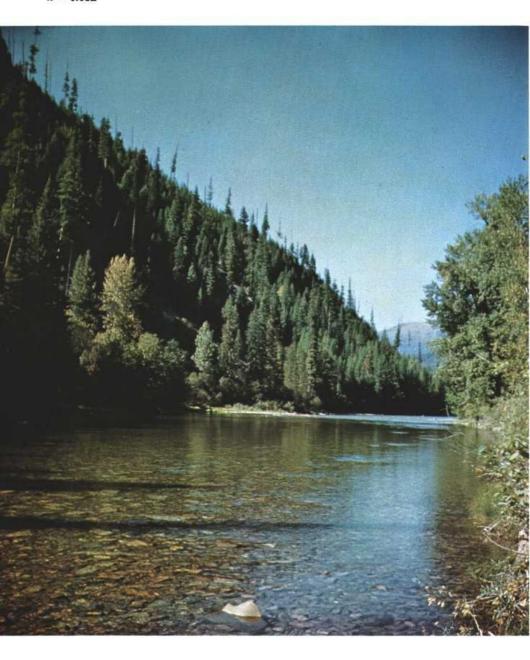
No. 34 downstream through reach from right bank, Coeur d'Alene River near Prichard, Idaho.

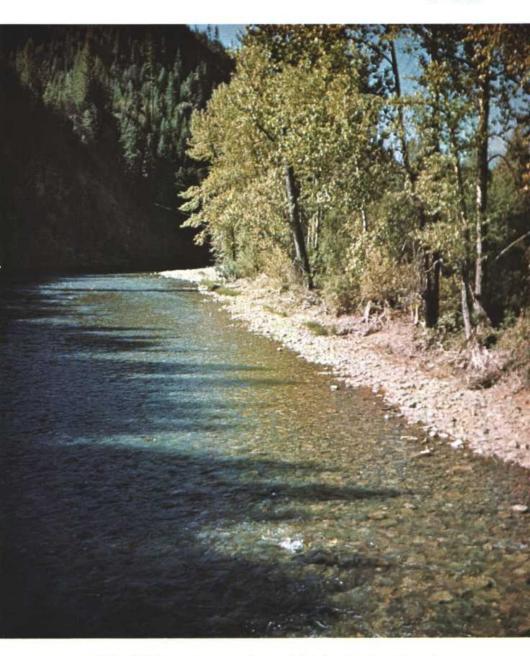
No. 36 downstream along right bank at section 1, Coeur d'Alene River near Pritchard, Idaho.

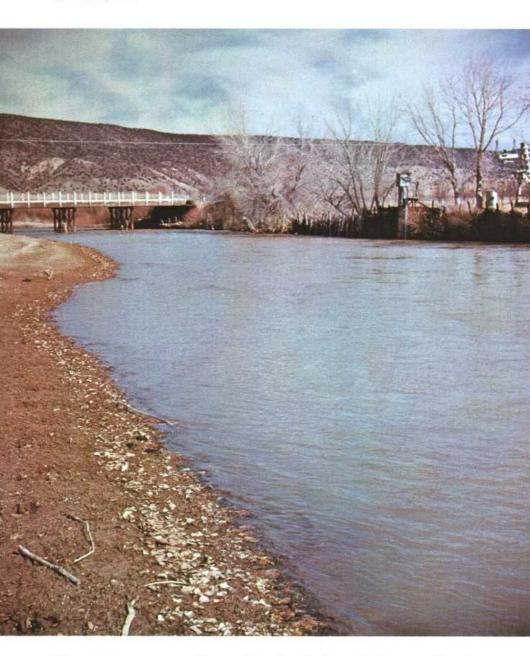
No. 547 upstream along right bank from below section 2, Rio Chama near Chamita, N. Mex.

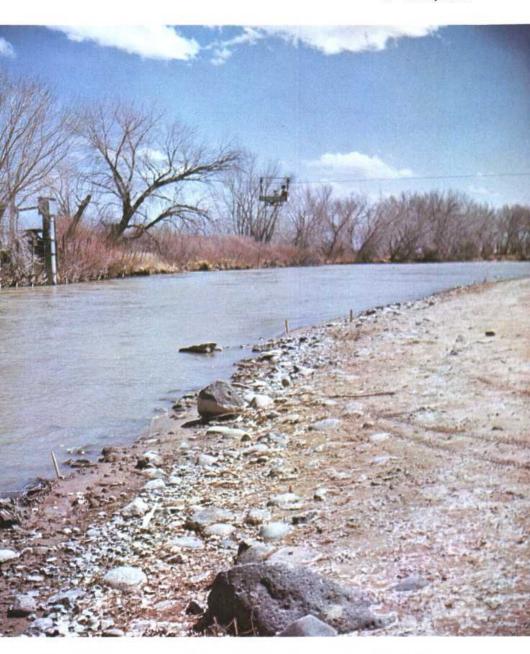
No. 550 downstream from right bank at section 1, Rio Chama near Chamita, N. Mex.

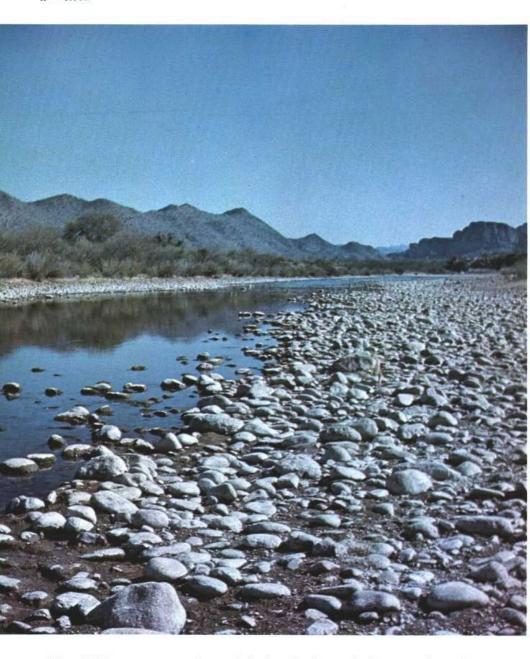
No. 817 upstream along left bank from below section 6 Salt River below Stewart Mountain Dam, Ariz.

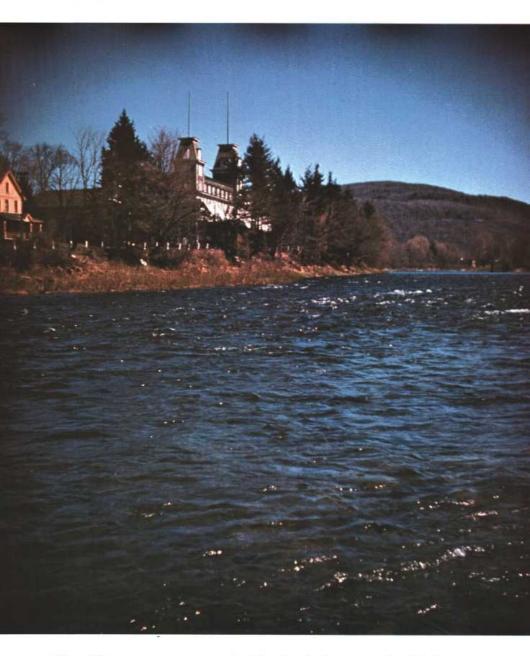
No. 366 upstream toward right bank from section 7, Beaver Kill at Cooks Falls, N.Y.

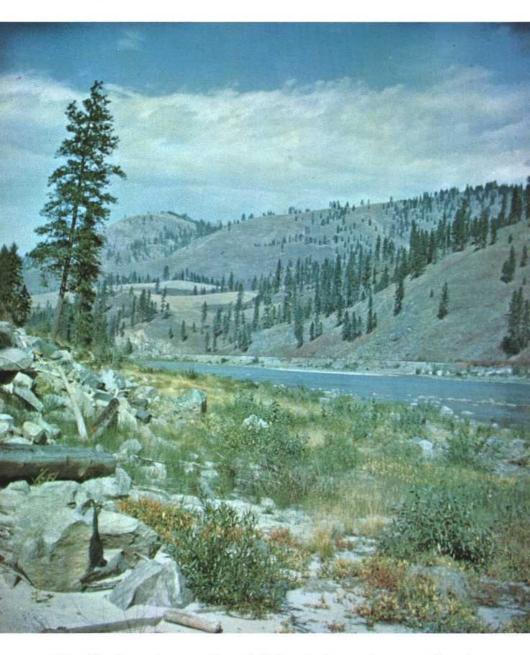
No. 29 downstream along left bank from above section 1, Clearwater River at Kamiah, Idaho.

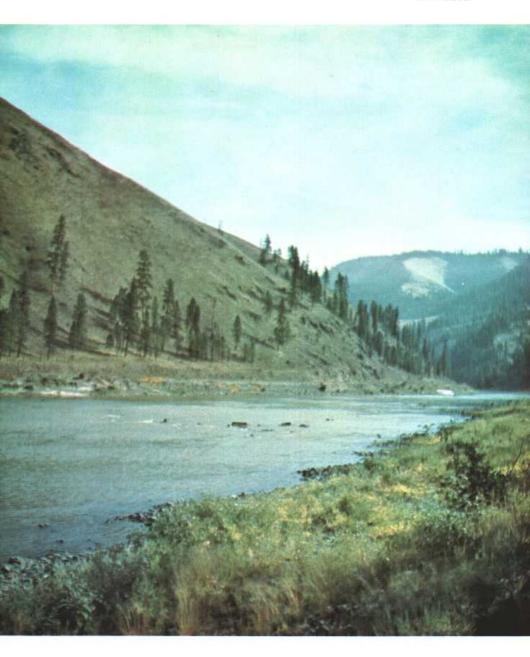
No. 32 upstream from left bank at section 3. Clearwater River at Kamiah, Idaho.

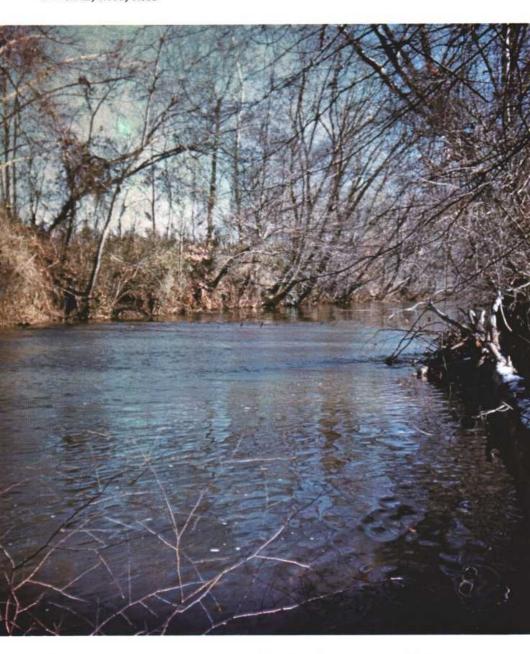
No. 1167 downstream from right bank above section 9, Etowah River near Dawsonville, Ga.

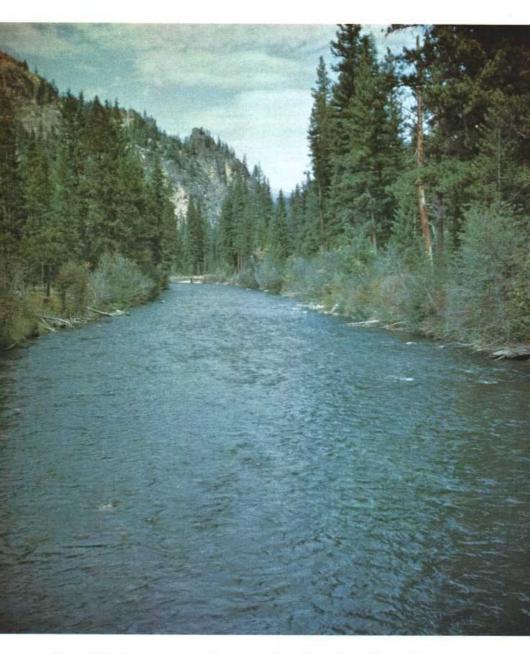
No. 175 downstream from section 1, West Fork Bitterroot River near Conner, Mont.

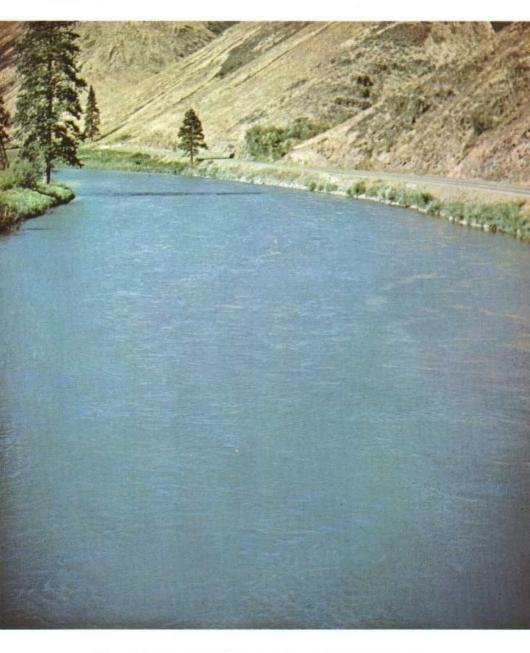
No. 186 upstream from section 3, Yakima River at Umtanum, Wash.

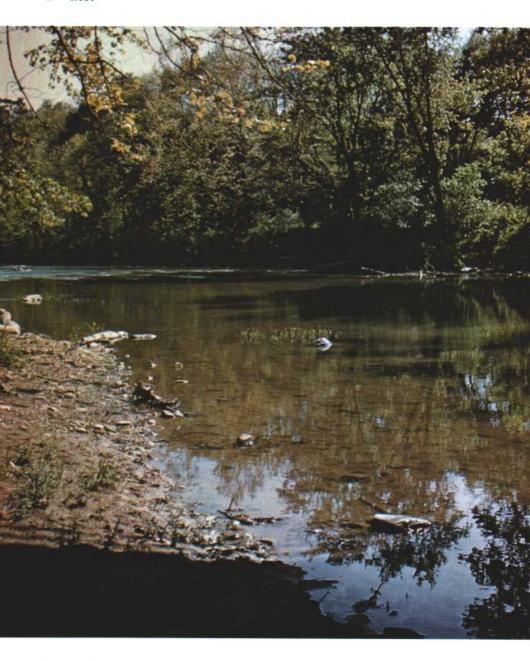
No. 833 downstream from left bank at section 1, Middle Fork Vermilion River near Danville, Ill.

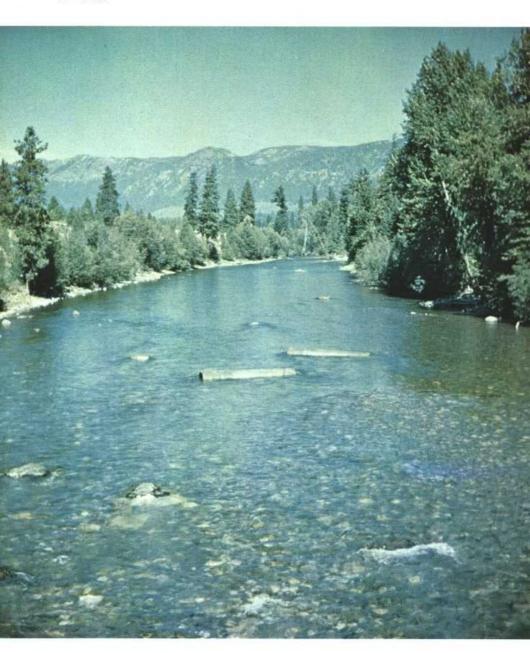
No. 169 downstream from above section 1, Wenatchee River at Plain, Wash.

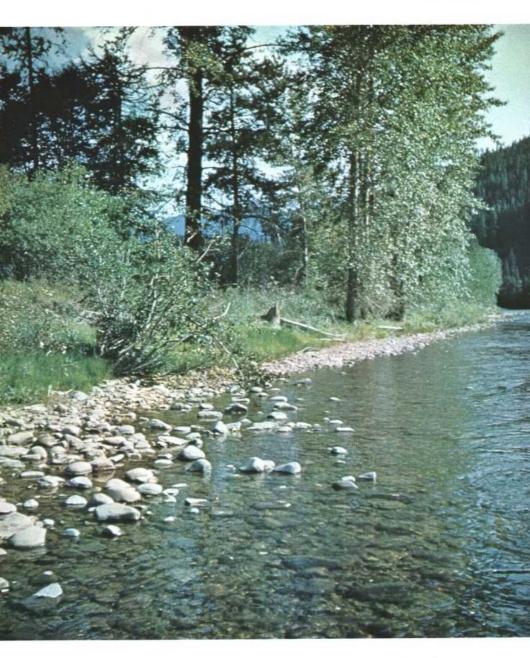
No. 126 downstream along left bank at section 3, Moyie River at Eastport, Idaho.

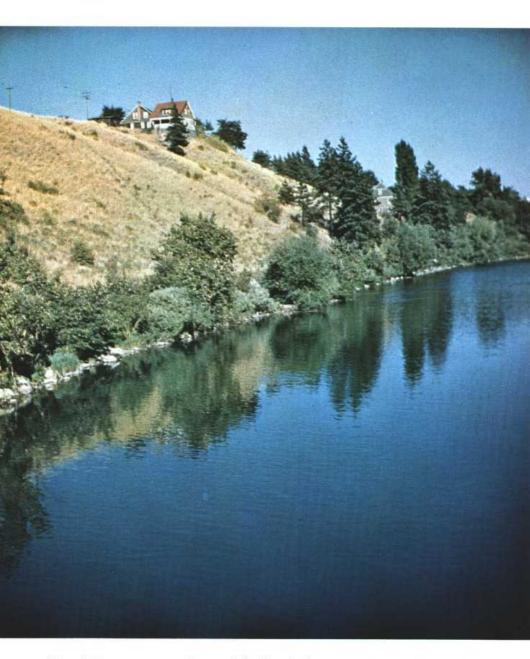
No. 162 upstream along right bank from section 4, Spokane River at Spokane, Wash.

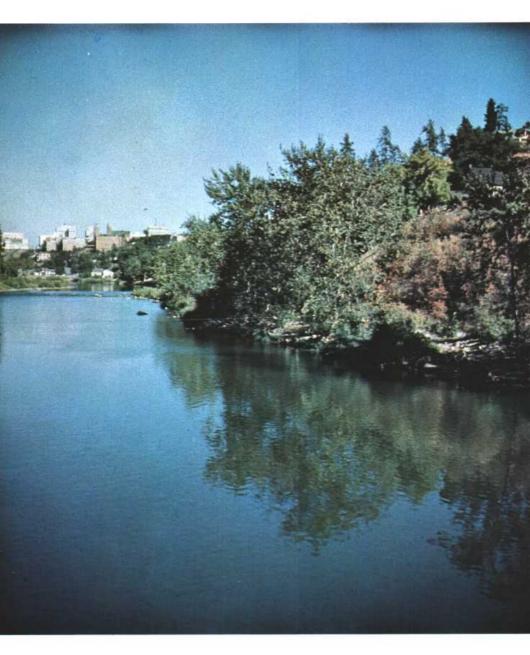
No. 163 upstream along left bank from section 4, Spokane River at Spokane, Wash.

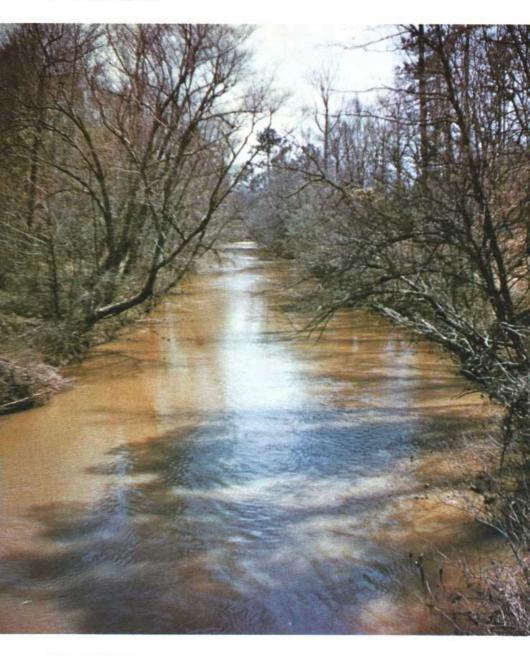
No. 1172 downstream from section 6, Tobesofkee Creek near Macon, Ga.

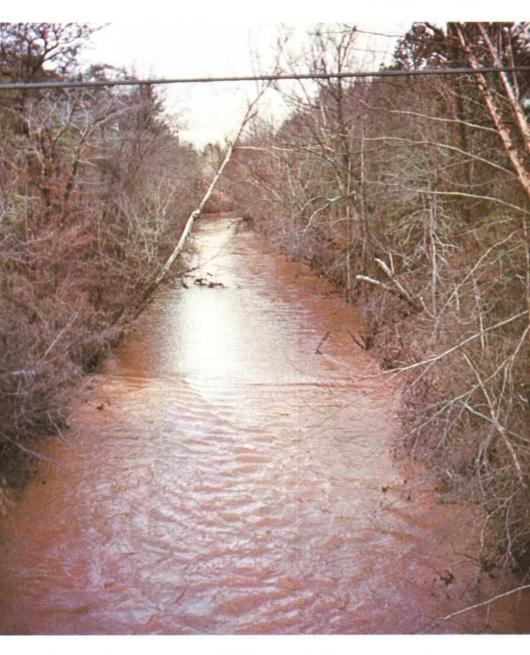
No. 1173 upstream from bridge section 12, Tobesofkee Creek near Macon, Ga.

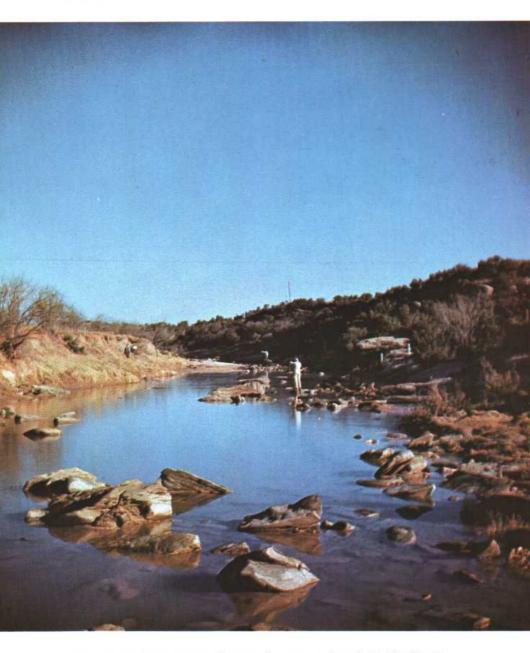
No. 342 downstream from above section 1, Bull Creek near Ira, Tex.

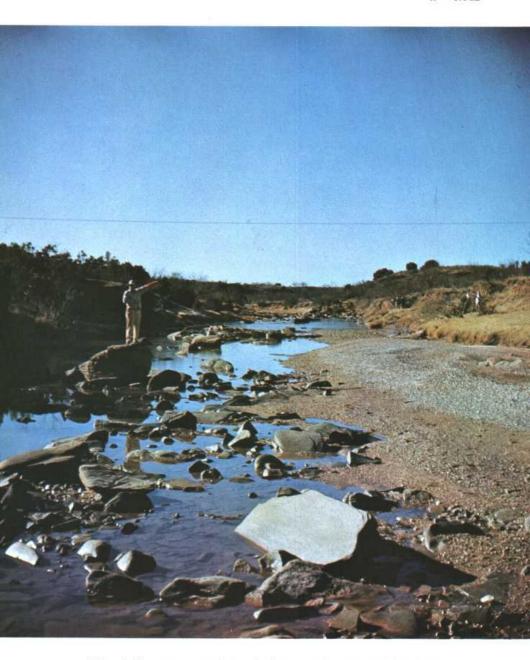
No. 345 upstream from below section 2, Bull Creek near Ira, Tex.

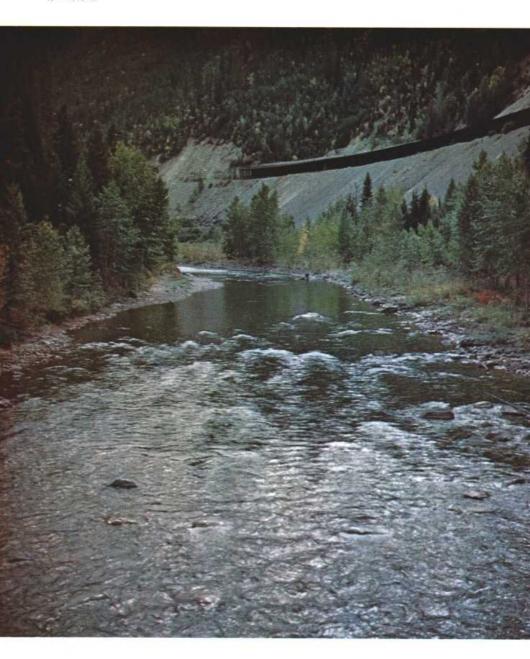
No. 112 upstream from section 4, Middle Fork Flathead River near Essex, Mont.

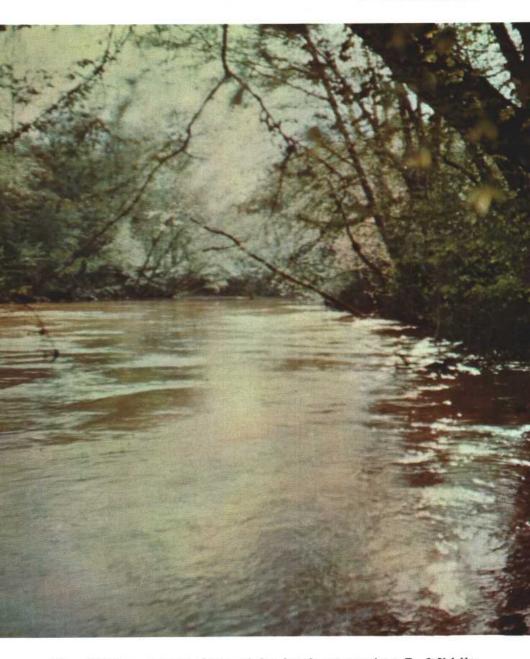
No. 1175 upstream from right bank at section 7, Middle Oconee River near Athens, Ga.

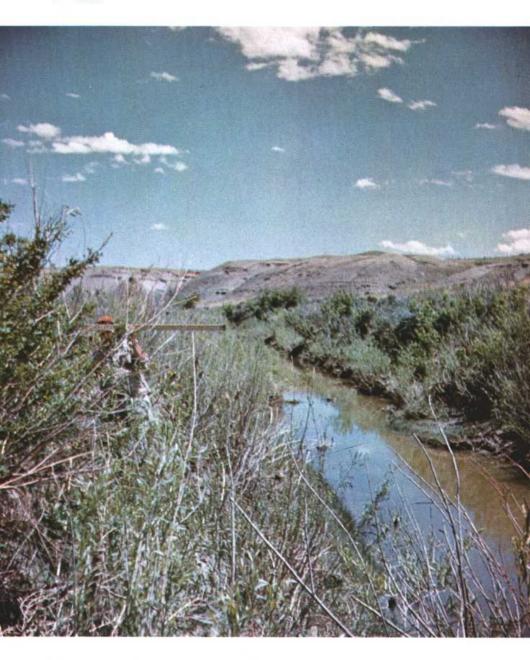
No. 959 downstream from left bank at section 1, Beaver Creek near Newcastle, Wyo.

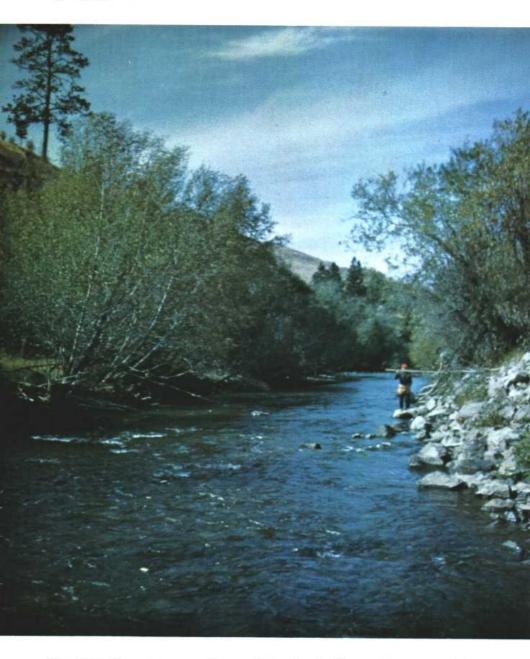
No. 10 downstream along right bank from above reach, Catherine Creek near Union, Oreg.

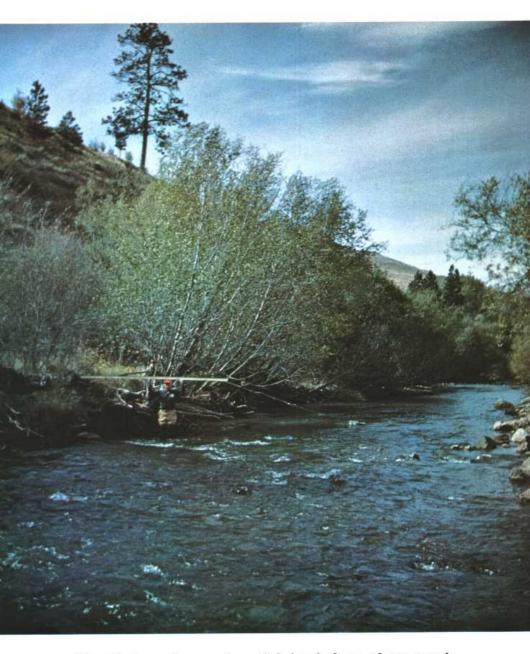
No. 11 downstream along left bank from above reach, Catherine Creek near Union, Oreg.

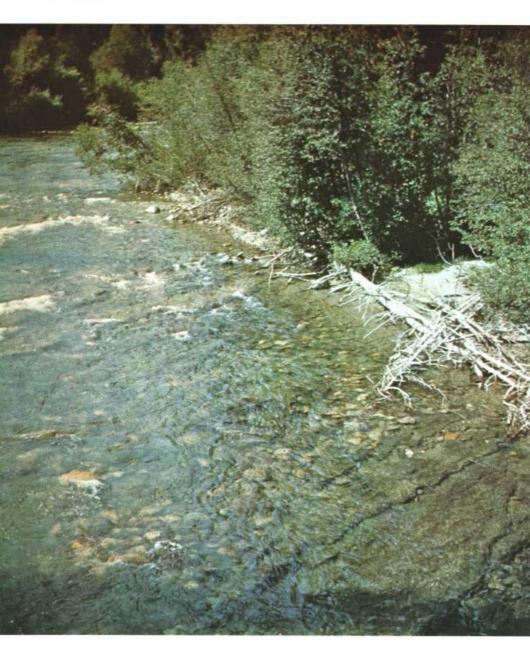
No. 13 upstream along left bank from section 2, Chiwawa River near Plain, Wash.

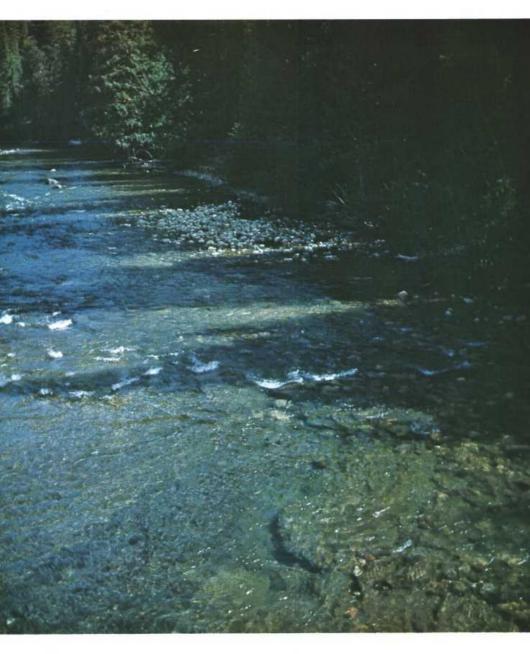
No. 15 downstream along right bank from section 2, Chiwawa River near Plain, Wash.

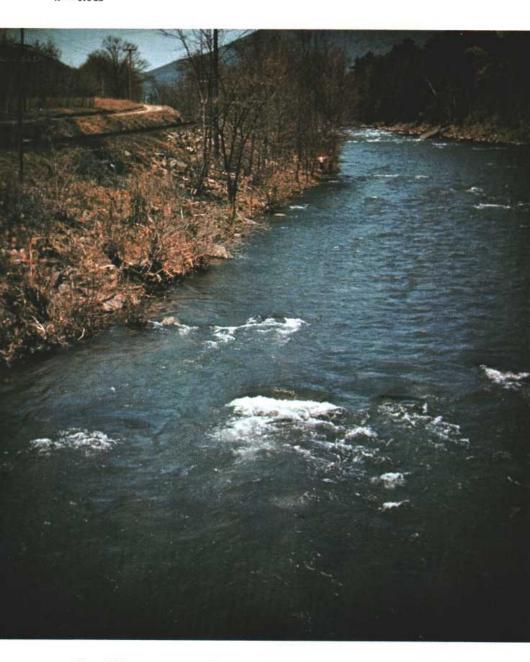
No. 358 upstream along right bank from below reach, Esopus Creek at Coldbrook, N.Y.

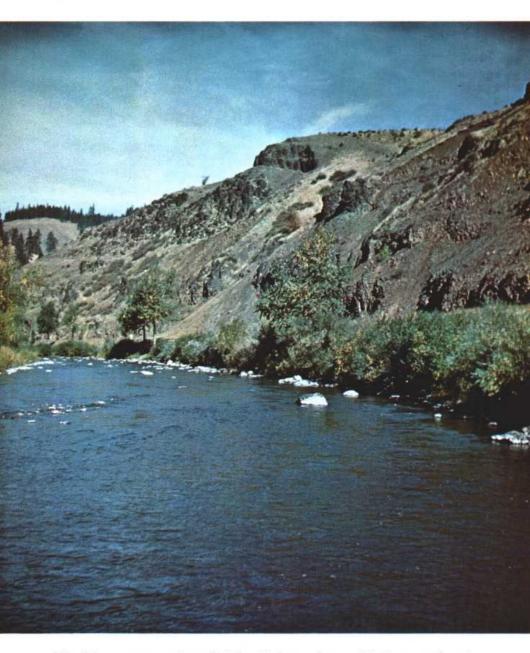
No. 78 upstream along left bank from channel below section 3, Grande Ronde River at La Grande, Oreg.

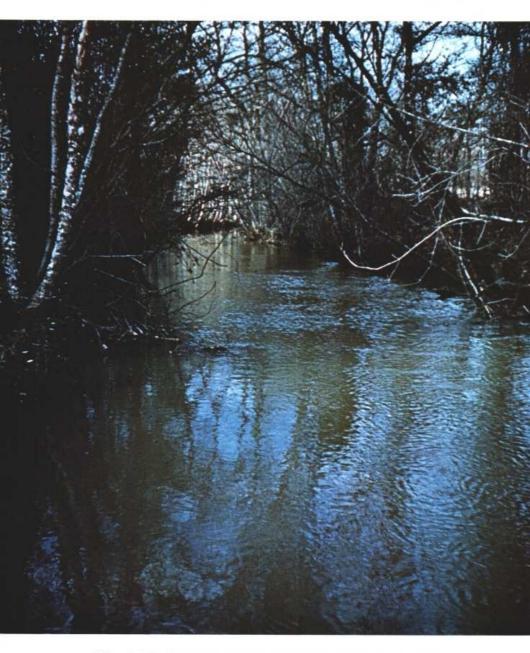
No. 1177 downstream from left bank at section 2, Murder Creek near Monticello, Ga.

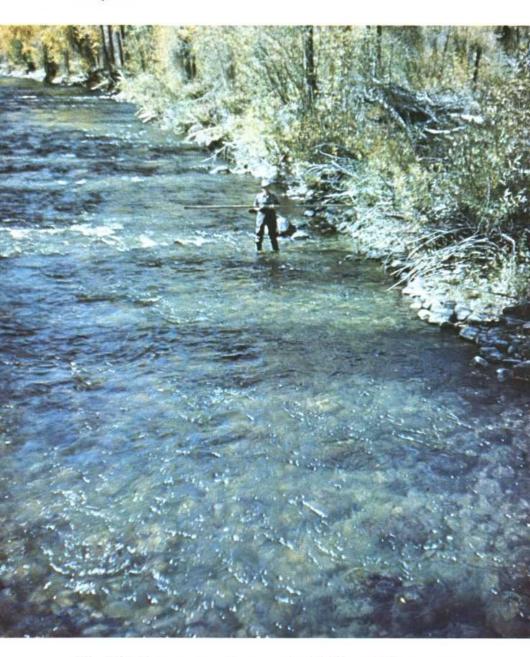
No. 769 downstream from section 3, Provo River near Hailstone, Utah.

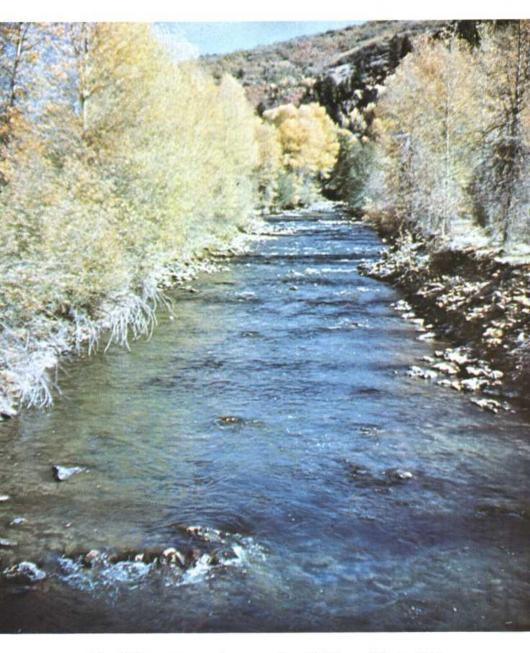
No. 770 upstream from section 3, Provo River near Hailstone, Utah.

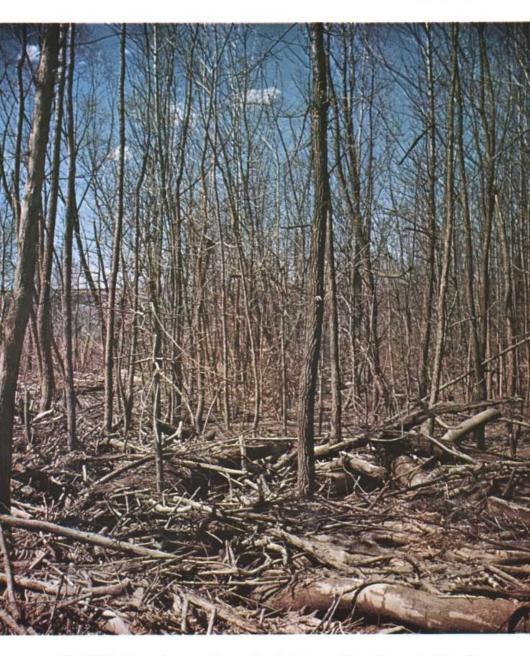
No. 391 downstream through right overflow from section 2, Rolling Fork at Boston, Ky.

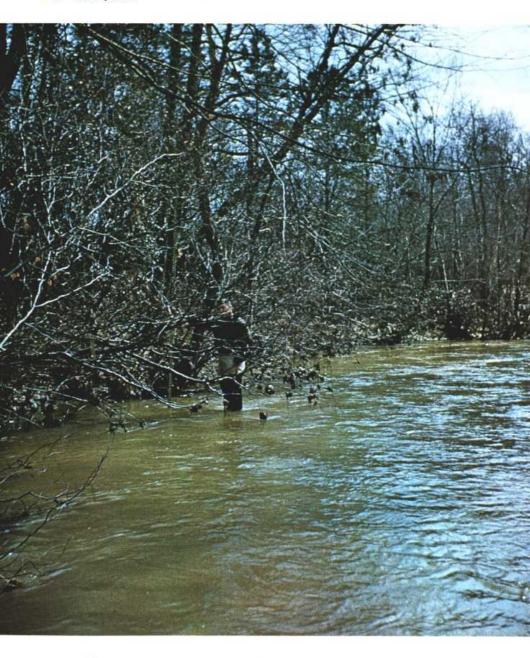
No. 1178 downstream along left bank from section 2, South Beaverdam Creek near Dewy Rose, Ga.

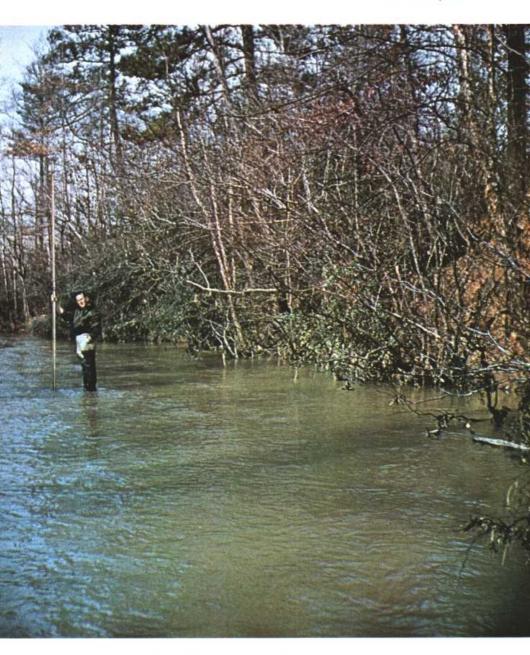
No. 1179 upstream from section 2, South Beaverdam Creek near Dewy Rose, Ga.

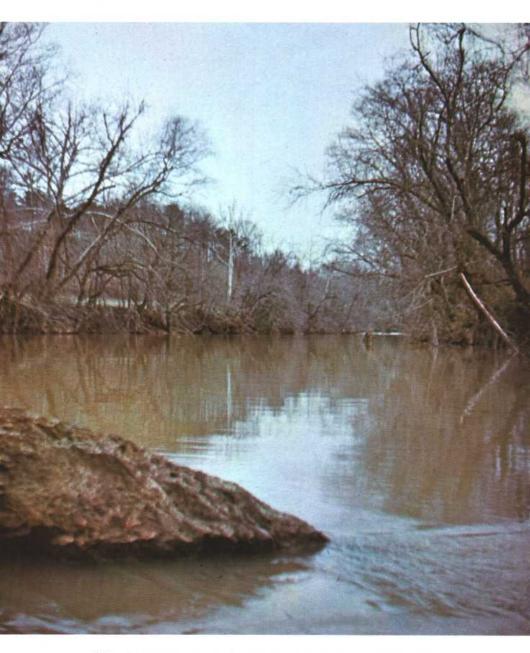
No. 1180 upstream from section 7, Deep River at Ramseur, N.C.

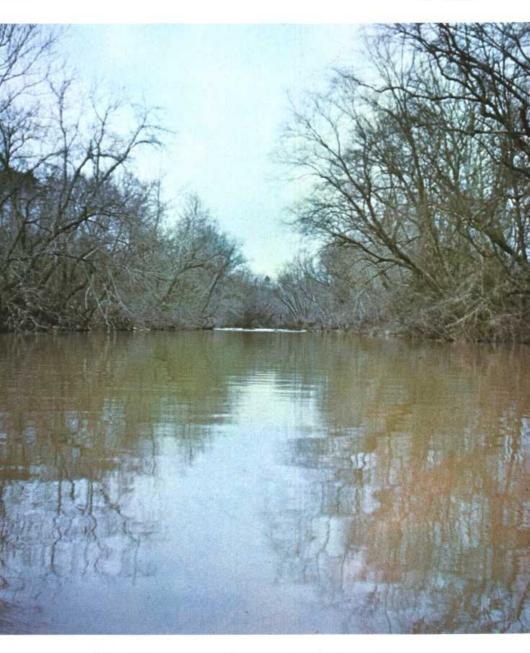
No. 1181 upstream from section 4, Deep River at Ramseur, N.C.

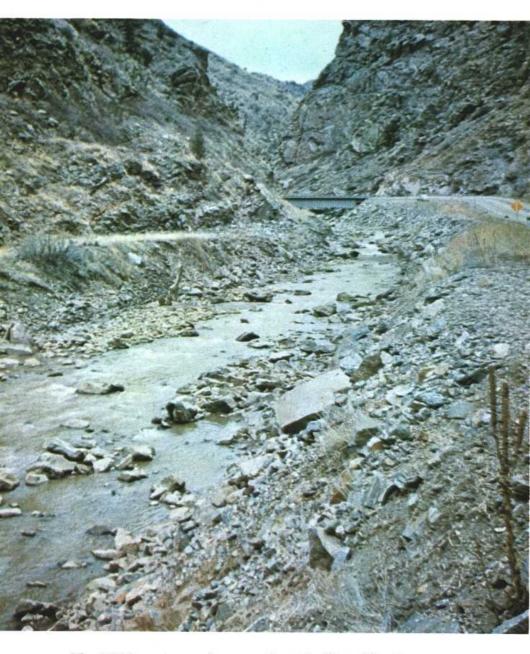
No. 1198 upstream from section 16, Clear Creek near Golden, Colo.

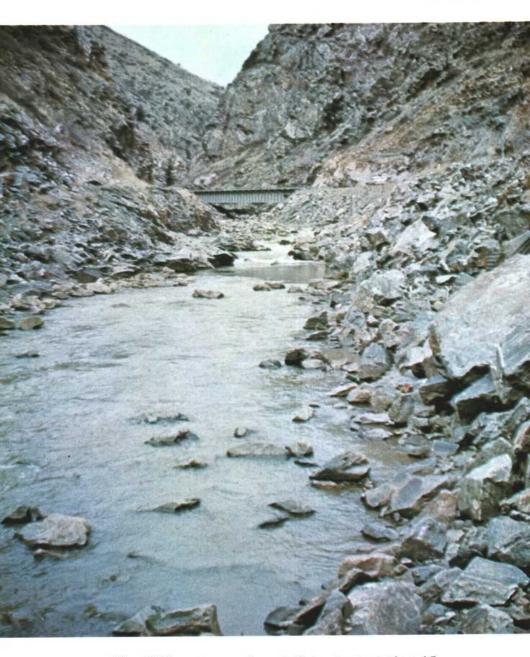
No. 1199 upstream from left bank at section 15, Clear Creek near Golden, Colo.

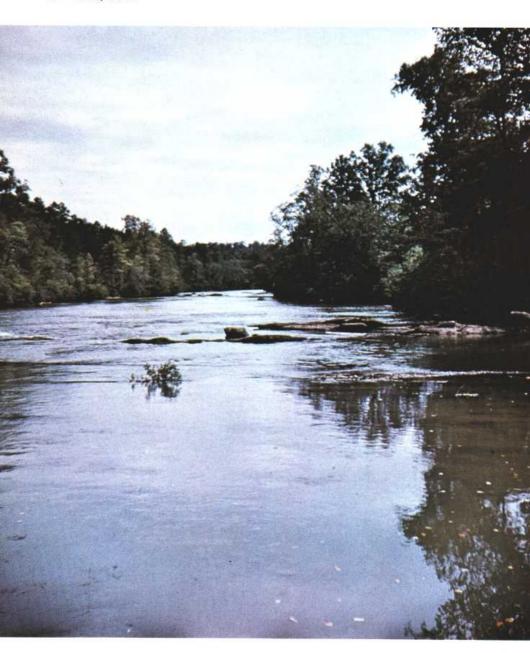
No. 1186 downstream from above section 2, Chattahoochee River near Leaf, Ga.

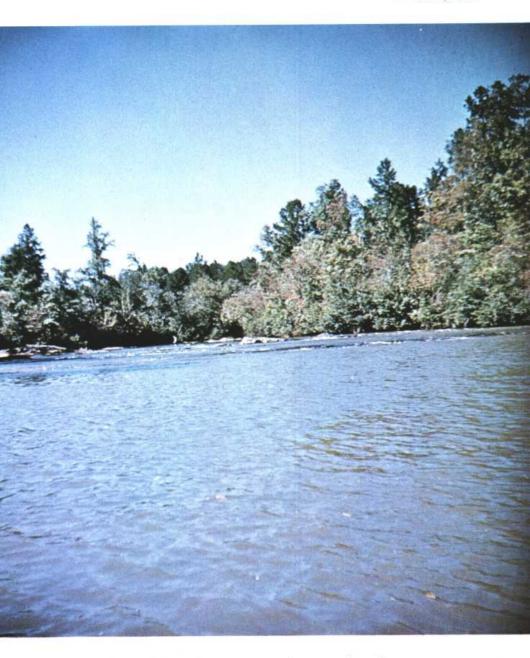
No. 1187 upstream from section 4, Chattahoochee River near Leaf, Ga.

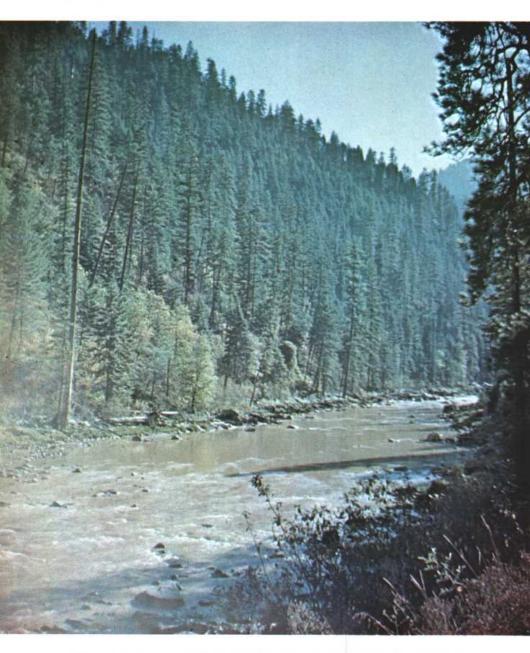
No. 155 upstream from left bank at section 3, South Fork Clearwater River near Grangeville, Idaho.

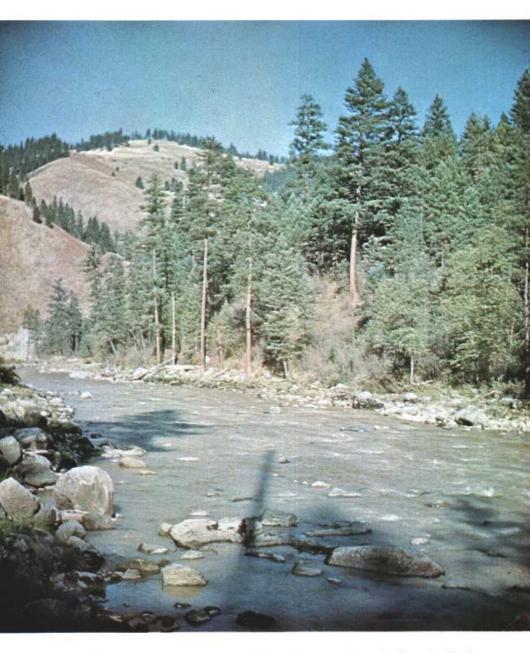
No. 156 downstream from left bank at section 2, South Fork Clearwater River near Grangeville, Idaho.

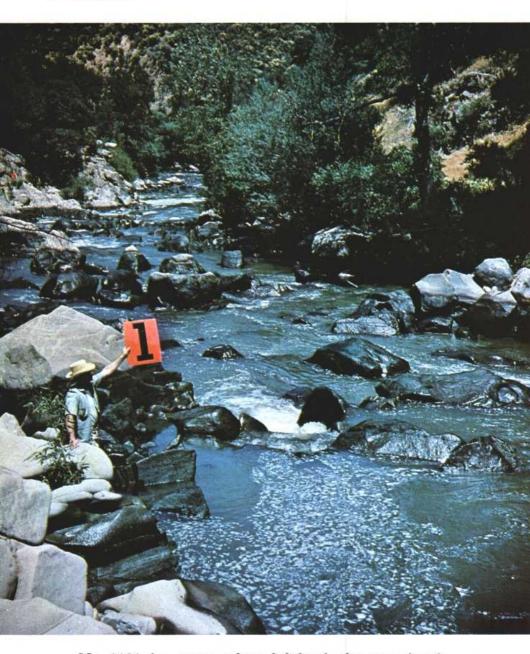
No. 1191 downstream from left bank above section 1, Cache Creek near Lower Lake, Calif.

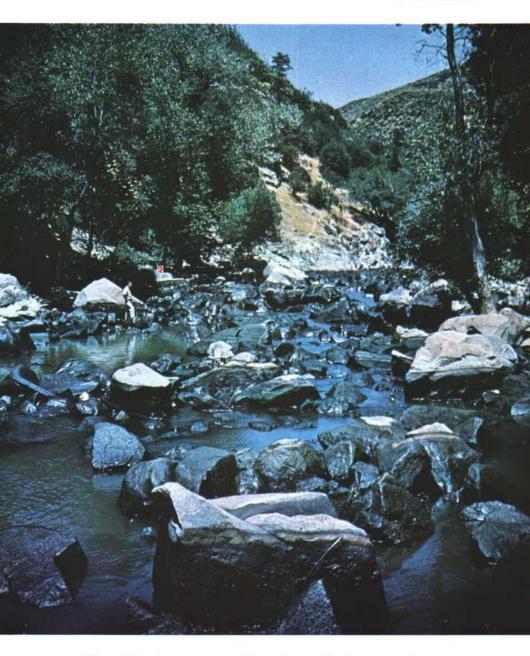
No. 1193 downstream from channel above section 1, Cache Creek near Lower Lake, Calif.

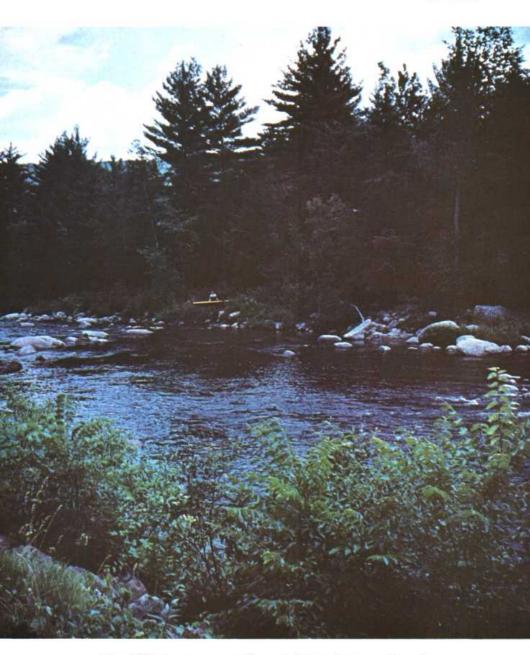
No. 700 downstream from left bank at section 1, East Branch Ausable River at Au Sable Forks, N.Y.

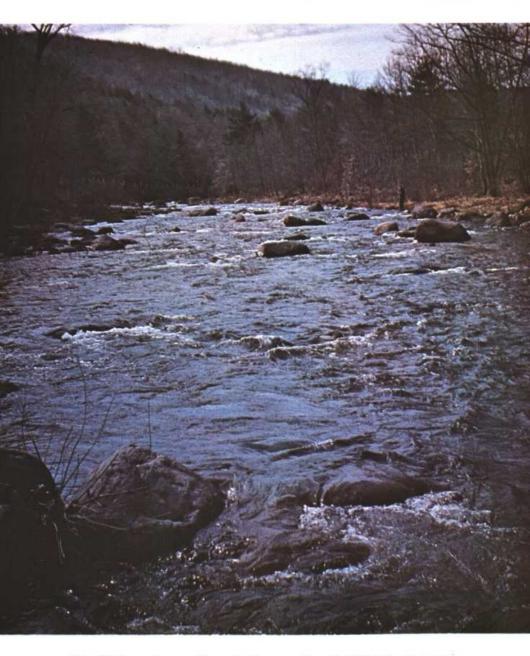
No. 316 upstream from below section 2, Middle Branch Westfield River at Goss Heights, Mass.

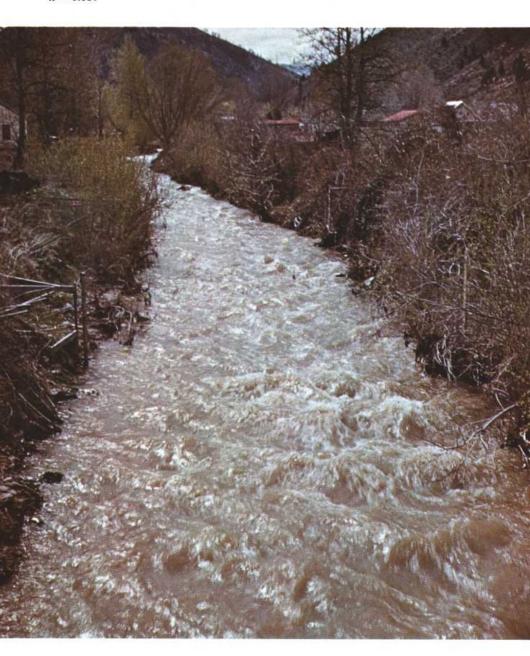
No. 1184 upstream from below section 3, Mission Creek near Cashmere, Wash.

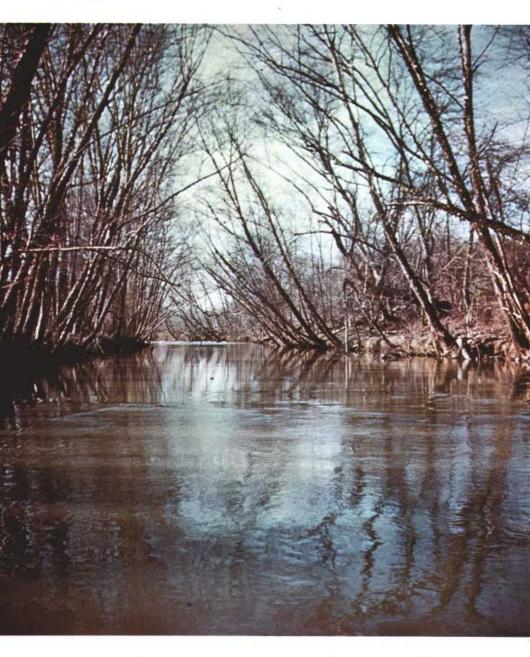
No. 1182 upstream from section 6, Haw River near Benaja, N.C.

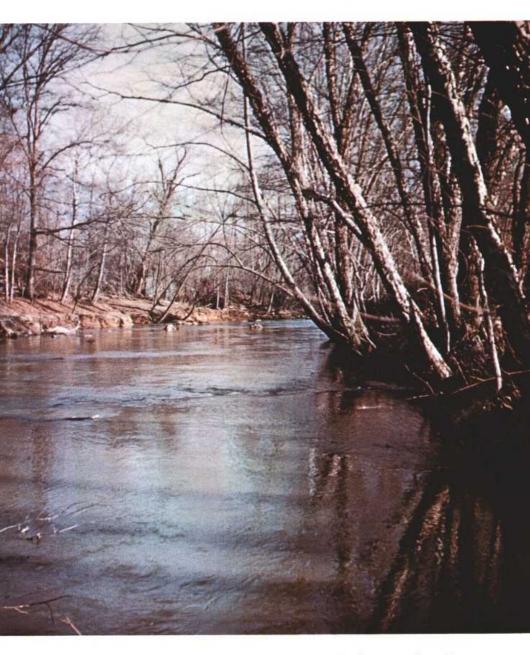
No. 1183 downstream along right bank from section 6, Haw River near Benaja, N.C.

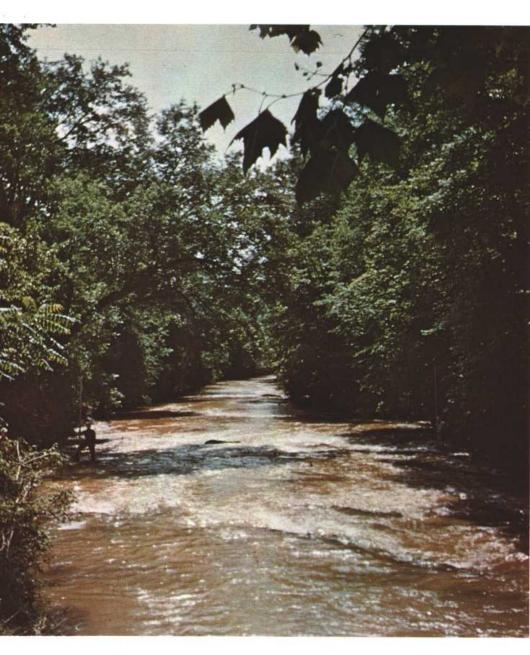
No. 431 downstream from above section 1, Hominy Creek at Candler, N.C.
