Roughness Characteristics of Natural Channels

By HARRY H. BARNES, JR.

U.S. GEOLOGICAL SURVEY WATER-SUPPLY PAPER 1849

Color photographs and descriptive data for 50 stream channels for which roughness coefficients have been determined

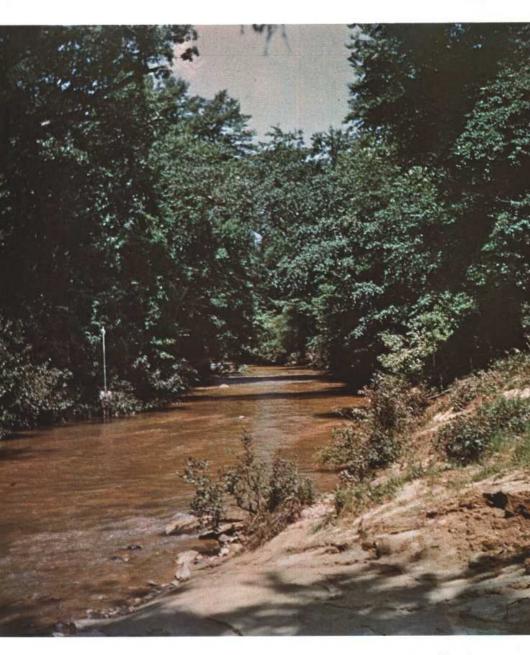
No. 432 upstream from left bank at section 3, Hominy Creek at Candler, N.C.

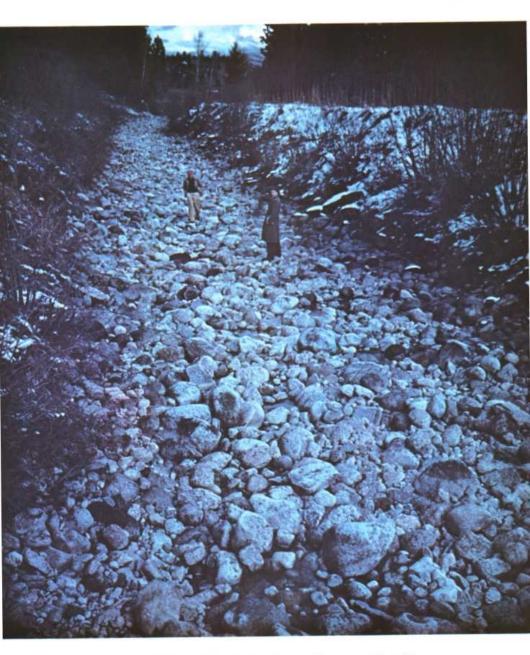
No. 137 downstream from above section 1, Rock Creek Canal near Darby, Mont.

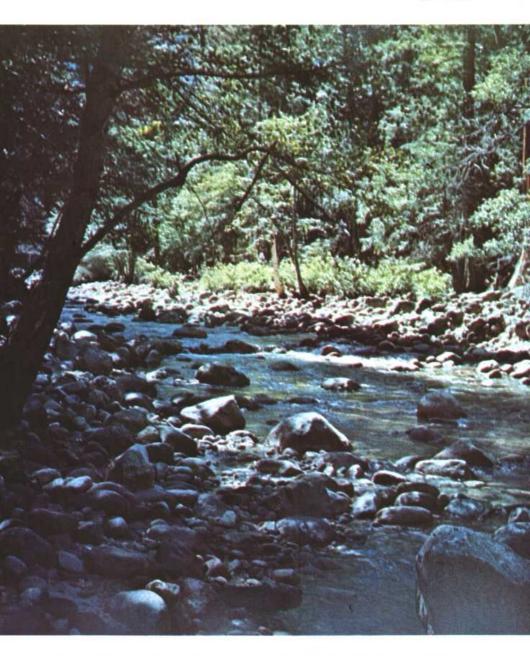
No. 1197 upstream from right bank at section 3, Merced River at Happy Isles Bridge, near Yosemite, Calif.

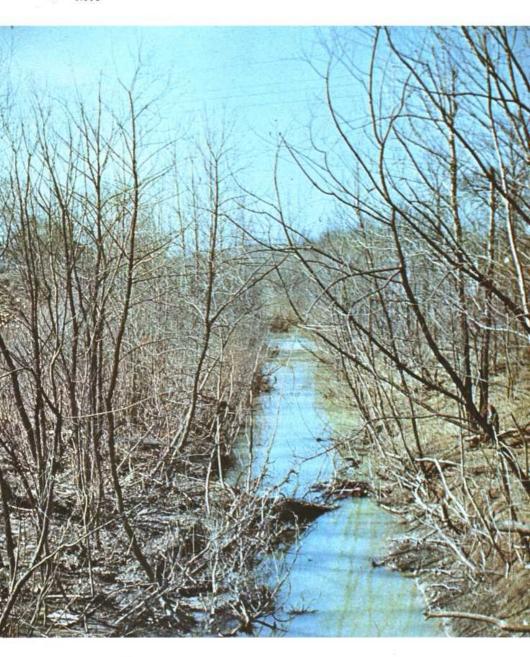
No. 452 downstream from above section 1, Pond Creek near Louisville, Ky.

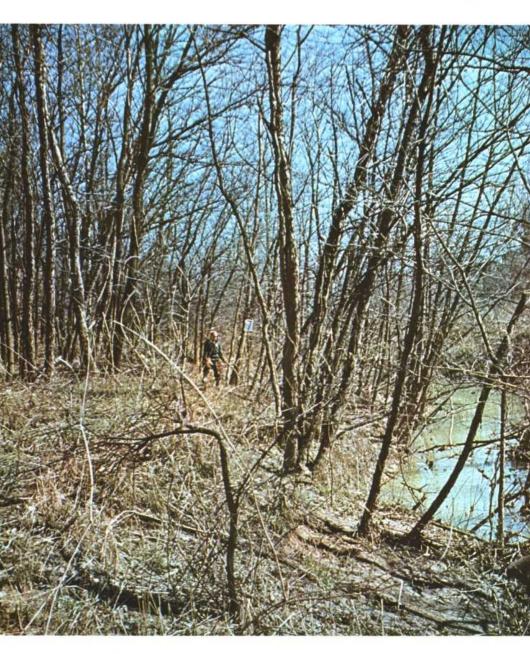
No. 453 upstream from right bank at section 7, Pond Creek near Louisville, Ky.

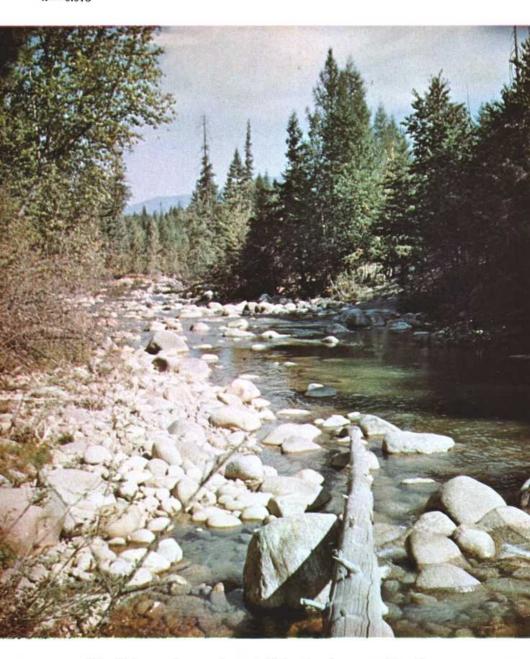
No. 5 downstream from left bank above section 1, Boundary Creek near Porthill, Idaho.

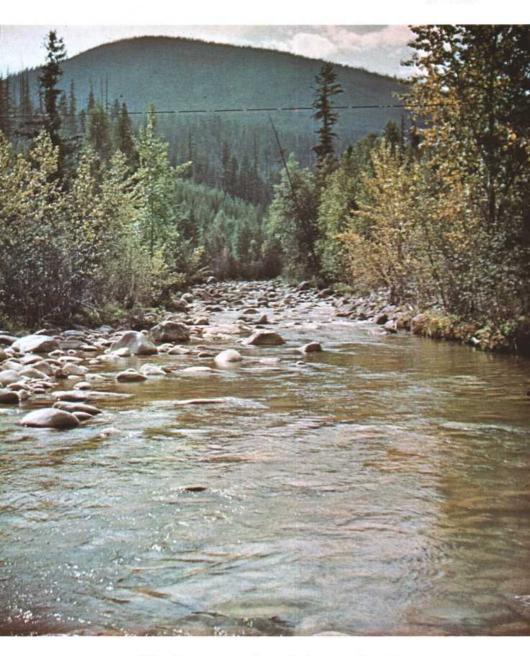
No. 8 upstream from below section 4, Boundary Creek near Porthill, Idaho.

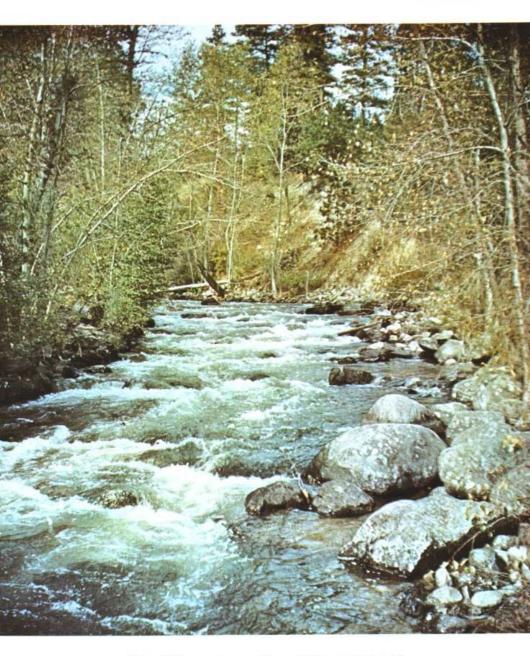
No. 133, upstream from below section 3, Rock Creek near Darby, Mont.
