Summary of Environmental Flow Monitoring for the Sustainable Rivers Project on the Middle Fork Willamette and McKenzie Rivers, Western Oregon, 2014–15

Open-File Report 2016–1186

By Krista L. Jones, Joseph F. Mangano, J. Rose Wallick, Heather D. Bervid, Melissa Olson, Mackenzie K. Keith, and Leslie Bach

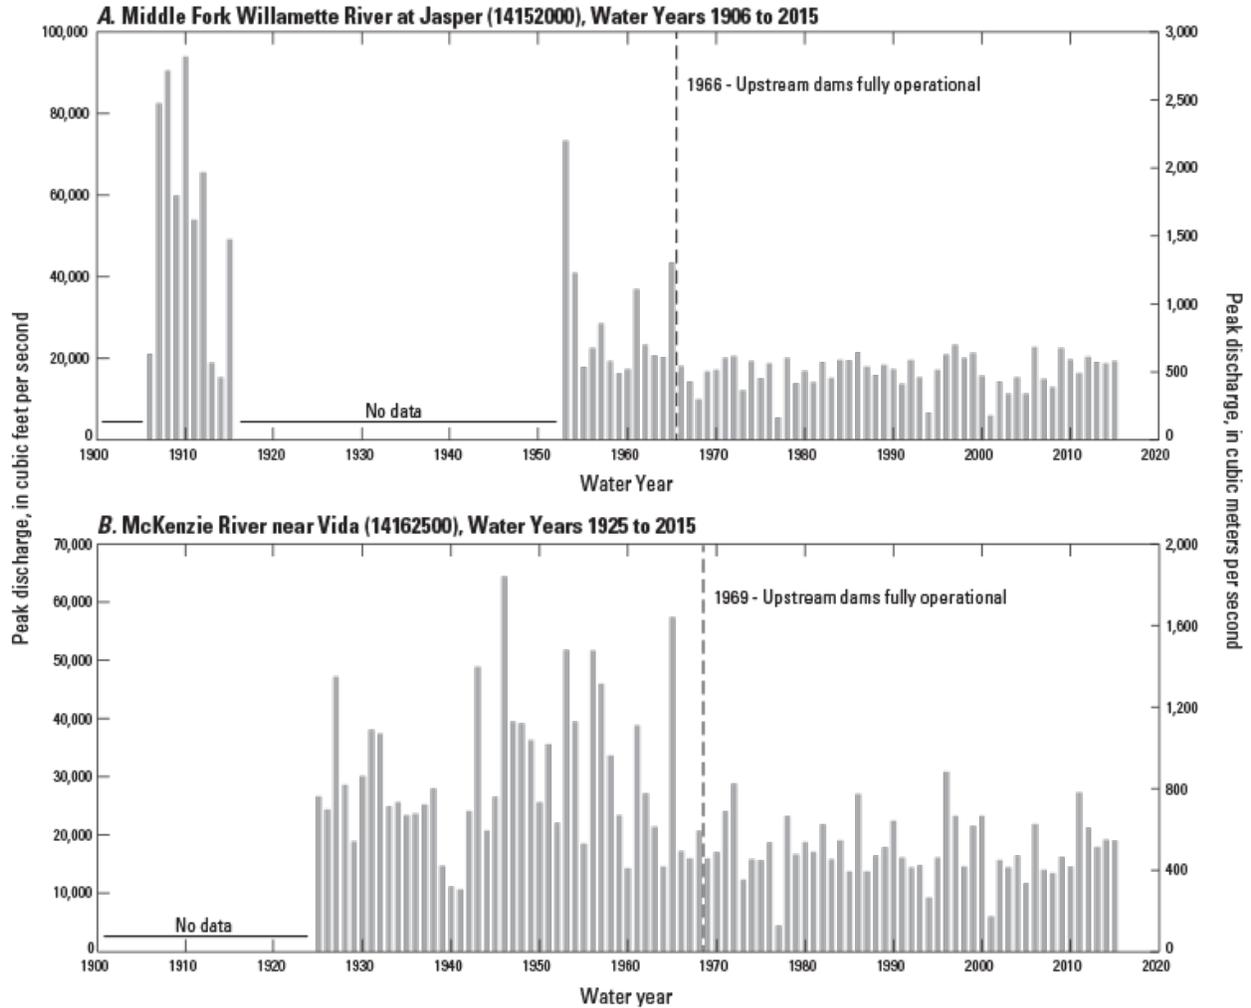
Figure 2. Graphs showing instantaneous peak streamflows for the (A) Middle Fork Willamette River at Jasper, Oregon (USGS streamgauge 14152000), water years 1906–2015; and (B) McKenzie River near Vida, Oregon (USGS streamgauge 14162500), water years 1925–2015.

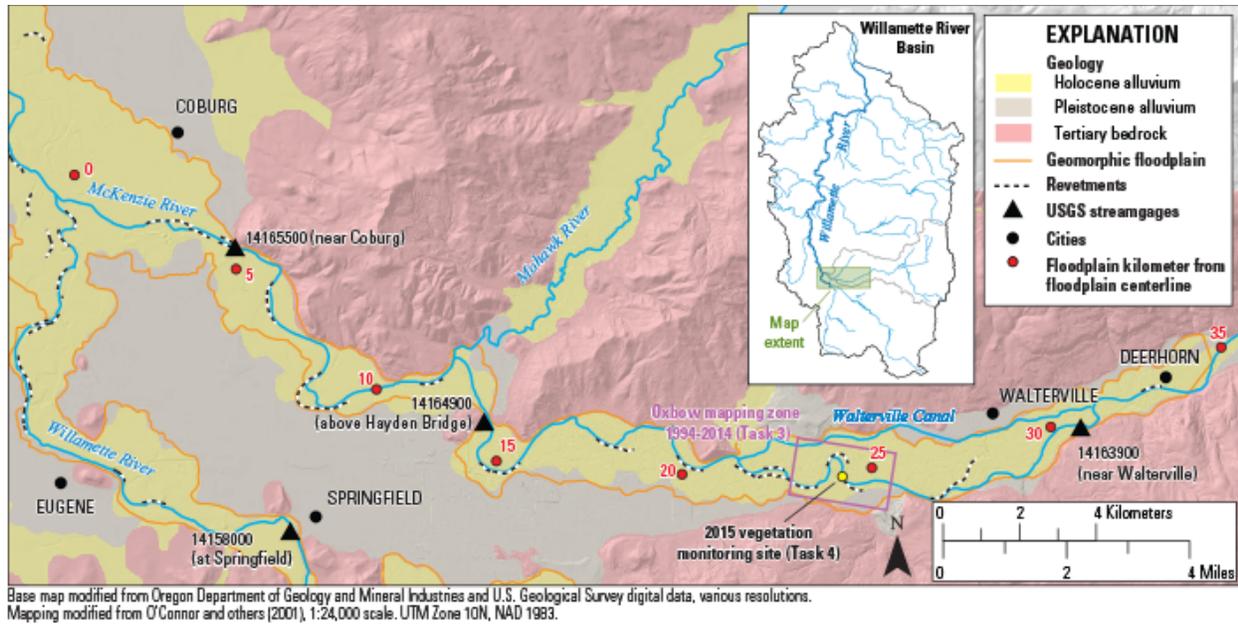
Figure 4. Schematic showing the alluvial section of the McKenzie River, western Oregon. Geology simplified from O'Connor and others (2001).

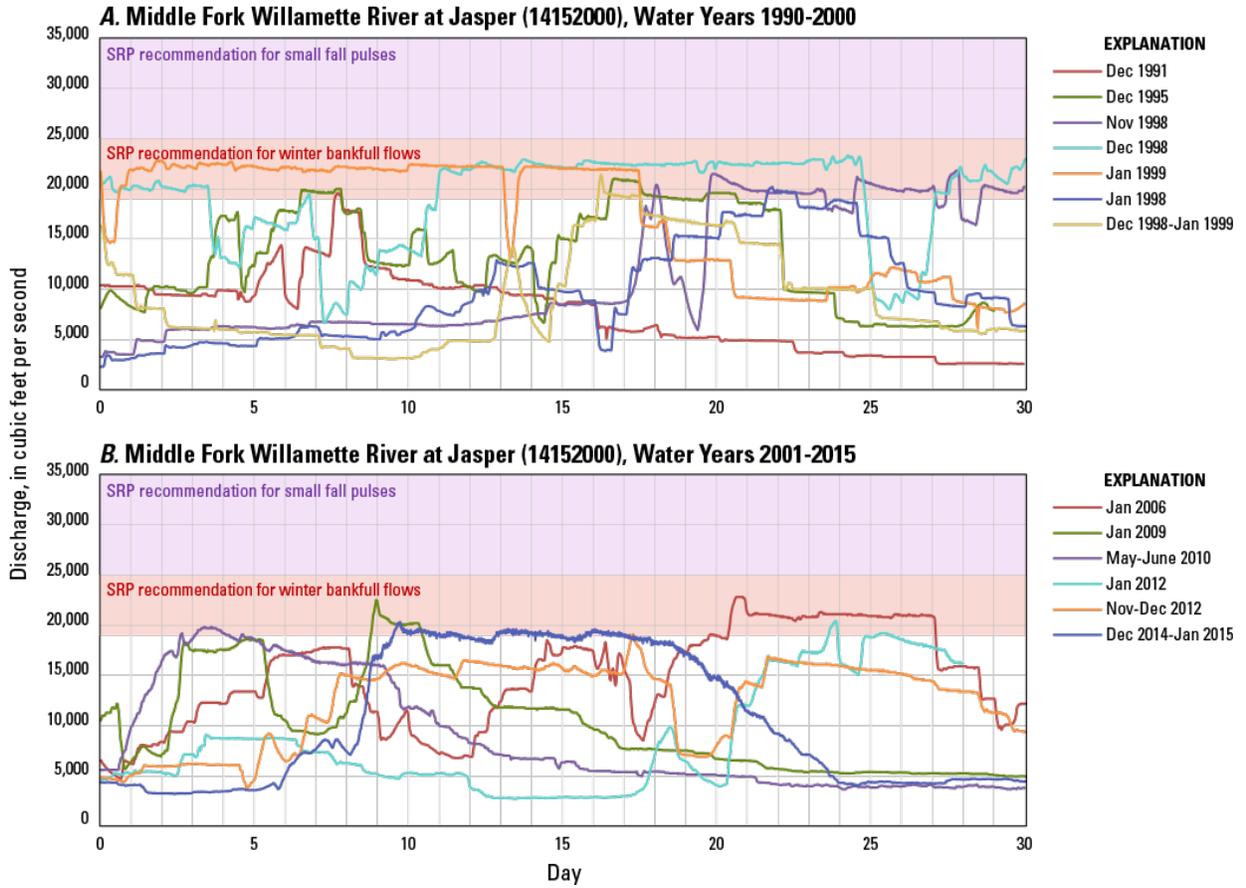
Figure 5. Graphs showing duration of flow events that exceeded bankfull discharge on the Middle Fork Willamette River at Jasper, Oregon (USGS streamgauge 141520000), for (A) water years 1990–2000, and (B) 2001–15. Sustainable Rivers Project (SRP) flow recommendations are from Gregory and others (2007b).

- Flow events that exceed the winter bankfull flow recommendation for multiple days, such as the January 2006 bankfull event that peaked at 22,800 cubic feet per second (ft³/s) and lasted for 6.5 days, are successful at scouring unvegetated gravel bars, resetting shrubs and herbaceous vegetation, and triggering substantial but localized channel changes (such as avulsions in areas with existing side channels). In contrast, shorter duration bankfull events (such as the January 2009 event that peaked at 22,500 ft³ and lasted 1.5 days) primarily affect the location and size of gravel bars and propagate meander migration.

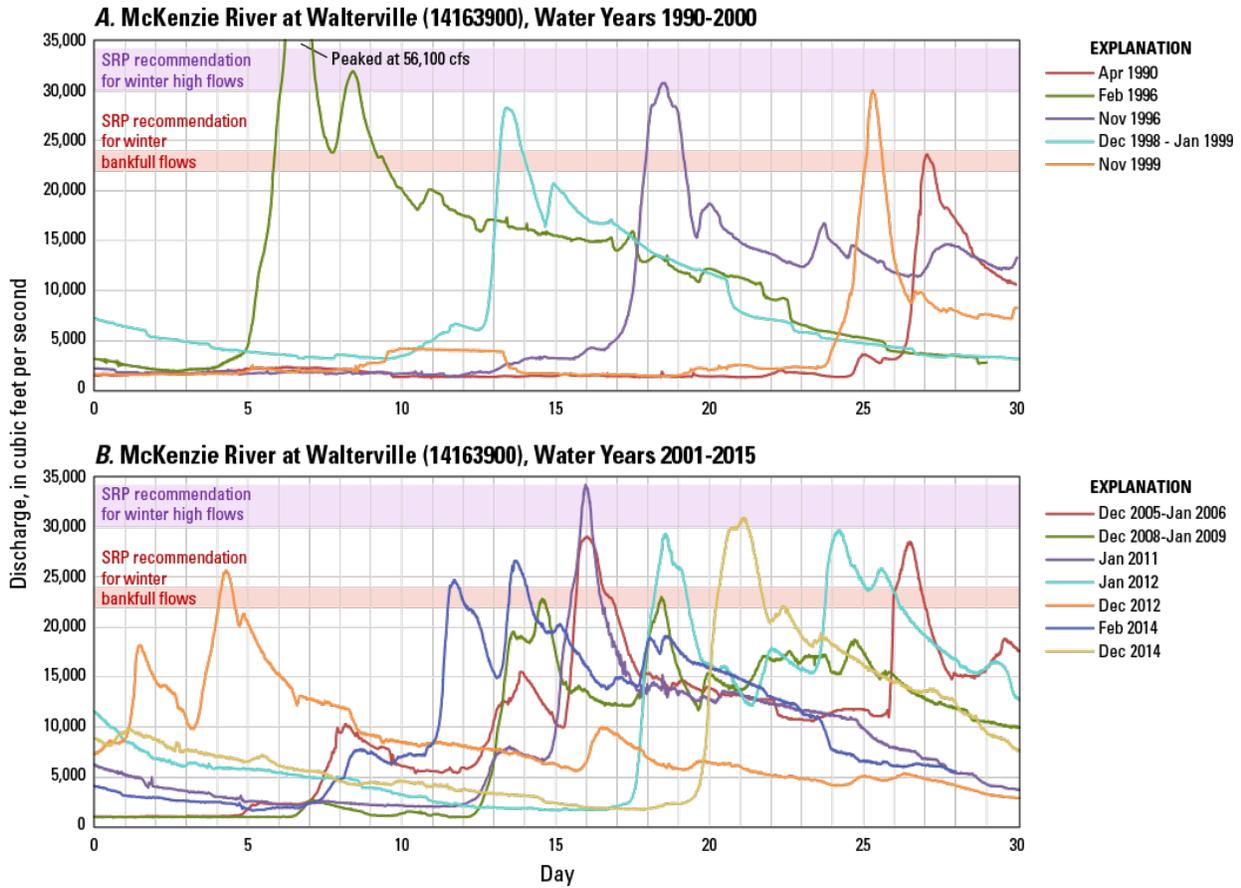
Figure 6. Graphs showing duration of flow events that exceeded bankfull discharge on the McKenzie River near Walterville, Oregon (USGS streamgage 14163900), for (A) water years 1990–2000, and (B) 2001–15. Sustainable Rivers Project (SRP) flow recommendations are from Risley and others (2010b).

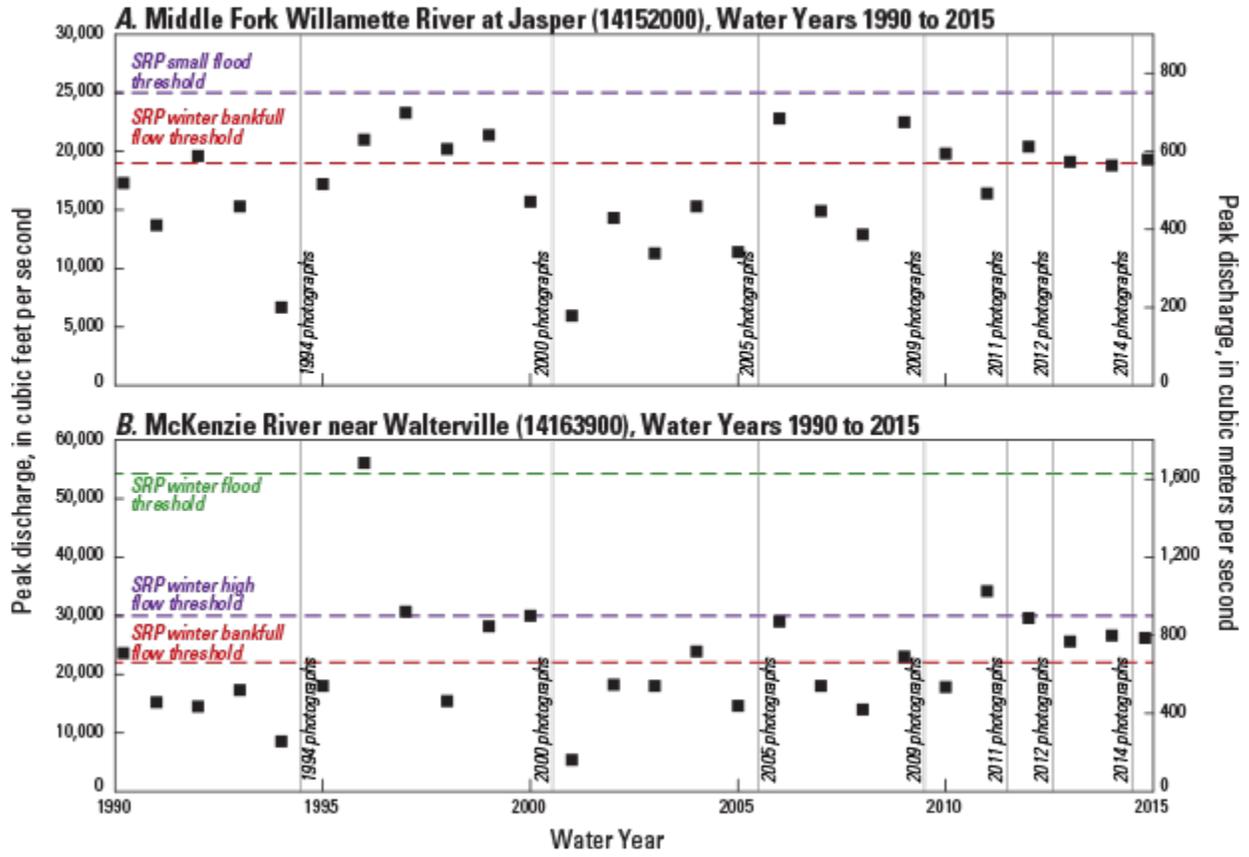
Figure 7. Graphs showing annual peak discharges and aerial photograph collections for water years 1990–15 on the (A) Middle Fork Willamette River at Jasper, Oregon (USGS streamgage 14152000), and (B) McKenzie River near Walthville (USGS streamgage 14163900). Fall flood and winter bankfull recommendations are from the Sustainable Rivers Project (SRP; Gregory and others, 2007b, Risley and others, 2010b). McKenzie River recommendations are for the canal reaches (Risley and others, 2010b).

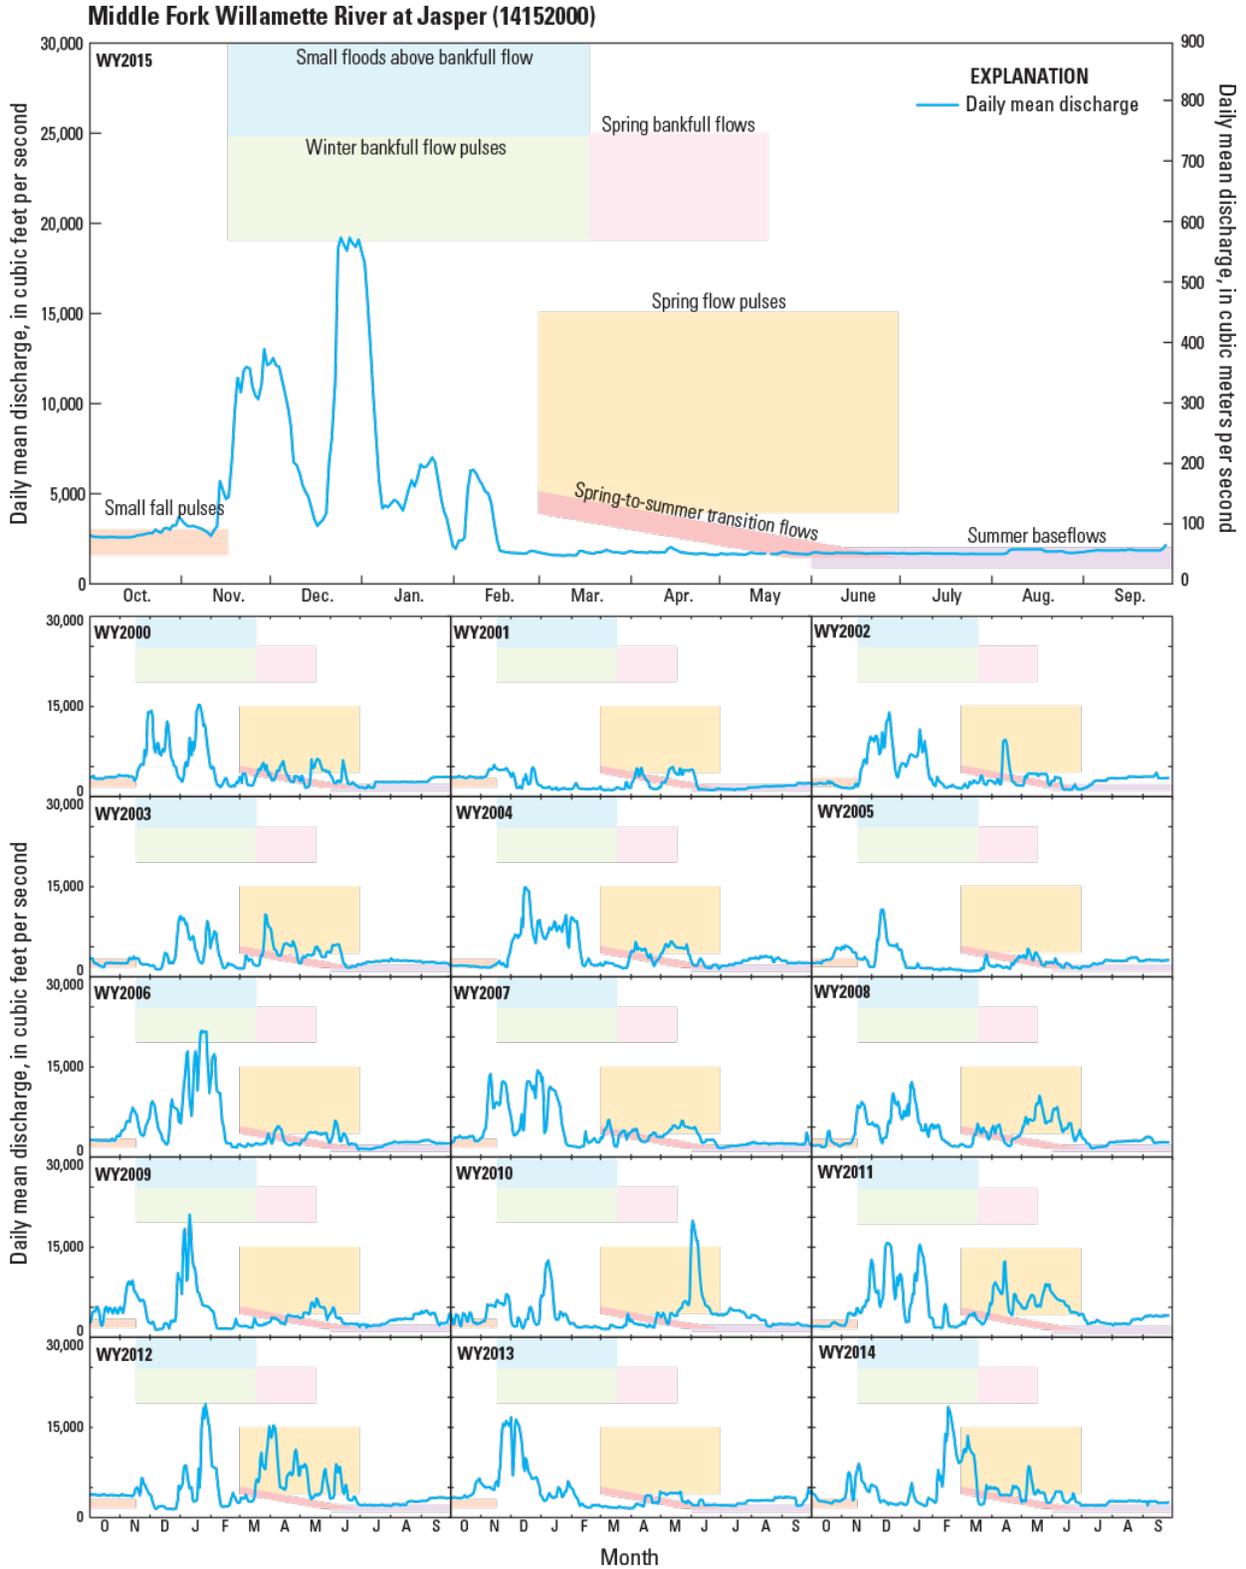
Figure 8. Hydrographs showing daily mean discharge on the Middle Fork Willamette River at Jasper, Oregon (USGS streamgage 14152000), water years 2000–15. Flow recommendations are from the Sustainable Rivers Project (SRP; Gregory and others, 2007b).

In October to mid-November, the Middle Fork Willamette River was near its magnitude for the small fall pulses recommendation (fig. 8; table 7). During this period, the McKenzie River had flows that generally were less than its fall flows recommendation except for during three flow events in November (fig. 9). Both rivers, then, had flow events in late December 2014 that exceeded their SRP winter bankfull recommendations. The bankfull event on the Middle Fork Willamette River surpassed the SRP bankfull recommendation of 19,000 ft³/s for four days during the seven day high-flow period from December 25 to 31, 2014. The bankfull event on the McKenzie River lasted two days, and peaked at 26,200 ft³/s on December 22, 2014.

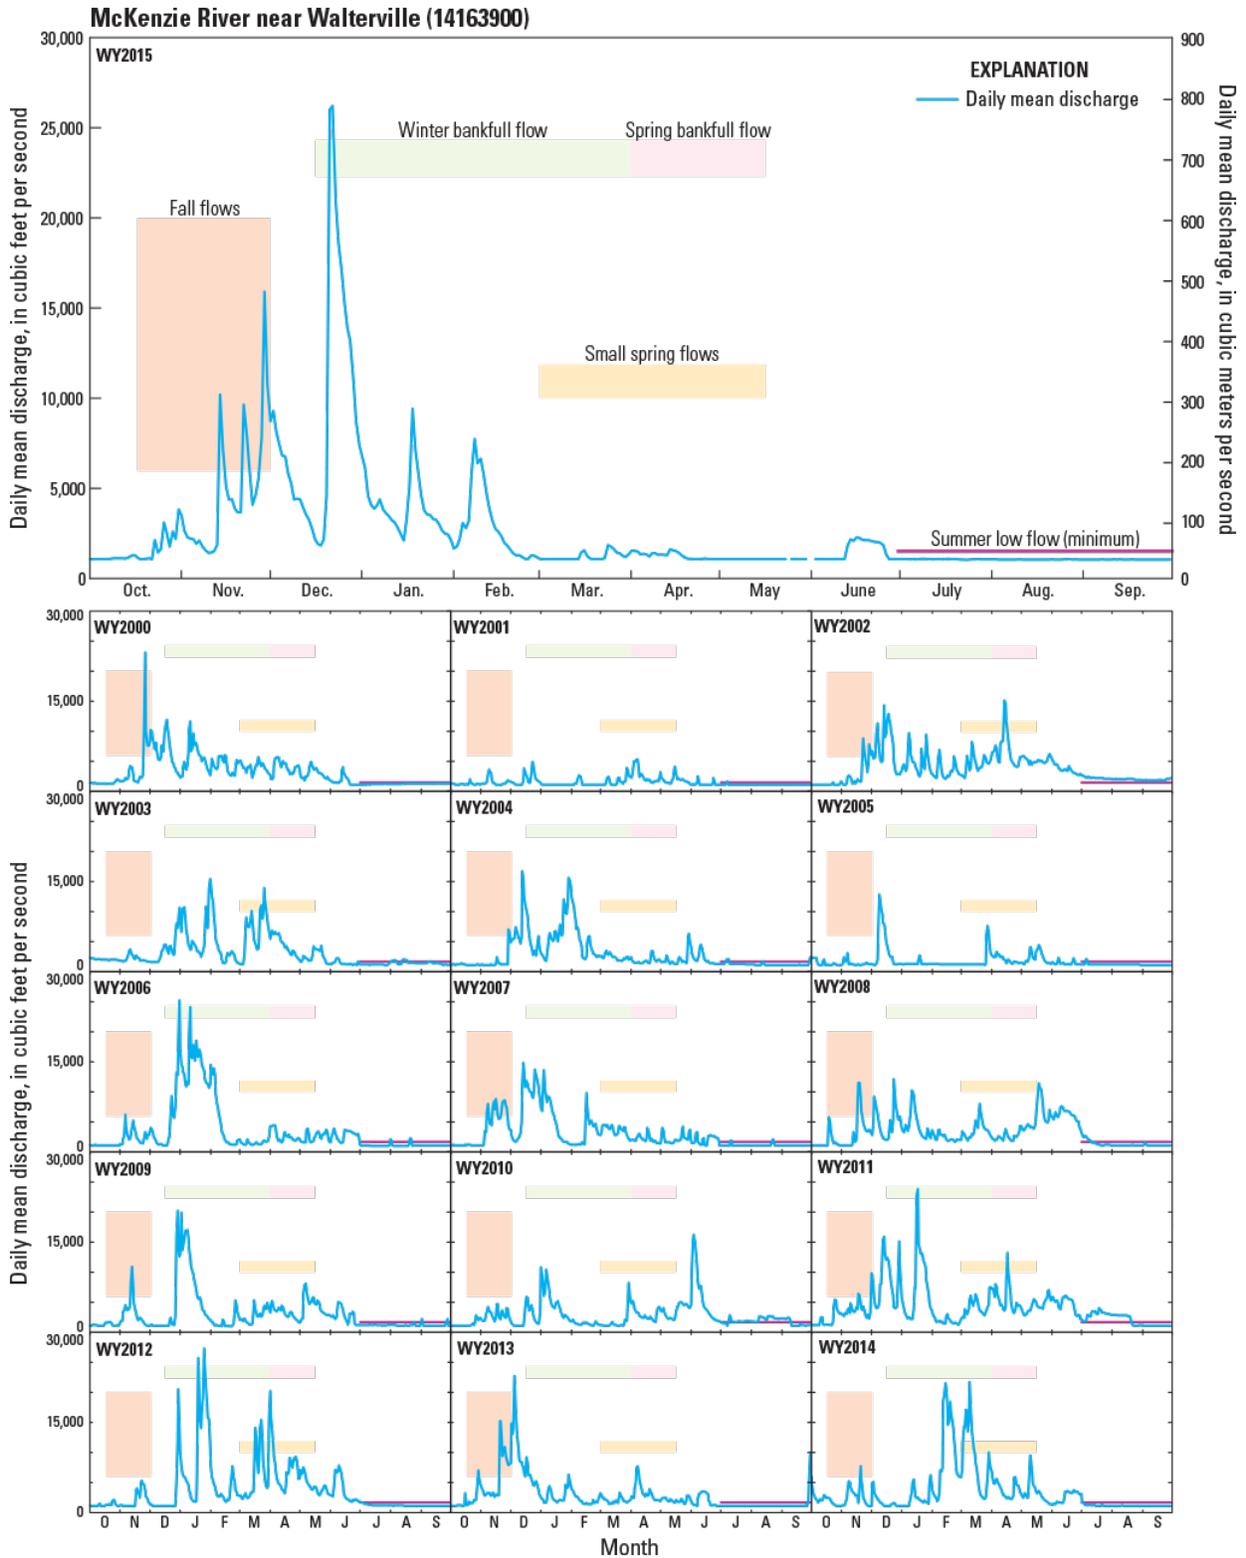
Figure 9. Hydrographs showing daily mean discharge on the McKenzie River near Walterville, Oregon (USGS streamgage 14163900). Flow recommendations are from the Sustainable Rivers Project (SRP) for the canal reaches (Risley and others, 2010b).

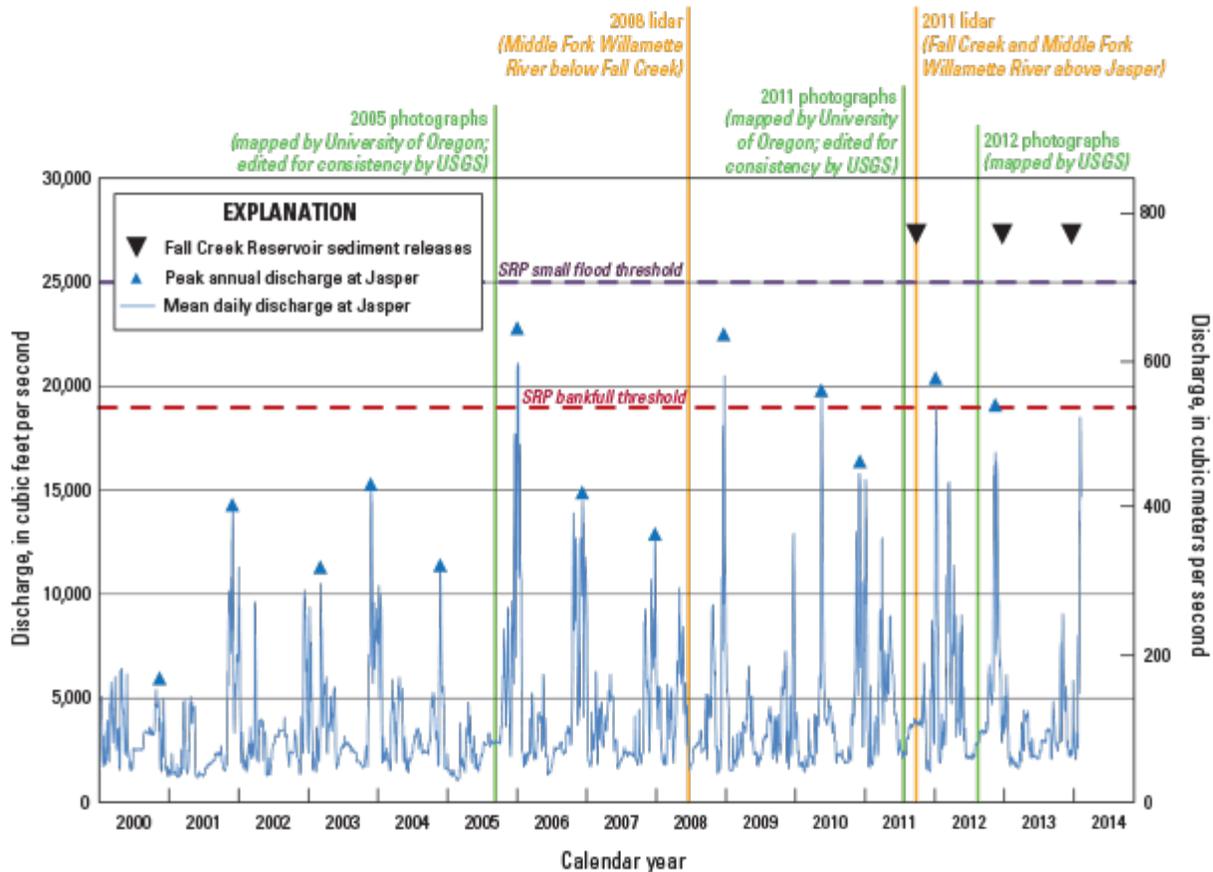
Figure 11. Graph showing peak and mean daily discharge on the Willamette River at Jasper, Oregon (USGS streamgauge 14152000), with dates of aerial photograph and lidar acquisition and releases from the Fall Creek Reservoir.

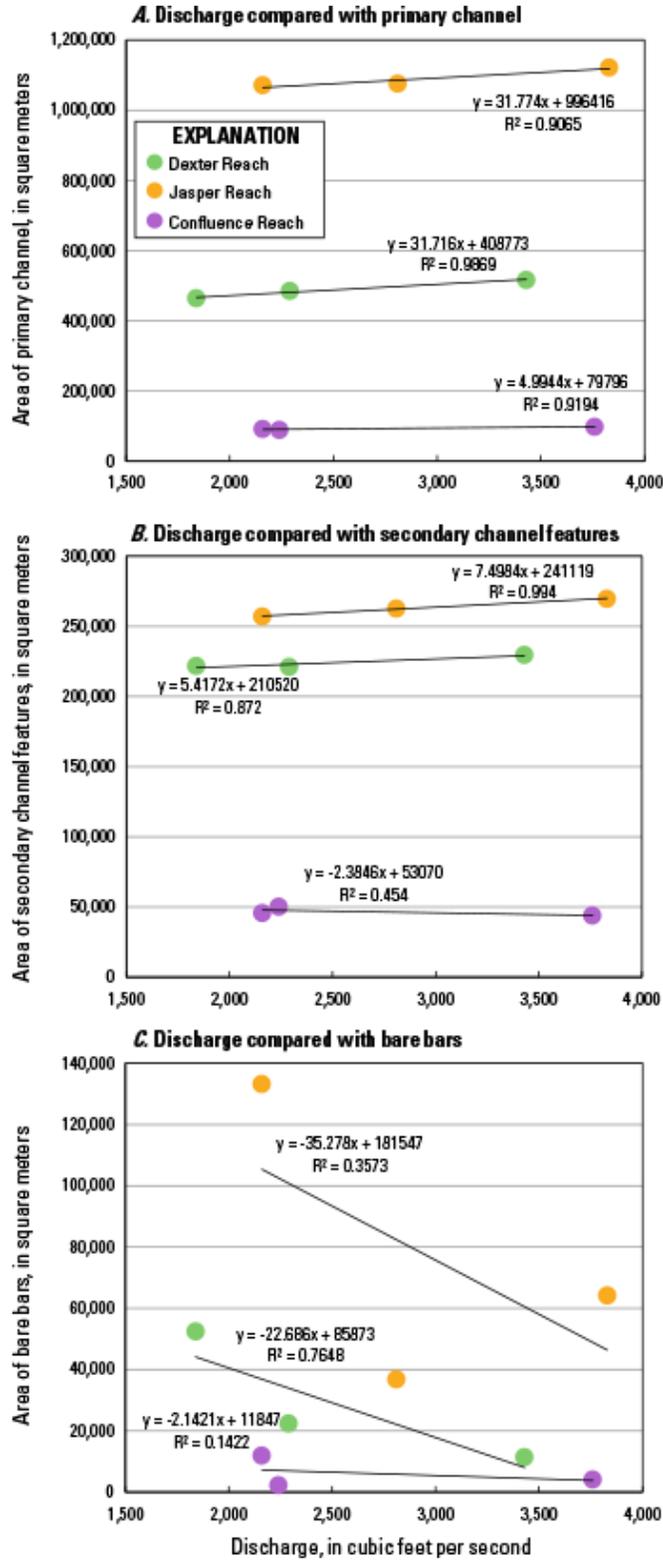
Figure 12. Graphs showing discharge at the time of aerial photograph collection compared with the mapped area of the (A) primary channel, (B) secondary channel features, and (C) bare bars in the alluvial section of the Middle Fork Willamette River, western Oregon, 2005–12.

Imprecise line placement, canopy cover, and differences in stream discharge at the time of aerial photograph acquisition are the key sources of mapping error in this study because they can cause differences in the areas and boundaries of actual and mapped features. Of these error sources, error from line placement is small (typically less than 9 m), and error related to canopy cover primarily affects the outer boundaries of small and narrow wetted features often obscured by dense canopy cover, such as sloughs and secondary channels. The most systematic error in the mapping datasets comes from the aerial photographs being taken at different discharges (“photograph discharge”) even though they were all collected in summer. Photograph discharge generally was least in 2012, slightly greater in 2005, and much greater in 2011 (table 8). This means mapping datasets will have less wetted channel areas and greater bar areas in 2012 (owing to low stage), but greater wetted channel areas and less bar areas in 2005 and 2011 (as channel widens and submerges low elevation bars with increasing discharge; fig. 12).

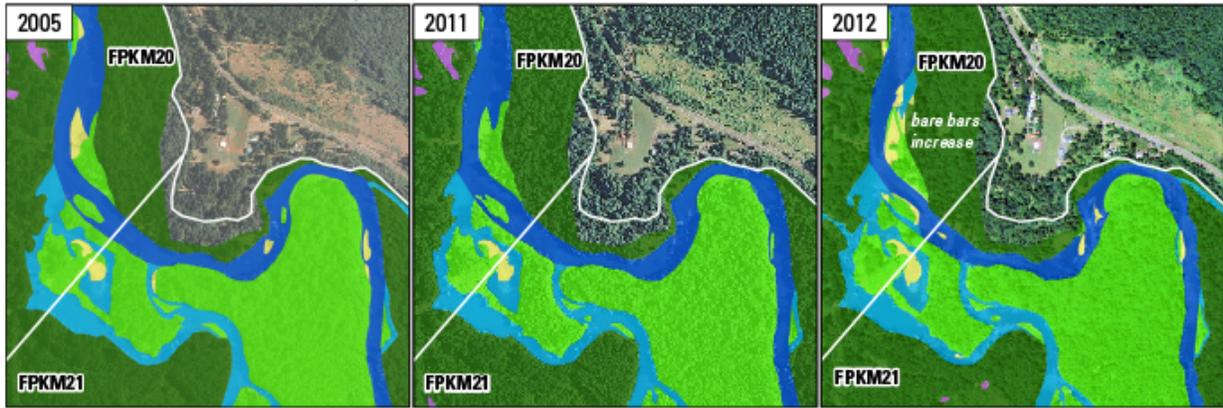
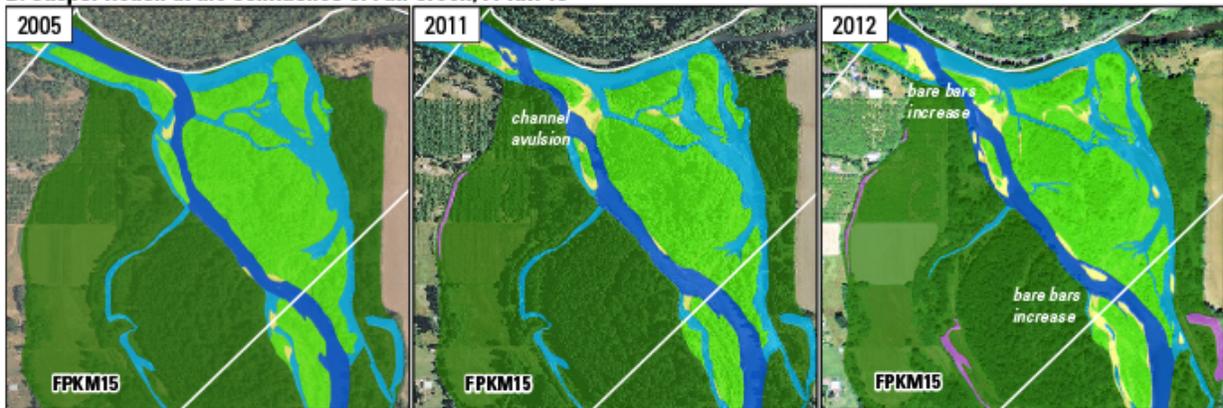
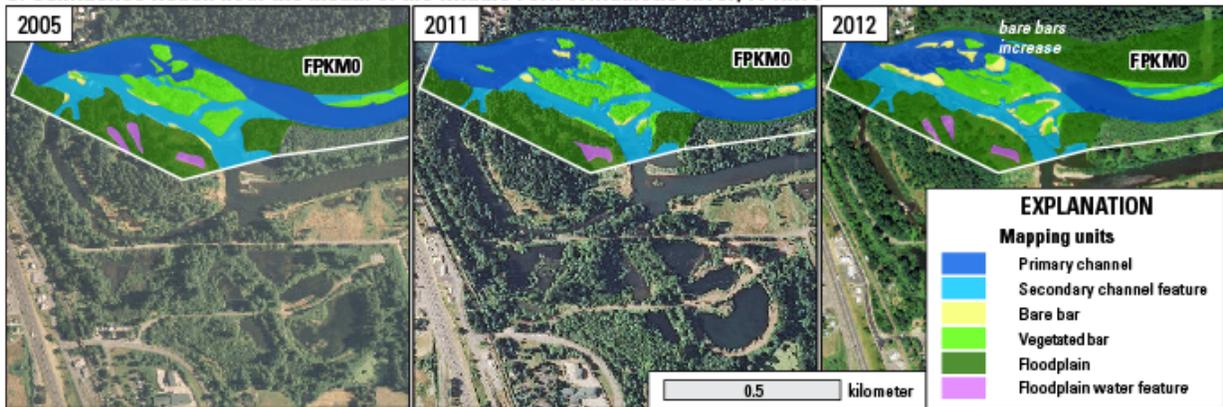
A. Dexter Reach below Dexter Dam, FPKM 20-21

B. Jasper Reach at the confluence of Fall Creek, FPKM 15

C. Confluence Reach near the mouth of the Middle Fork Willamette River, FPKM 0

Figure 13. Aerial photographs showing examples of active channel features and channel change near floodplain kilometers (FPKM) (A) 20–21, (B) 15, and (C) 0 on the Middle Fork Willamette River, western Oregon, 2005–12.

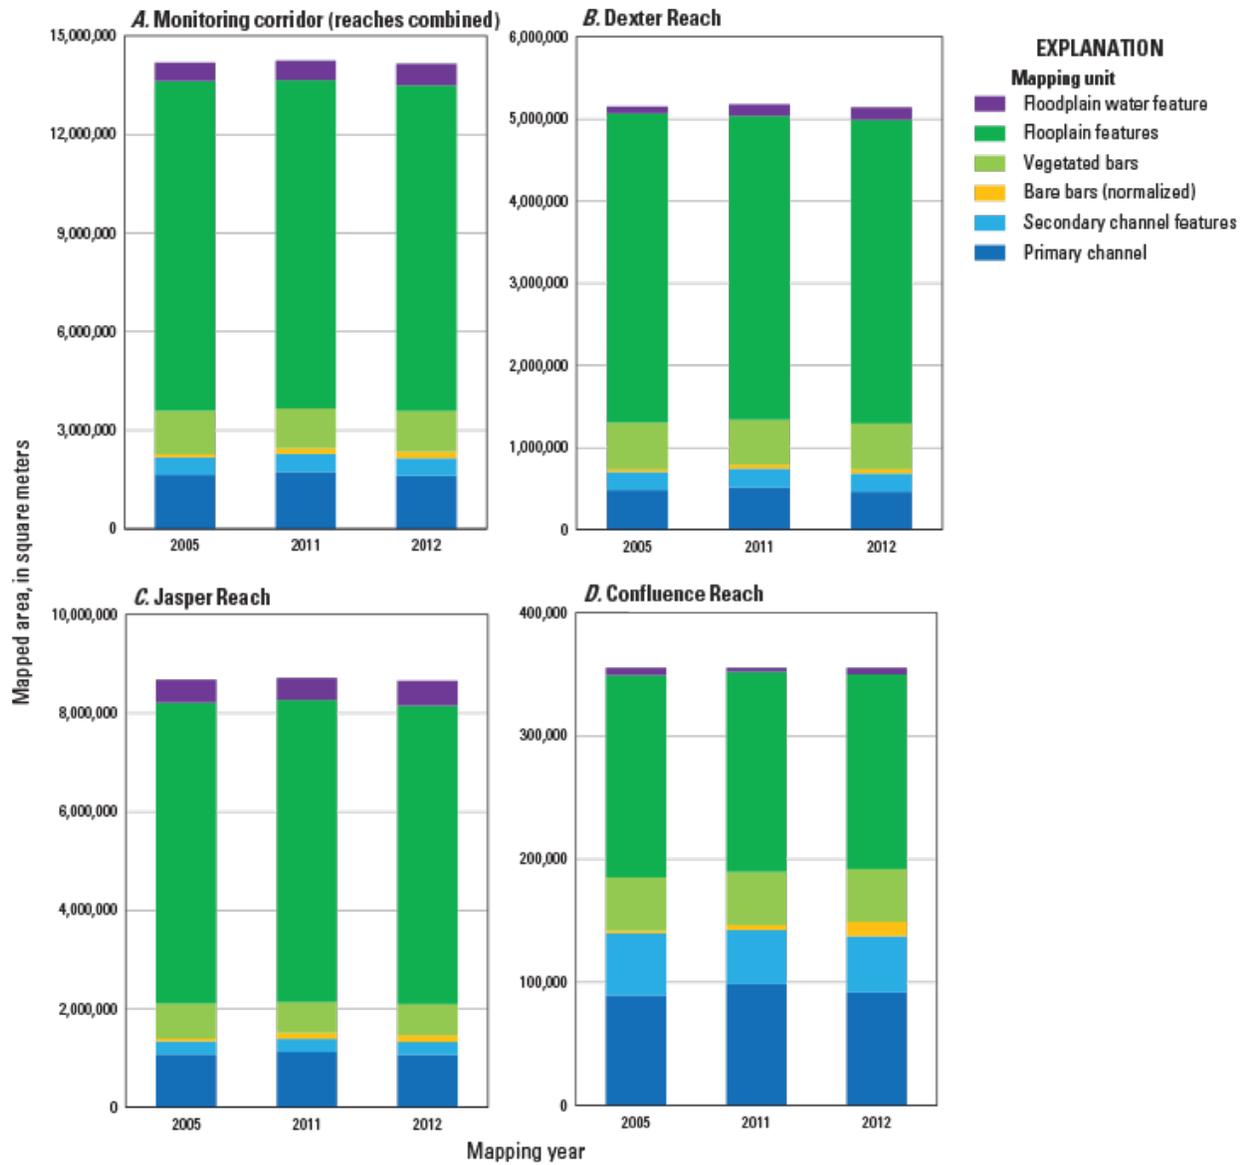
Figure 14. Graphs showing areas of active channel and floodplain features for the monitoring corridor (reaches combined) (A), and Dexter (B), Jasper (C), and Confluence (D) study reaches, Middle Fork Willamette River, western Oregon, 2005, 2011, and 2012.

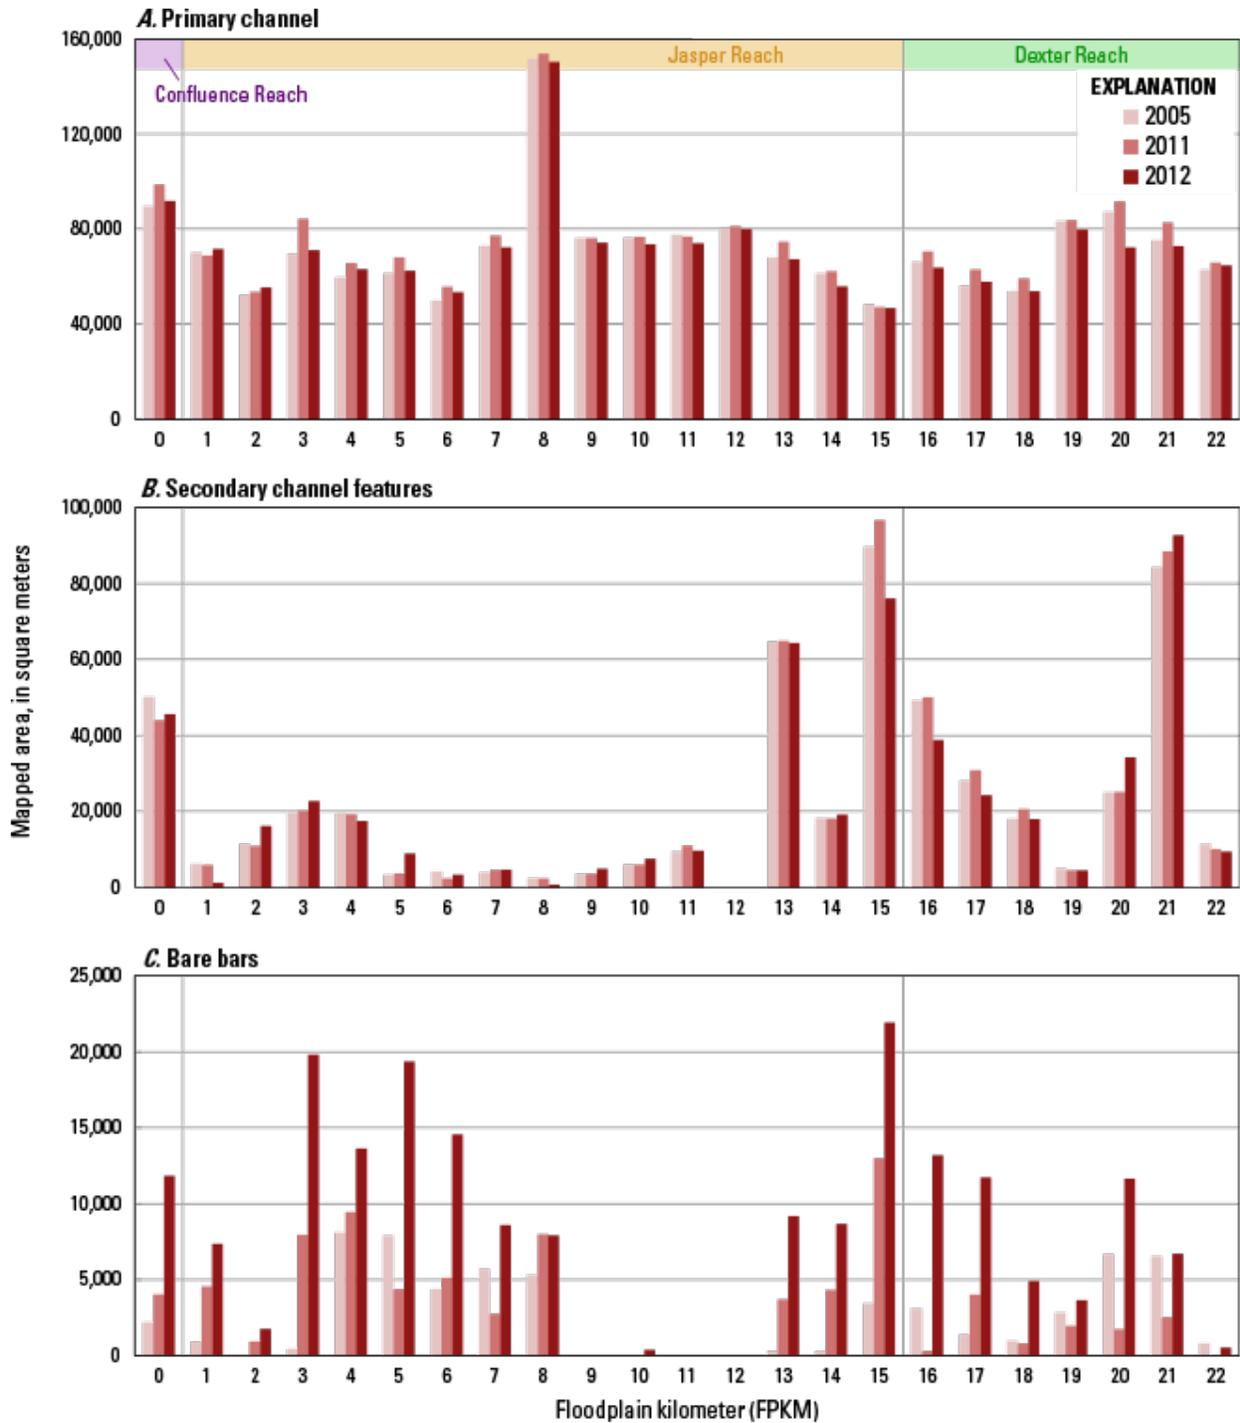
Figure 15. Graphs showing sizes of mapped areas, by floodplain kilometer (transect), of (A) primary channel, (B) secondary channel features, and (C) bare bars in the alluvial section of the Middle Fork Willamette River, western Oregon, in 2005, 2011, and 2012. Areas shown for each floodplain kilometer represent mapped areas that are not normalized by discharge.

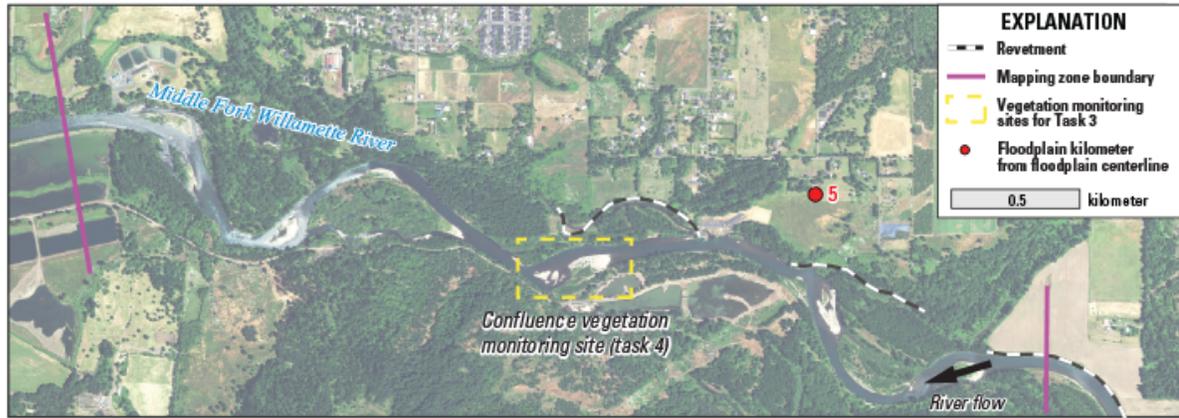
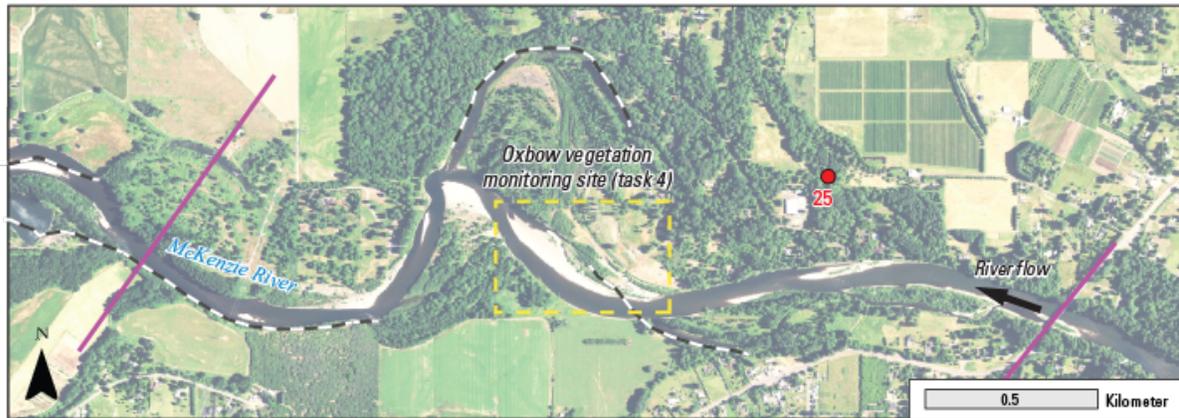
A. Confluence mapping zone near FPKM 3-6, Middle Fork Willamette River

B. Oxbow mapping zone near FPKM 23-25, McKenzie River

Figure 17. Aerial photographs showing mapping zones for mapping channel features and vegetation on the (A) Middle Fork Willamette River near floodplain kilometers (FPKMs) 3–6, and (B) McKenzie River near FPKMs 23–25, western Oregon, 1994–2014. Photographs also show the locations of two vegetation monitoring sites located in these mapping zones.

We focused repeat mapping of channel features and vegetation coverage in two mapping zones, one on the Middle Fork Willamette River (fig. 17A) and one on the McKenzie River (fig. 17B). These mapping zones correspond with the monitoring zones identified in the forthcoming SRP monitoring framework as critical river segments to focus future monitoring efforts for the Sustainable Rivers Program (Rose Wallick, USGS, verbal commun., May 18, 2015). The mapping zones for this study were identified as geomorphically dynamic segments with actively shifting gravel bars, side channels and flanking low elevation floodplains, and young stands of woody vegetation that were more likely to respond to environmental flows than other, more intrinsically stable sections of each river corridor. The mapping zones used in this study have comparable water surface slopes when measured from lidar, ranging from 0.225 percent in the Middle Fork Willamette River zone to 0.204 and 0.255 percent in the McKenzie zone before and after the channel avulsion. The selected zones encompass the TNC Willamette Confluence Preserve on the Middle Fork Willamette River (FPKMs 3–6) and the McKenzie Oxbow Conservation Area (FPKMs 23–25), where we set up two sites for monitoring black cottonwood and other vegetation for Task 4. Historically, these zones were shaped by similar geomorphic processes, including avulsions and meander migration.

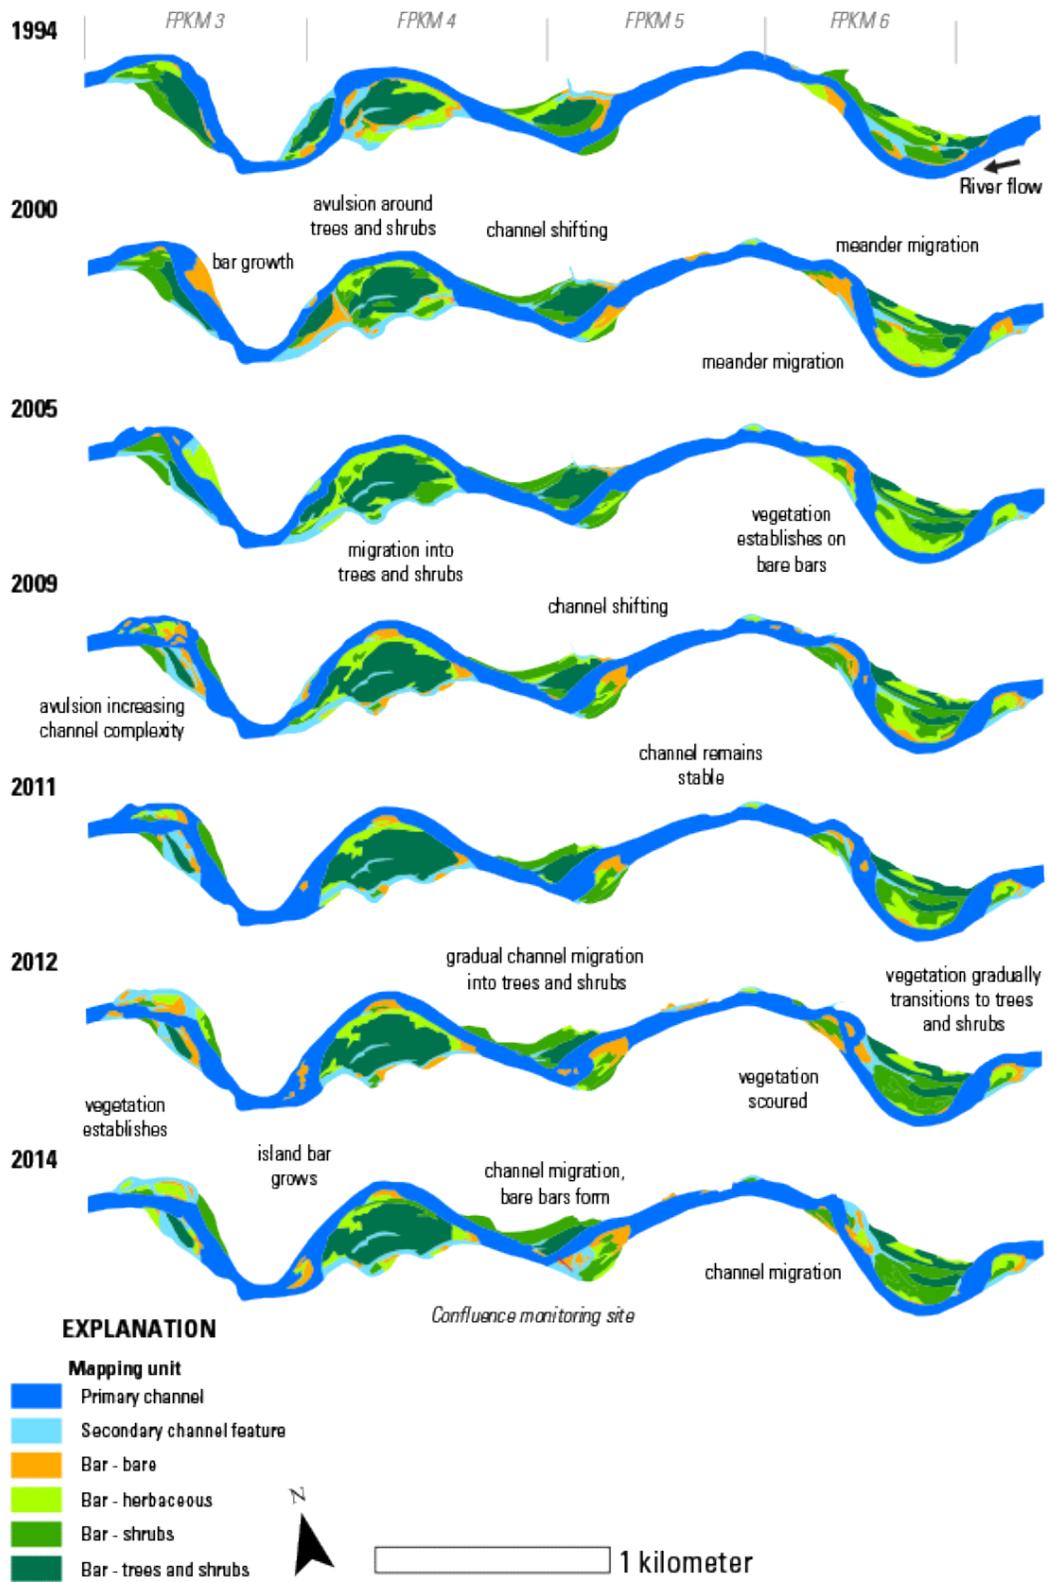
Figure 18. Diagrams showing mapped channels and vegetation features near floodplain kilometers (FPKMs) 3–6 in the Confluence mapping zone of the Middle Fork Willamette River, western Oregon, 1994–2014.

- From 2012 to 2014, the channel migrated 35 m into trees and shrubs in FPKM 6, leaving behind secondary channel features and bare bars. It also migrated 20 m at the boundary of FPKMs 4 and 5, creating new secondary channel features and bare bars. The mapped area of secondary channel features increased from 58,000 to 73,1005 m² (about 26 percent)

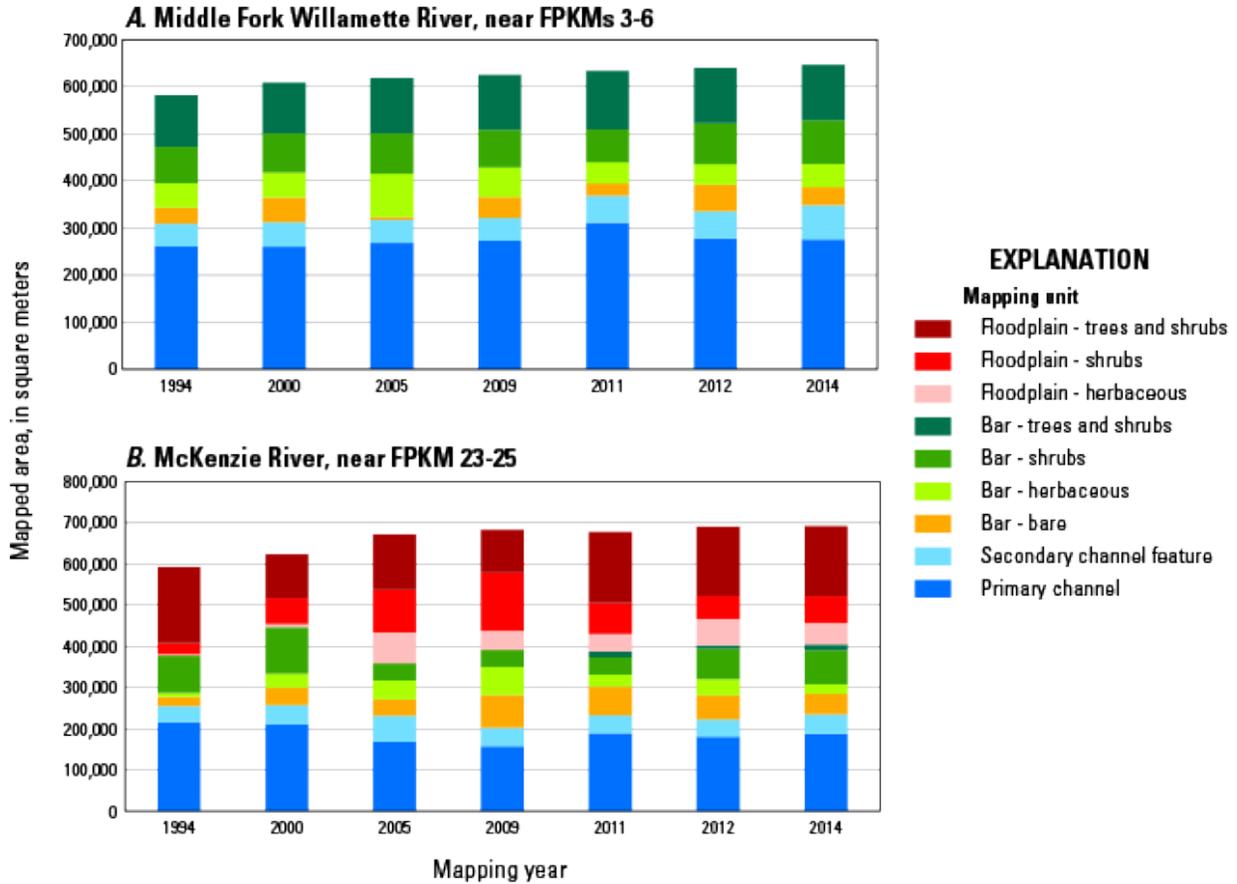
Figure 19. Graph showing relative sizes of mapped areas of primary channel, secondary channel features, and gravel bars in each floodplain transect for the (A) Confluence mapping zone of the Middle Fork Willamette River, and (B) Oxbow mapping zone of the McKenzie River, western Oregon, 1994–2014.
