Summary of Environmental Flow Monitoring for the Sustainable Rivers Project on the Middle Fork Willamette and McKenzie Rivers, Western Oregon, 2014–15

Open-File Report 2016–1186

By Krista L. Jones, Joseph F. Mangano, J. Rose Wallick, Heather D. Bervid, Melissa Olson, Mackenzie K. Keith, and Leslie Bach

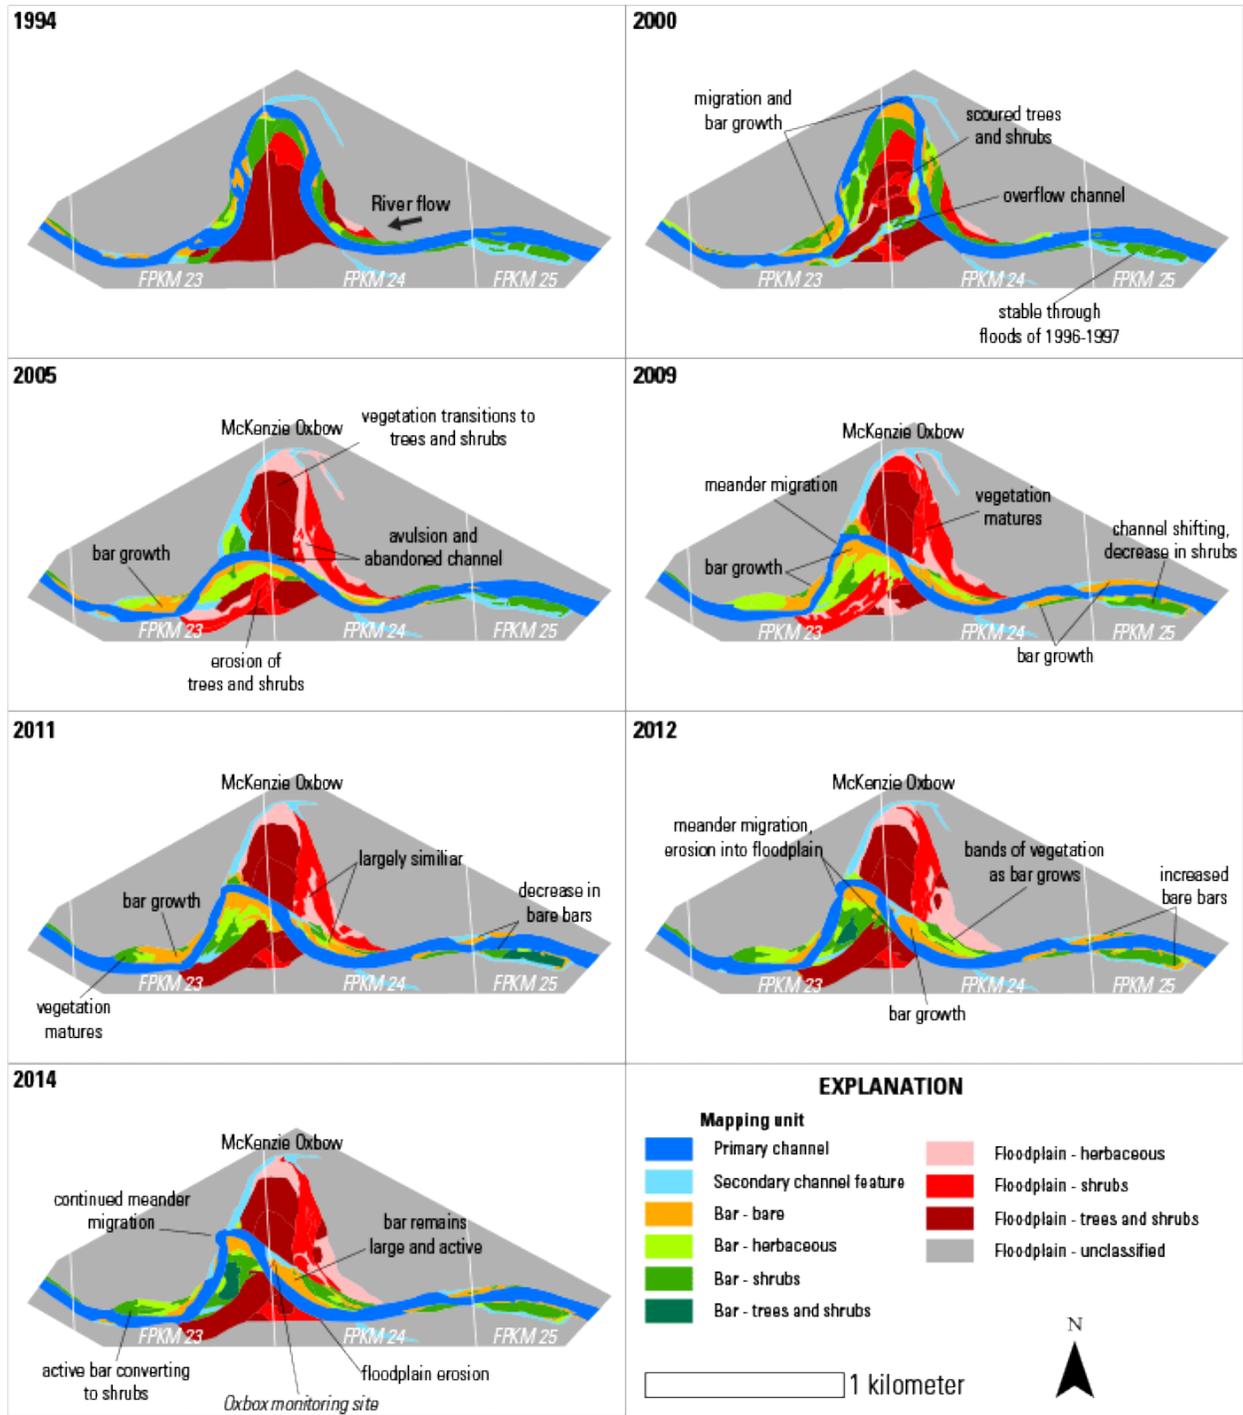
Figure 20. Diagrams showing mapped channels and vegetation features near floodplain kilometers (FPKMs) 23–25 in the Oxbow mapping zone of the McKenzie River, western Oregon, 1994–2014.

- From 2009 to 2011, the primary channel had a stable planform. The much greater photograph discharge for 2011 compared to 2009 probably accounts for some of the increases in the mapped area of primary channel and decreases in the mapped area of bare gravel bars (table 11). Vegetation transitioned to trees and shrubs along the overflow channel.

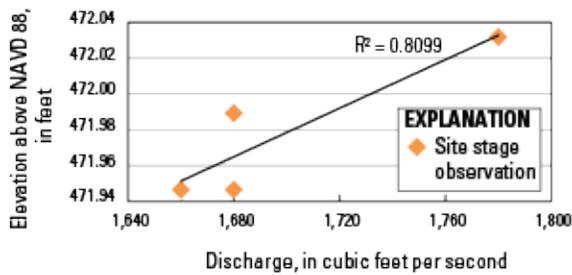
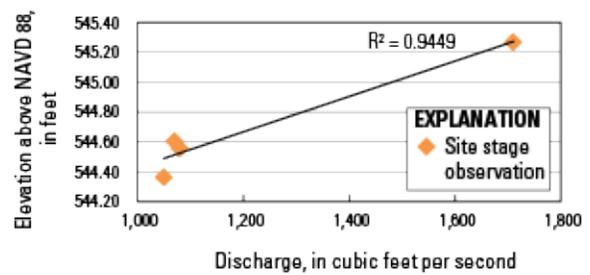
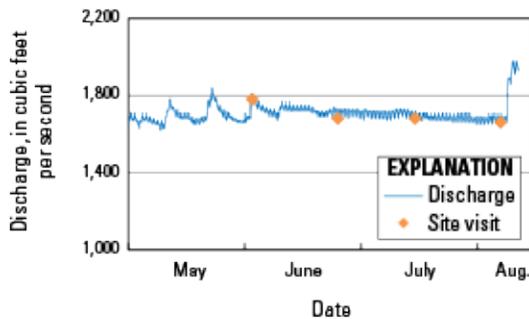
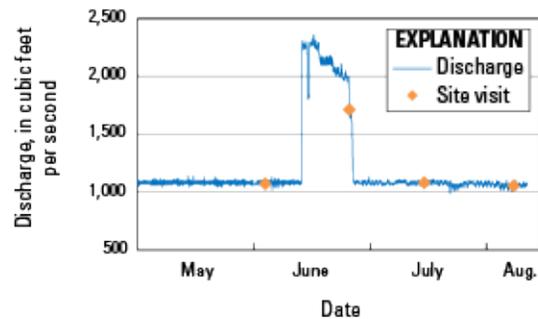
A. Discharge from the Middle Fork Willamette River at Jasper (14152000) streamgauge compared with stage observations at the Confluence monitoring site

B. Discharge from the McKenzie River near Walterville (14163900) streamgauge compared with stage observations at the Oxbow monitoring site

C. Timing of site stage observations compared with discharge from the Middle Fork Willamette River at Jasper (14152000)

D. Timing of site stage observations compared with discharge from the McKenzie River near Walterville (14163900)

Figure 22. Graphs showing instantaneous discharge at USGS streamgages (Middle Fork Willamette at Jasper [14152000] and McKenzie River near Walterville [14163900]) and stage observations at the Confluence monitoring site on Middle Fork Willamette River (A,C) and Oxbow Monitoring site on the McKenzie River (B,D), western Oregon.

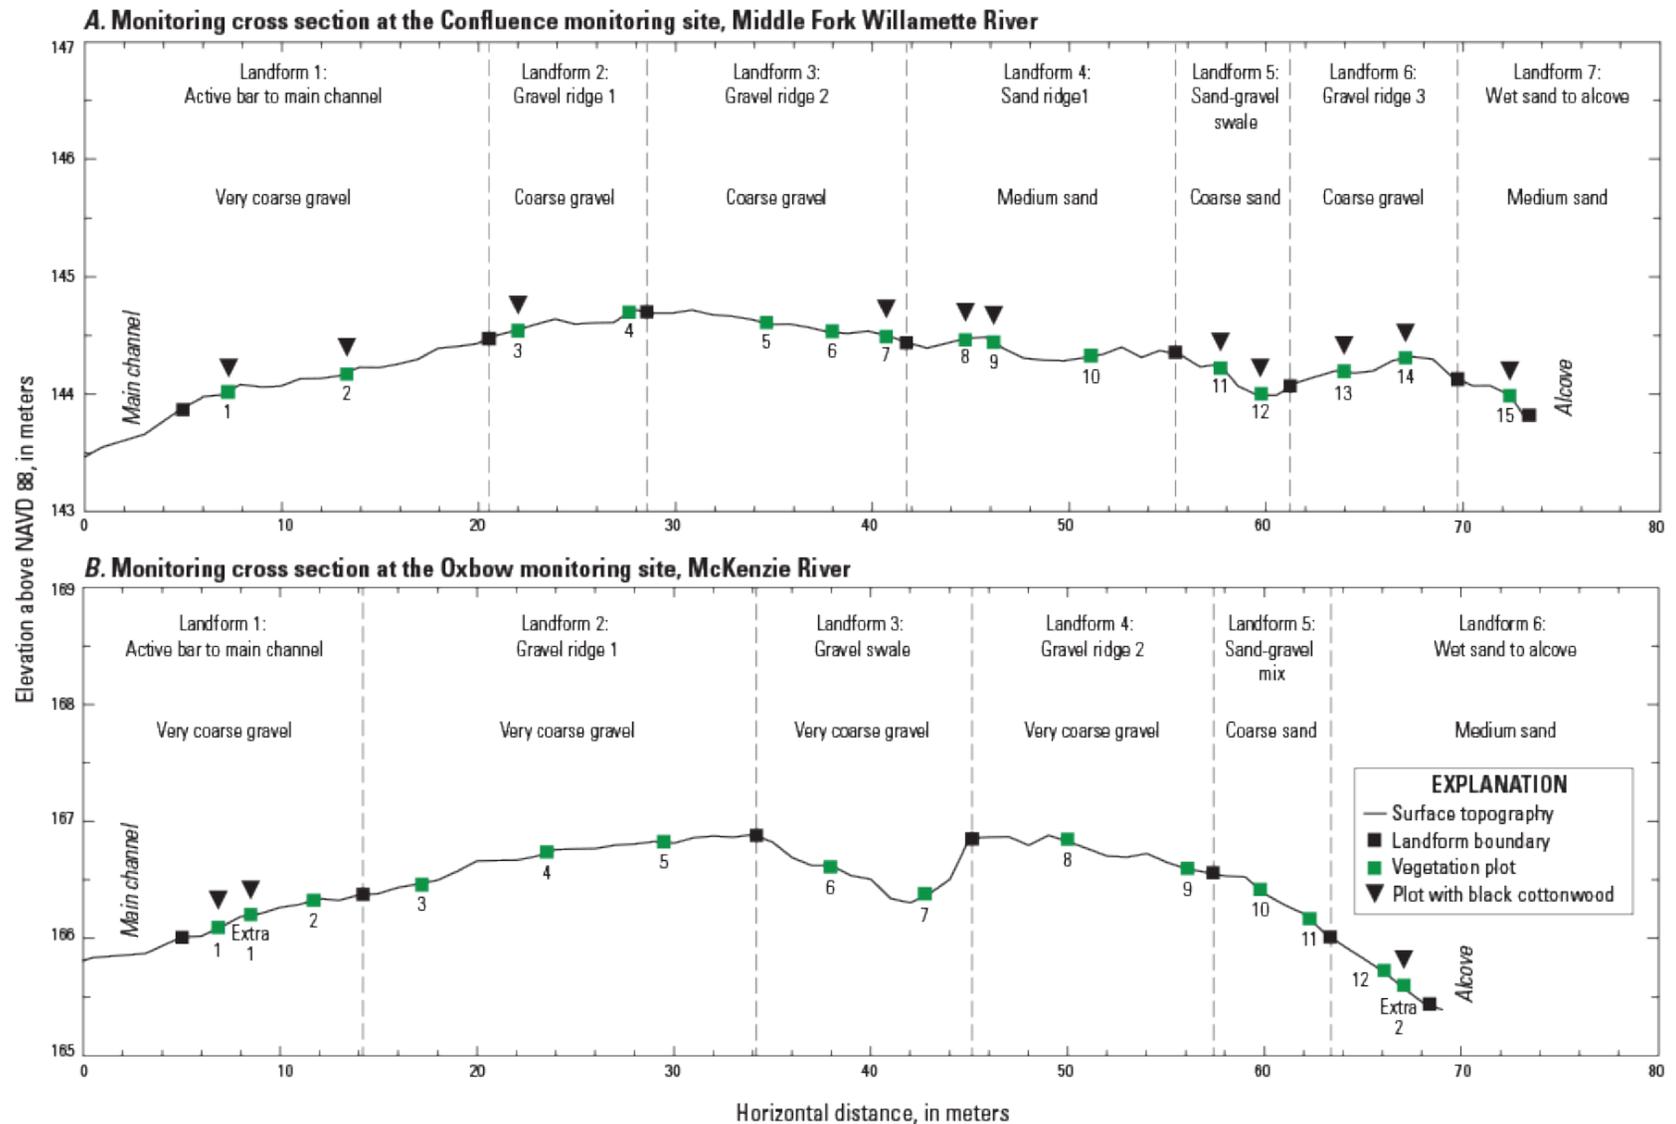
Figure 23. Graphs showing landforms and vegetation plots along monitoring cross sections at (A) The Nature Conservancy Willamette Confluence Preserve site on the Middle Fork Willamette River, and (B) McKenzie Oxbow Conservation Area site on the McKenzie River, western Oregon.

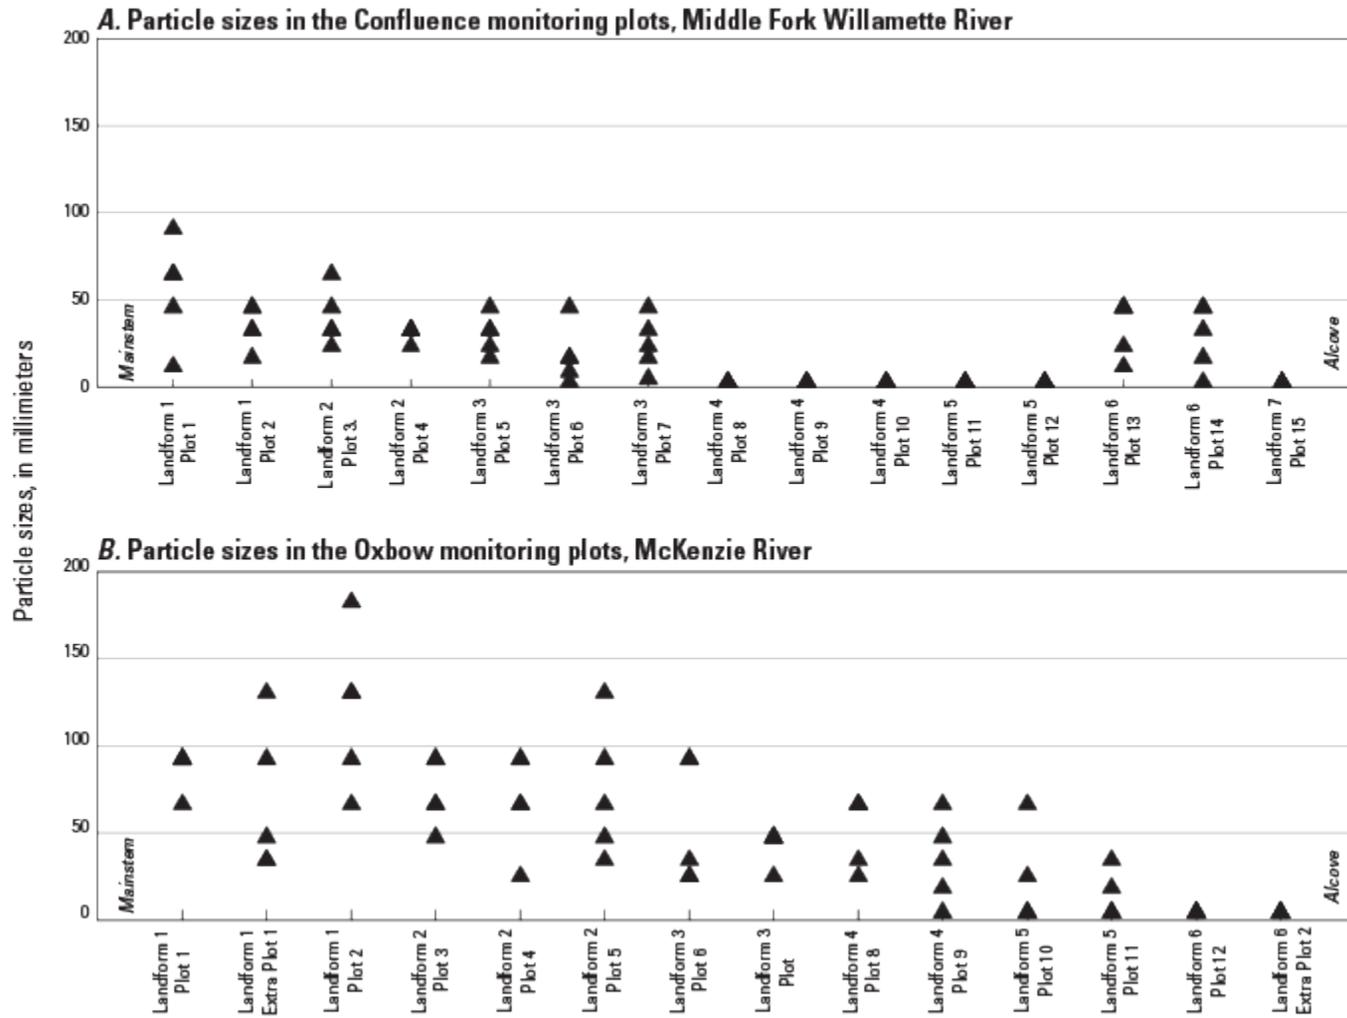
Figure 24. Five particle measurements made in plots along monitoring cross sections at (A) The Nature Conservancy Willamette Confluence Preserve site on the Middle Fork Willamette River, and (B) McKenzie Oxbow Conservation Area site on the McKenzie River, western Oregon. Particle size measurements overlapped for plots where five points are not visible.

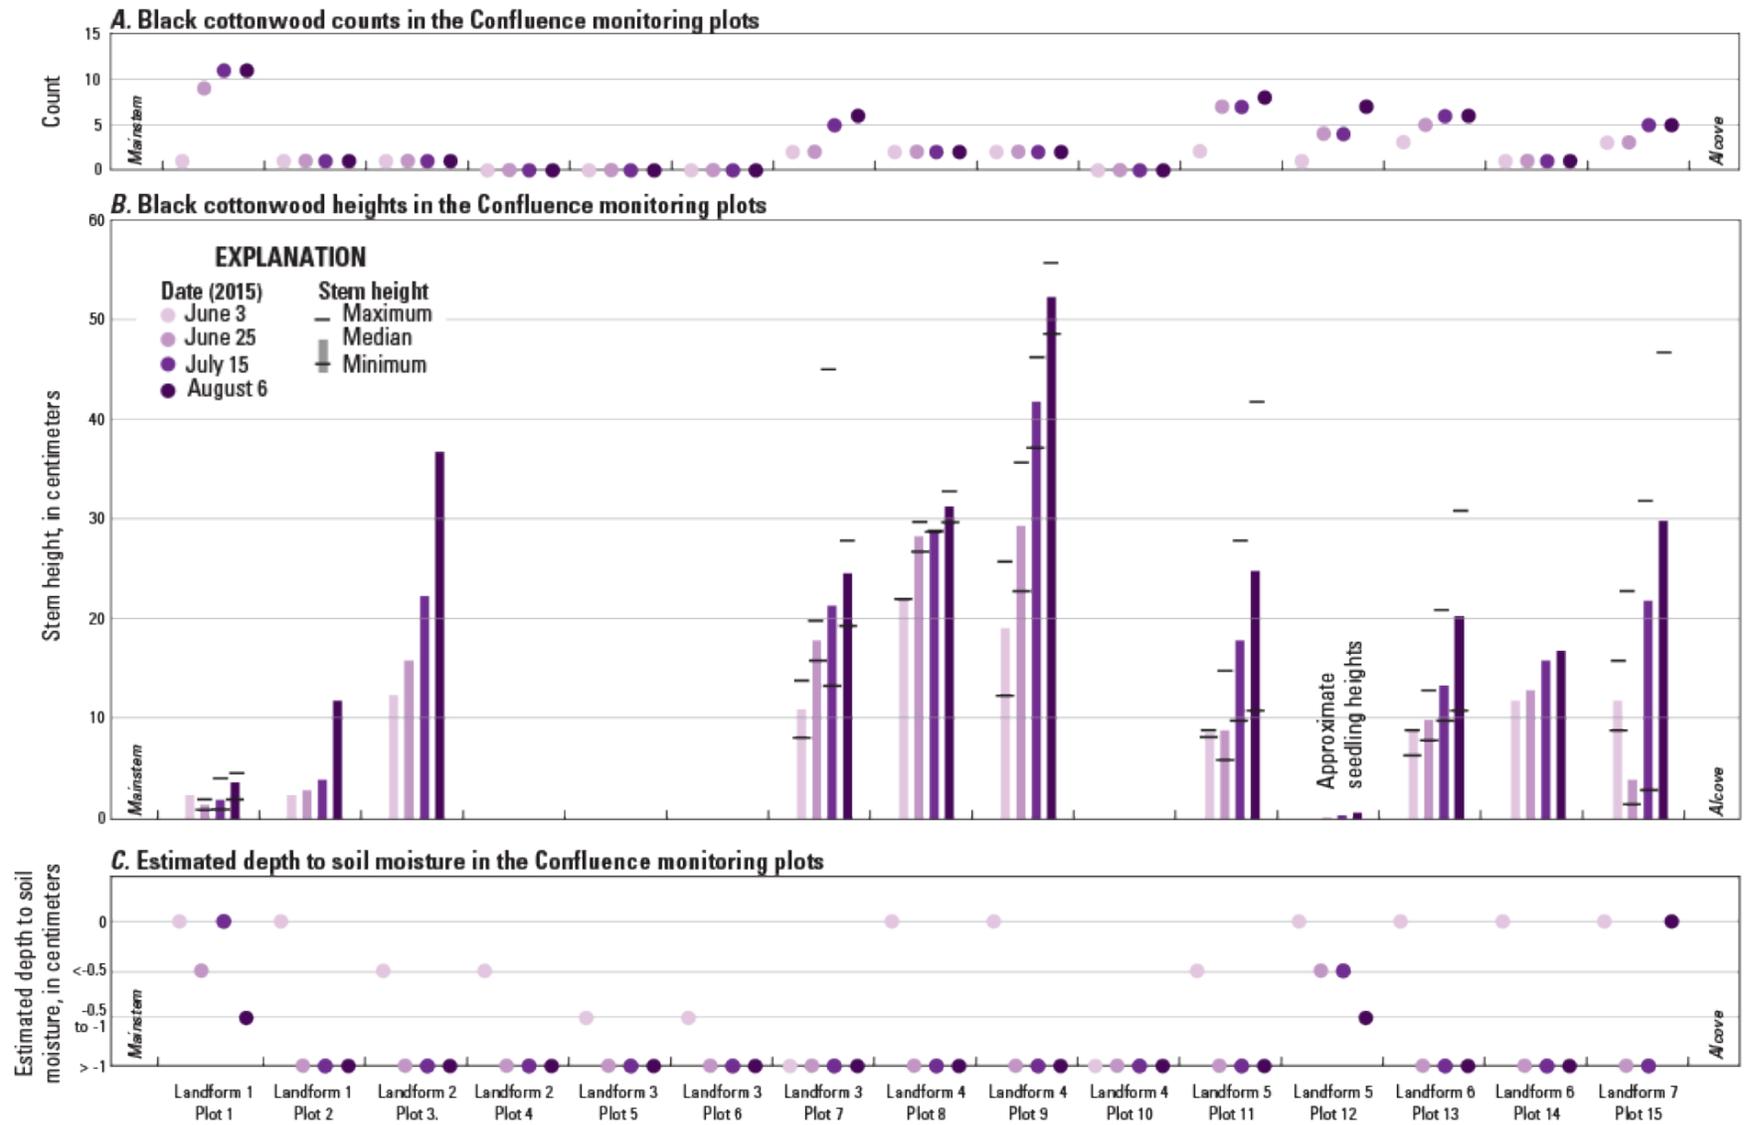
Figure 25. Graphs showing observations of (A) black cottonwood counts, (B) black cottonwood heights, and (C) depth to soil moisture over the monitoring season at The Nature Conservancy Willamette Confluence Preserve site on the Middle Fork Willamette River, western Oregon.

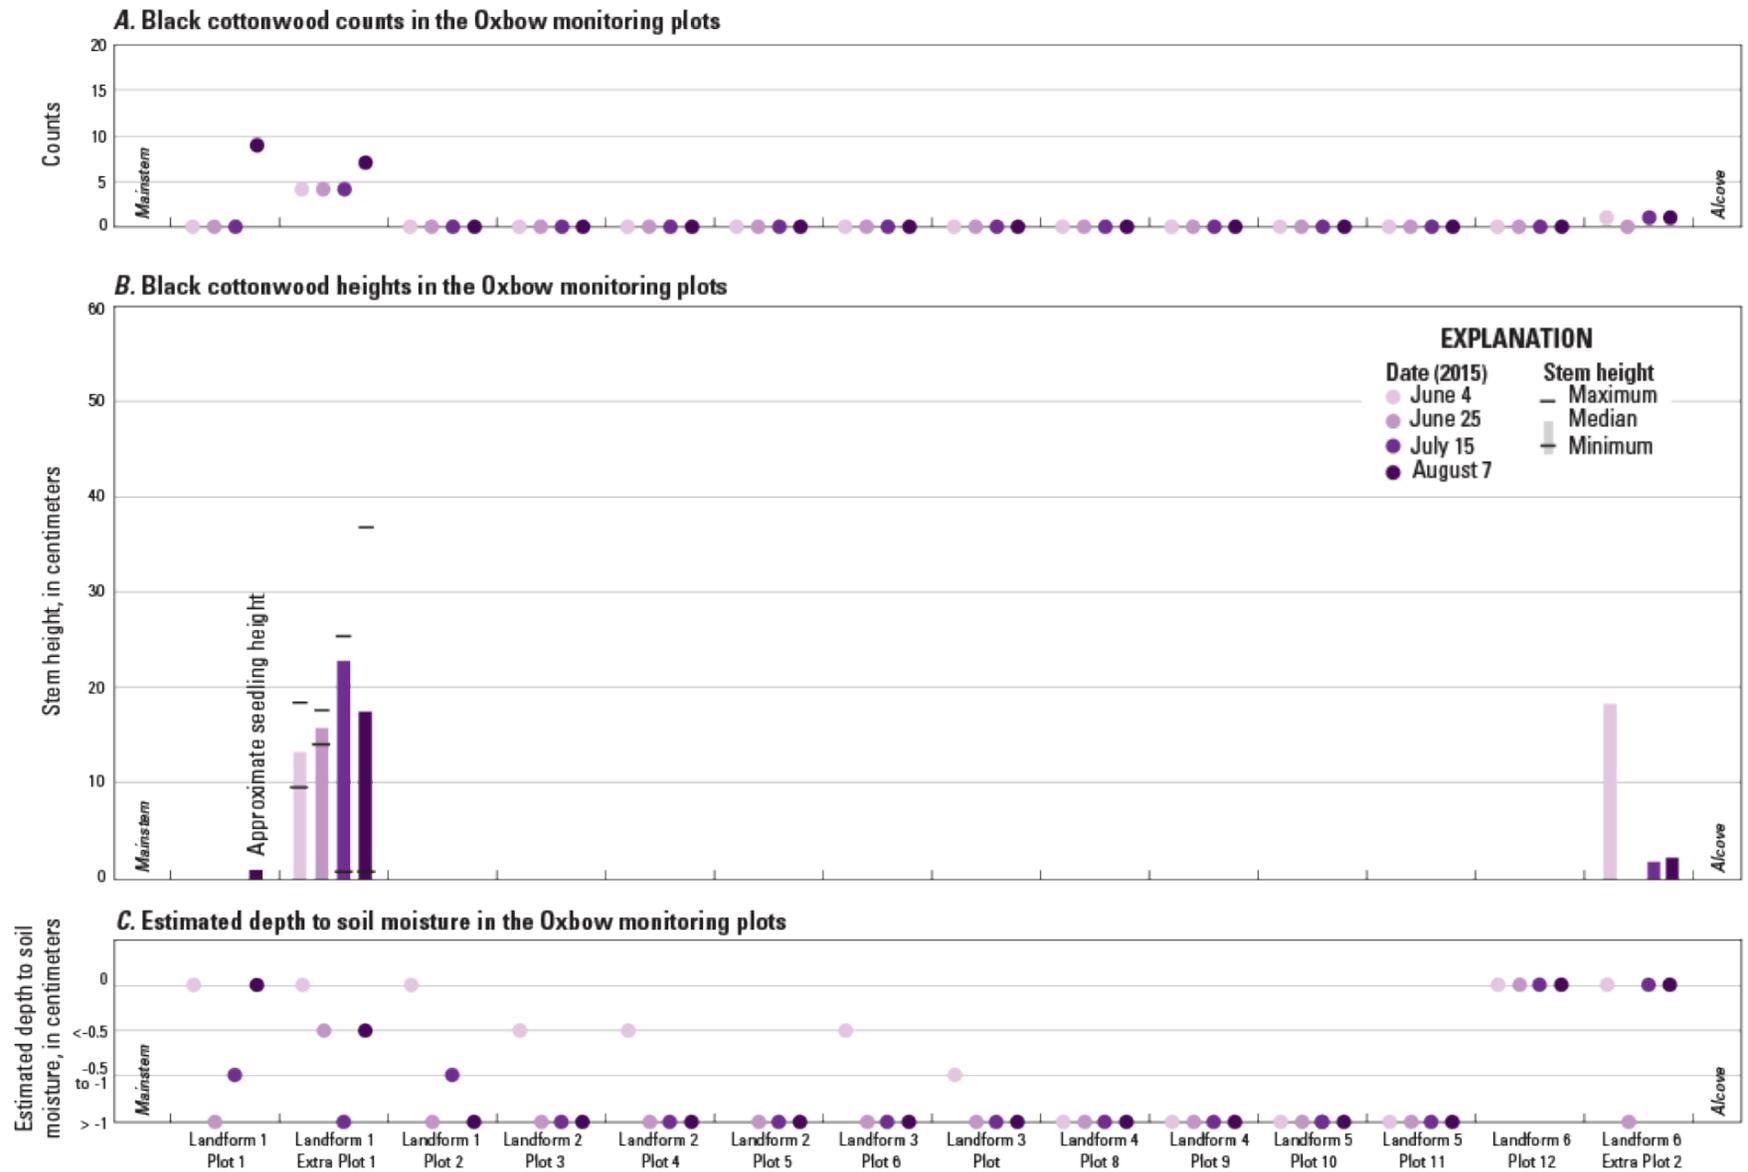
Figure 26. Graphs showing observations of (A) black cottonwood counts, (B) black cottonwood heights, and (C) depth to soil moisture over the monitoring season at the McKenzie Oxbow Conservation Area site on the McKenzie River, western Oregon.

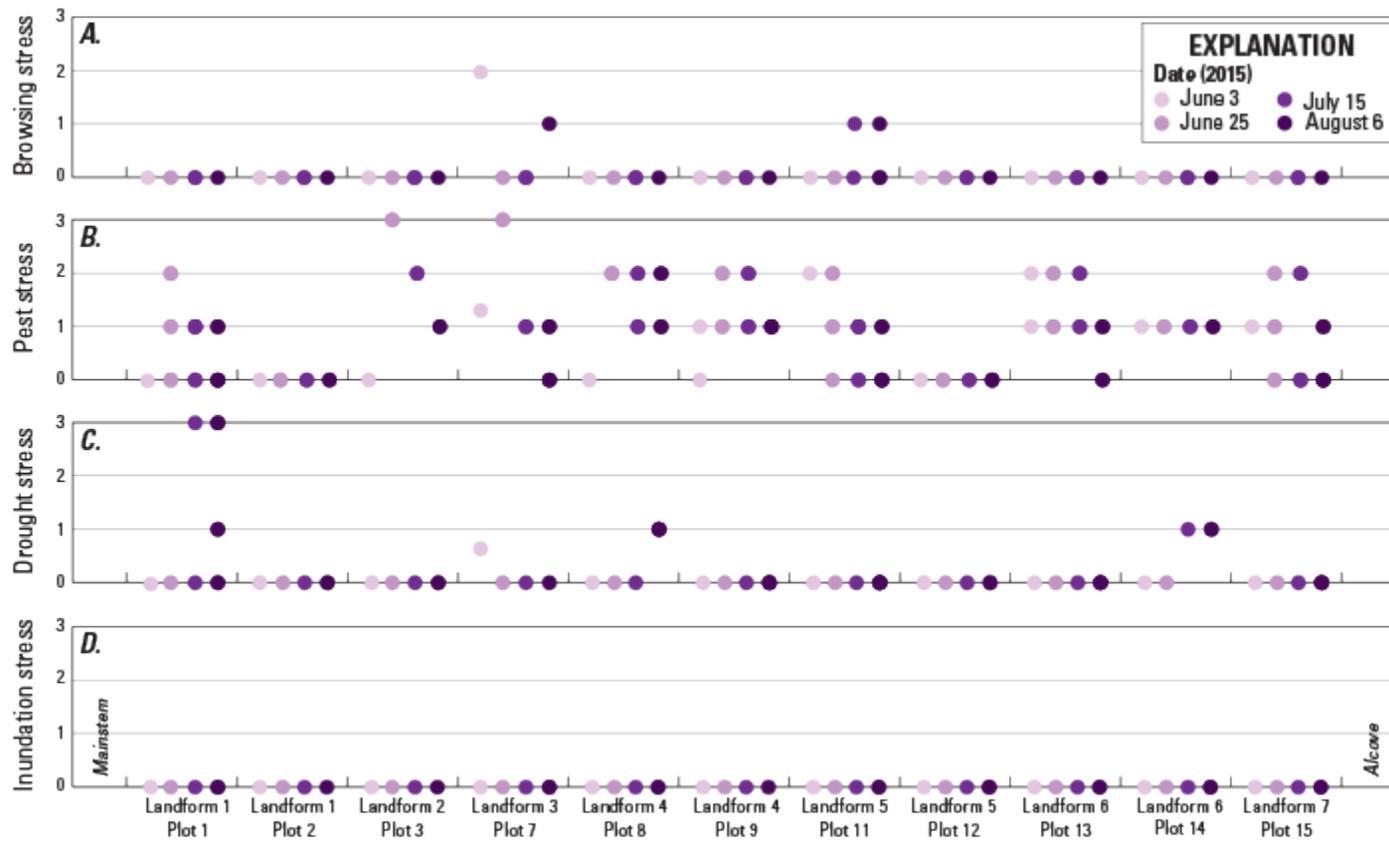
Figure 27. Graphs showing observations of (A) browsing, (B) pest, (C) drought, and (D) inundation stress for black cottonwood over the monitoring season at The Nature Conservancy Willamette Confluence Preserve site, Middle Fork Willamette River, western Oregon. Only monitoring plots with black cottonwood are shown. Stress levels were ranked qualitatively in the field from 0 (none) to 3 (high).

Over the summer, black cottonwoods in the monitoring plots experienced some browsing and pest stress at these sites (figs. 27A–B and 28A–B). Based on scat and track observations, deer were the likely browsers, decreasing the heights of some plants to a few centimeters (fig. 29). Pests included larval and adult forms of beetles, such as possibly striped willow leaf beetle (*Disonycha alternata*). Pest damage resulted in skeletal, dry leaves on black cottonwoods and willows across the Confluence plots and primarily at the Oxbow plots near the mainstem. Pest damage generally seemed to diminish somewhat over the summer, and plants tended to rebound from browsing and pest damage (fig. 29).

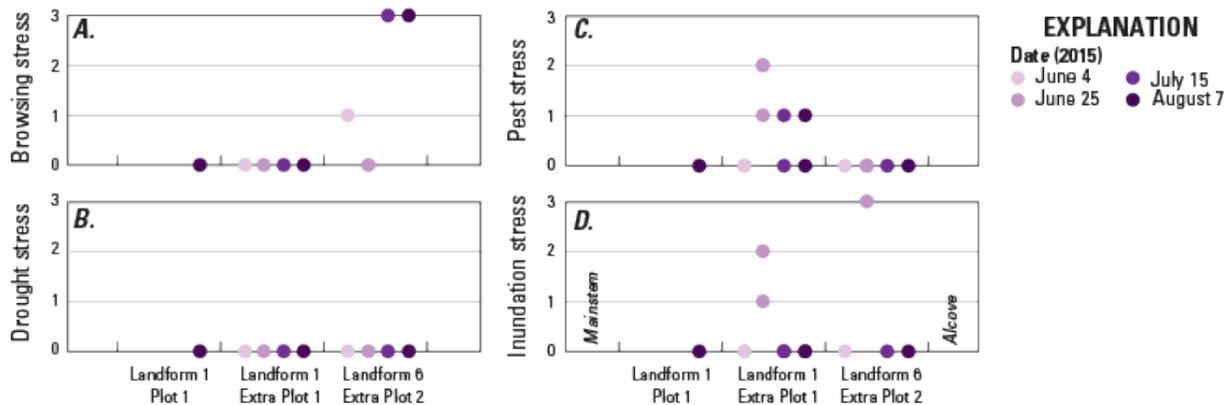
Figure 28. Graphs showing observations of (A) browsing, (B) pest, (C) drought, and (D) inundation stress for black cottonwood over the monitoring season at the McKenzie Oxbow Conservation Area site, McKenzie River, western Oregon. Only monitoring plots with black cottonwood are shown. Stress levels were ranked qualitatively in the field from 0 (none) to 3 (high).

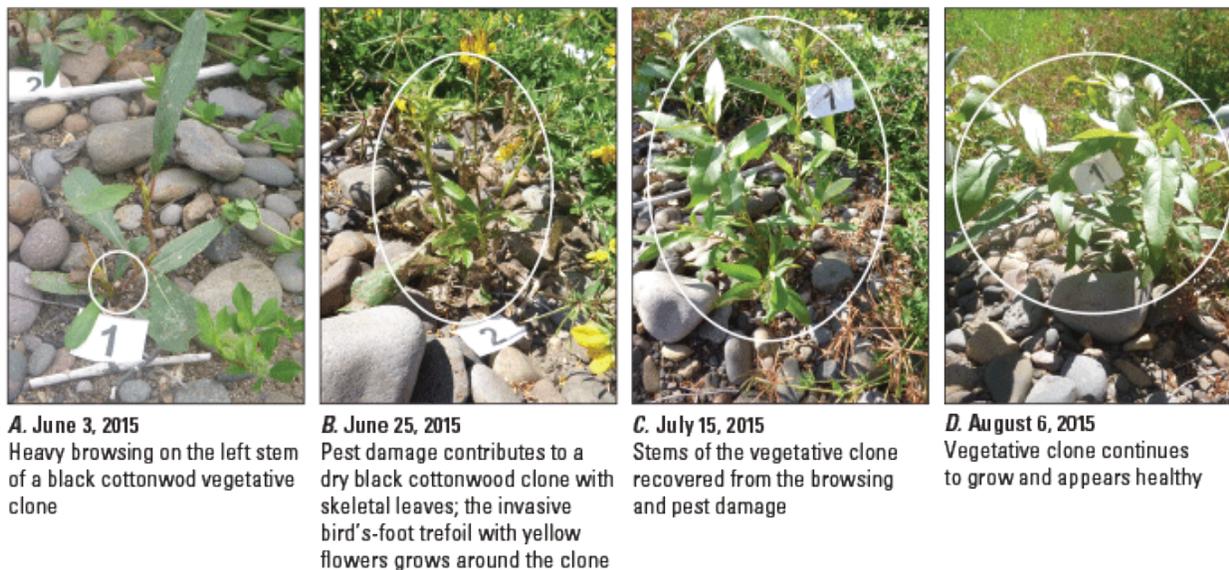
Figure 29. Photographs of repeat plot showing black cottonwood with browsing and pest damage and subsequent recovery in Plot 7 at The Nature Conservancy Willamette Confluence Preserve site on the Middle Fork Willamette River, western Oregon, (A) June 3, (B), June 25, (C), July 15, and (D), August 6, 2015.

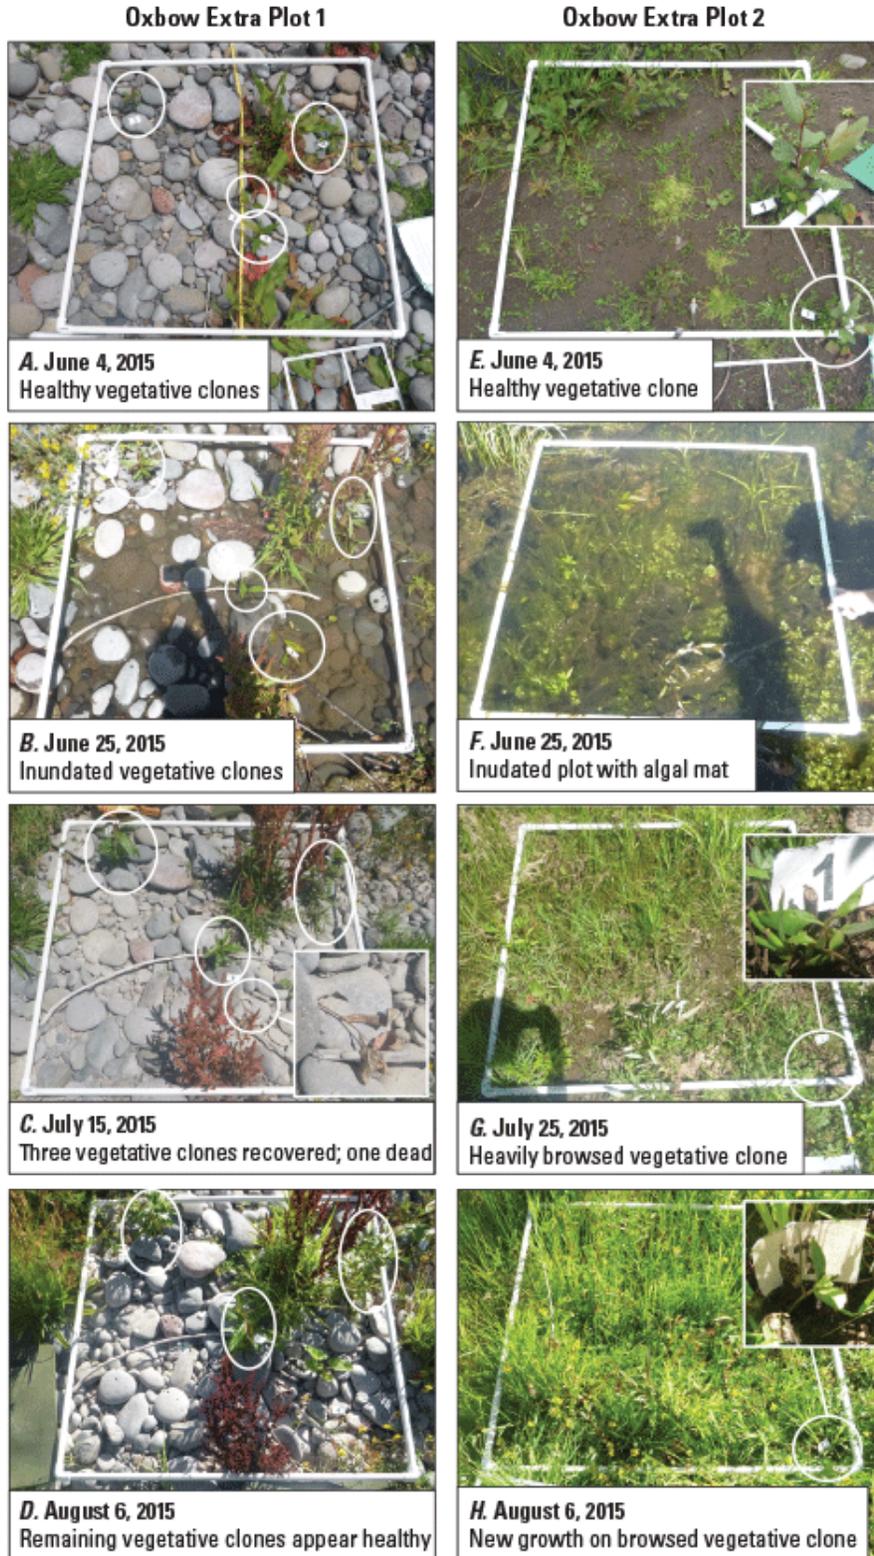
Figure 30. Photographs of repeat plot showing black cottonwood with some inundation in Extra Plots 1 (A–D) and 2 (E–H) at the McKenzie Oxbow Conservation Area site on the McKenzie River, western Oregon, 2015.

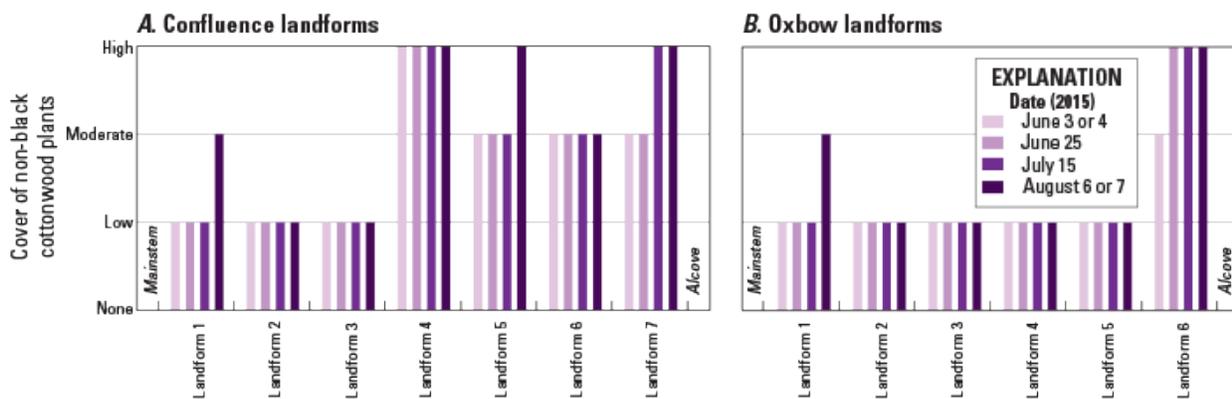
Figure 33. Graphs showing coverage of non-black cottonwood plants recorded during census surveys at (A) The Nature Conservancy Willamette Confluence Preserve site on the Middle Fork Willamette River, and (B) McKenzie Oxbow Conservation Area on the McKenzie River, western Oregon, June 3–August 7, 2015.
