# Dam Breach Parameters

Stanford Gibson, PhD

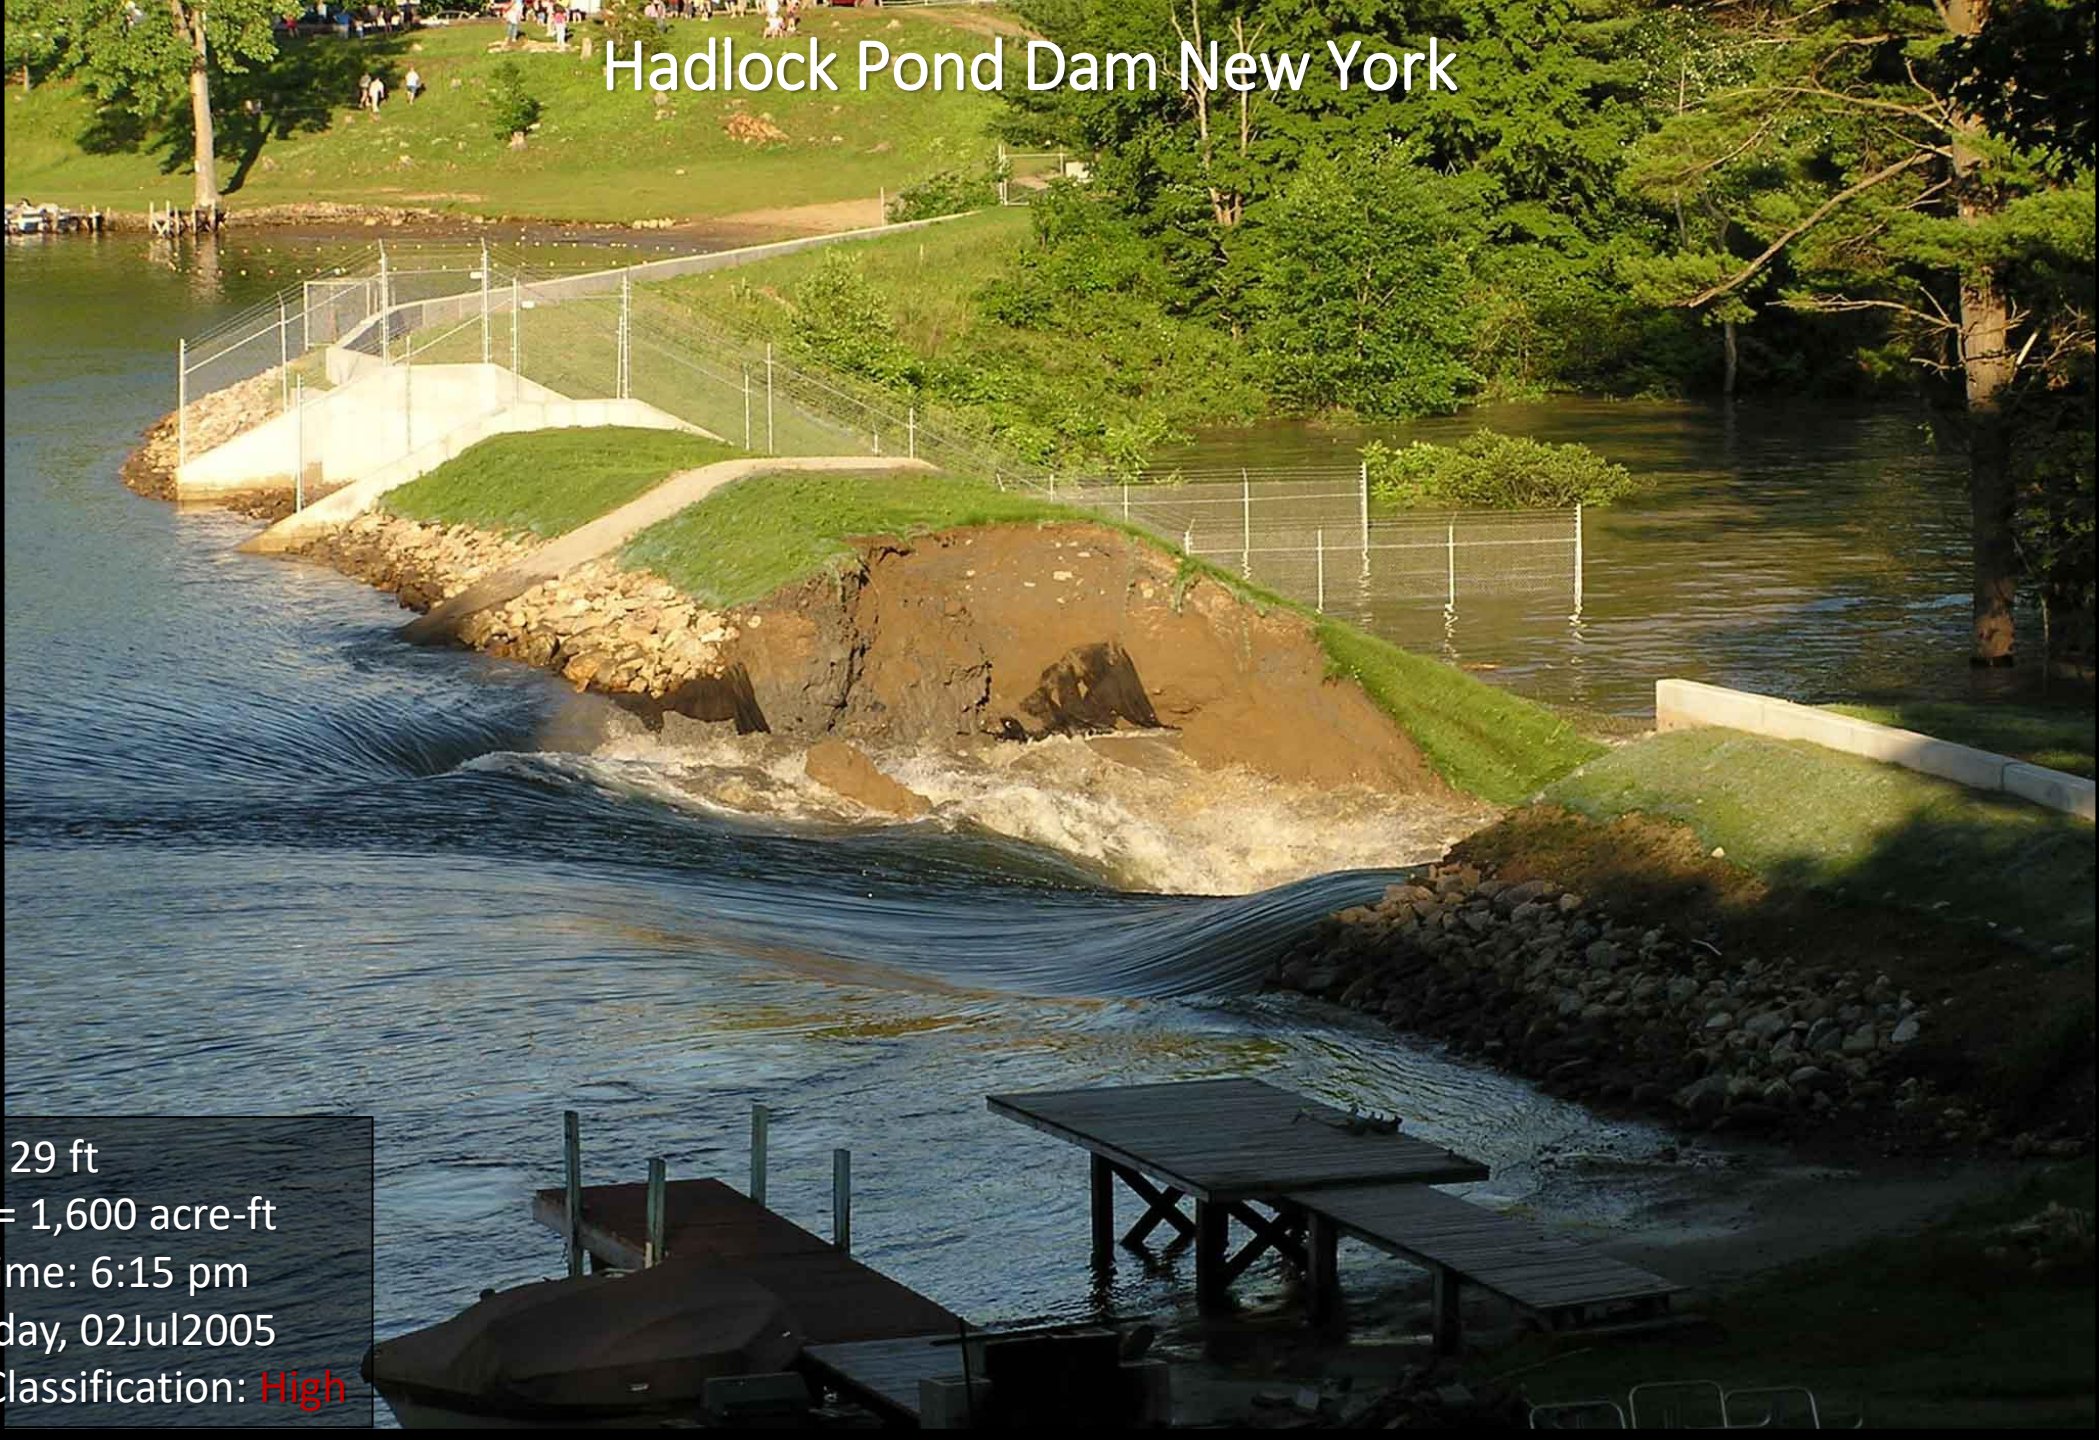
# Hadlock Pond Dam New York

Height = 29 ft  
Storage = 1,600 acre-ft  
Failure time: 6:15 pm  
Saturday, 02Jul2005  
Hazard Classification: High

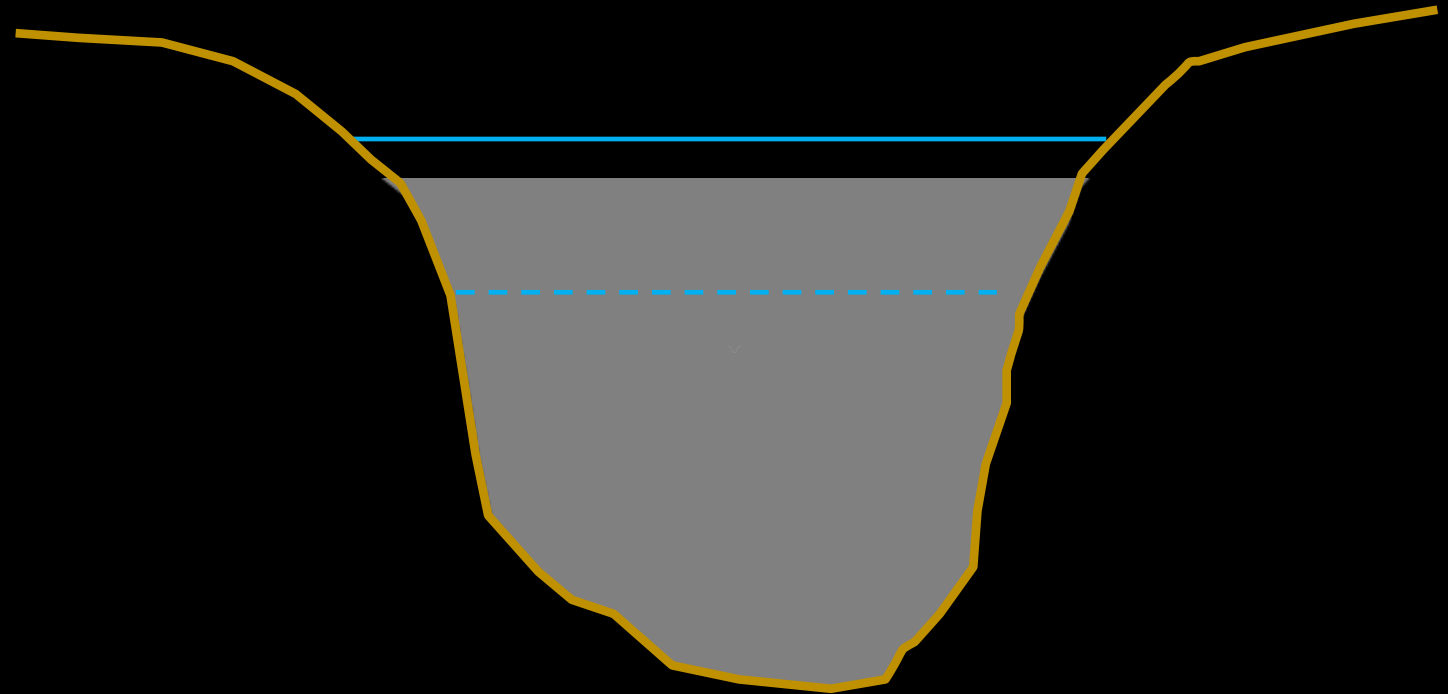
## Dam (Inline Structure) Breach Data

Inline Structure **Bald Eagle Cr. Lock Haven**

Failure Mode: Piping

Trigger Failure at: WS Elev

Starting WS 676.8

This doesn't matter much for a dam

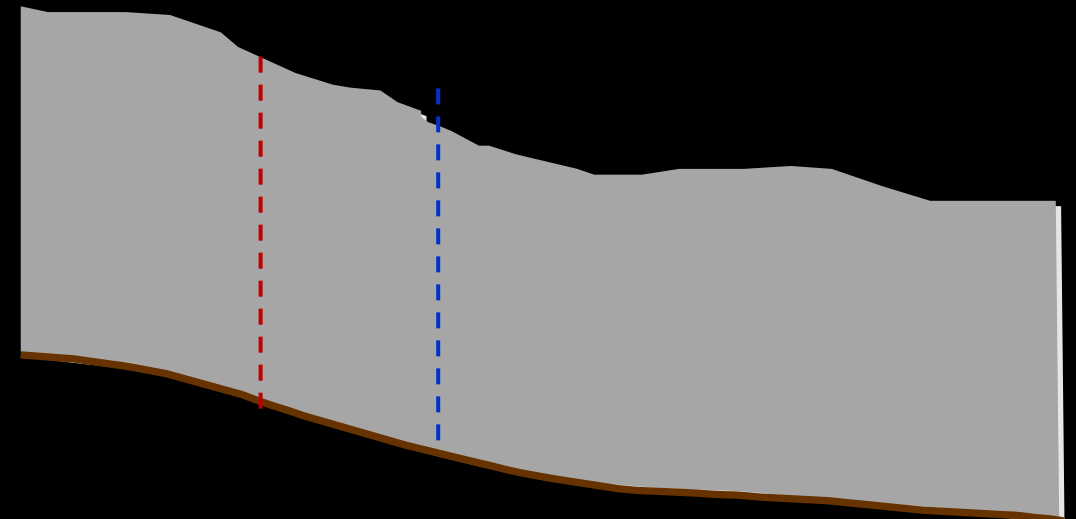
But levees can be more complicated

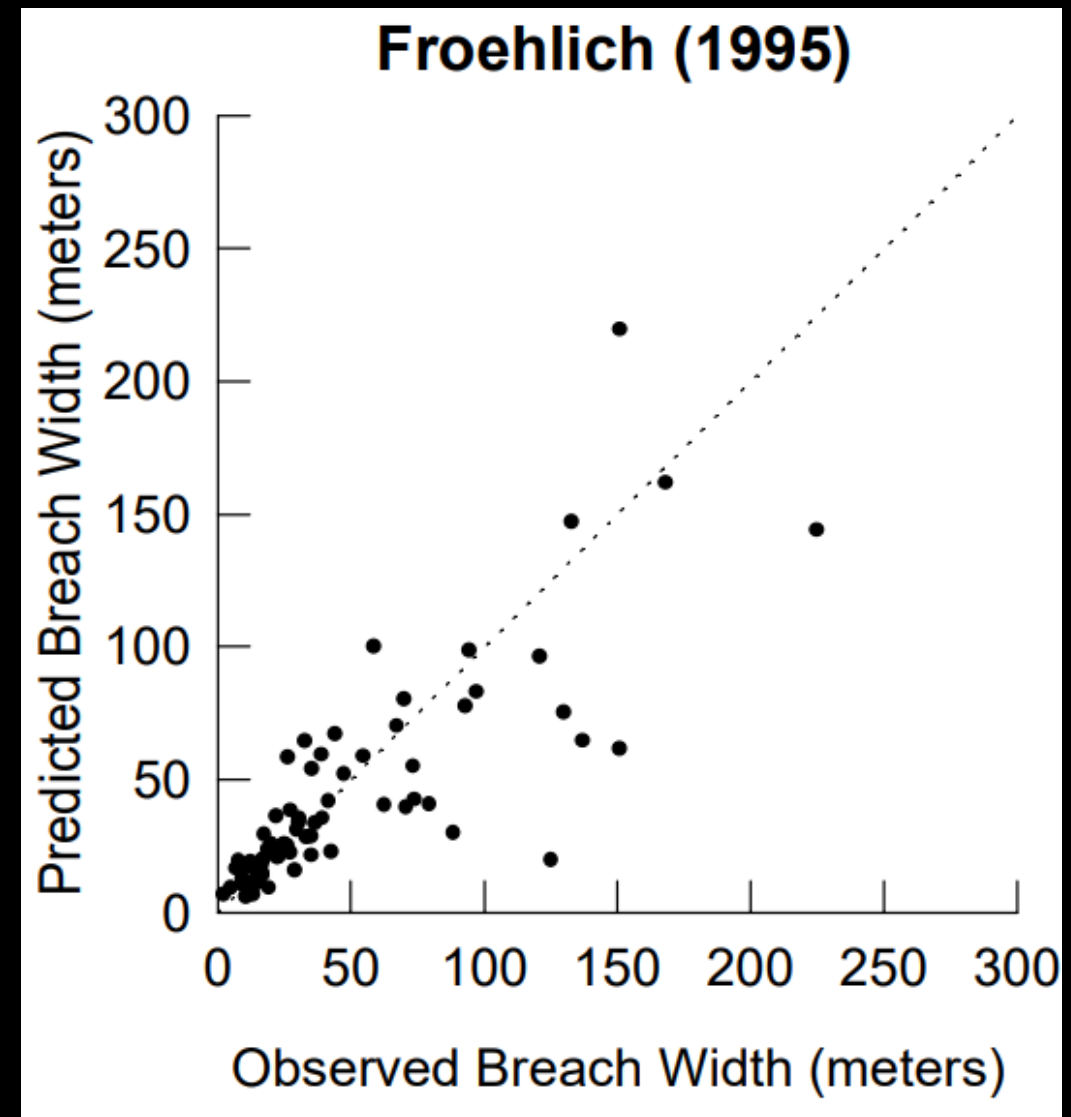
$$B_{avg} = 0.27 K_o V_w^{0.32} h_b^{0.04}$$

$$t_f = 20.18 V_w^{0.5} h_b^{-1.0}$$

$V_w$  = Volume of water at h

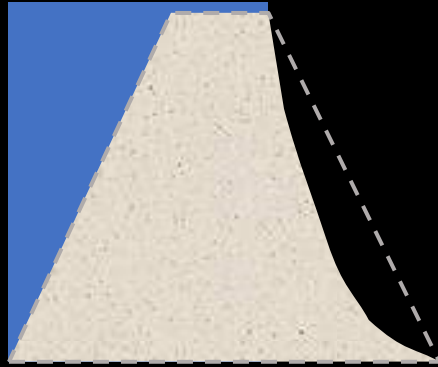
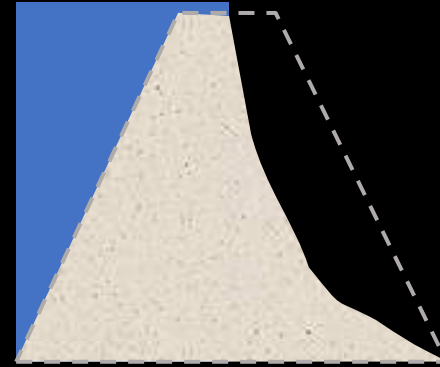
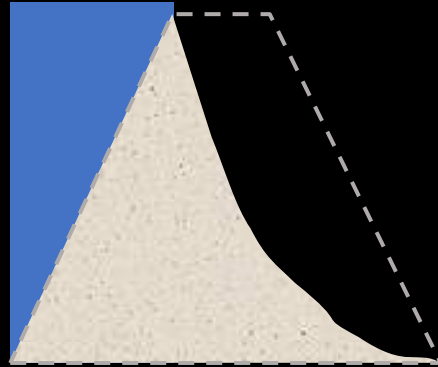
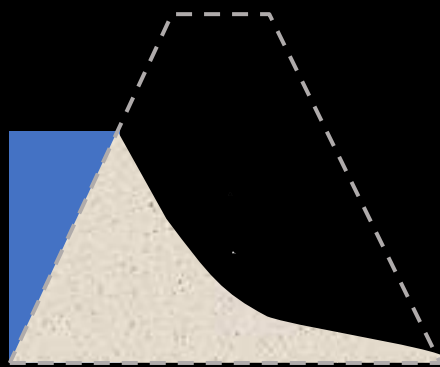
When does the clock start for “breach time” in HEC-RAS?

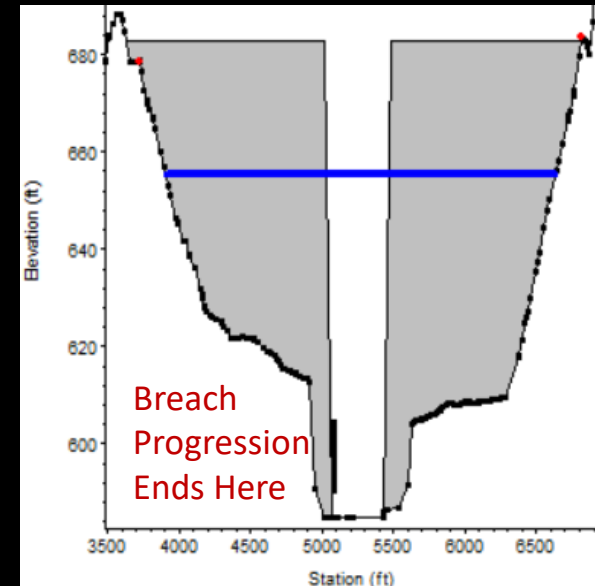
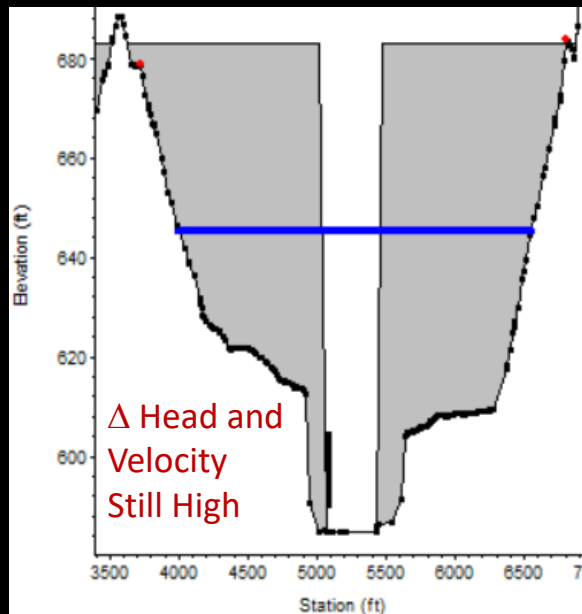
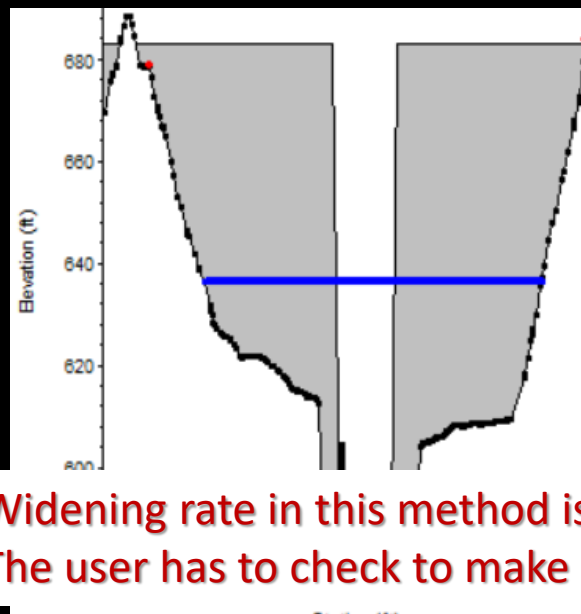
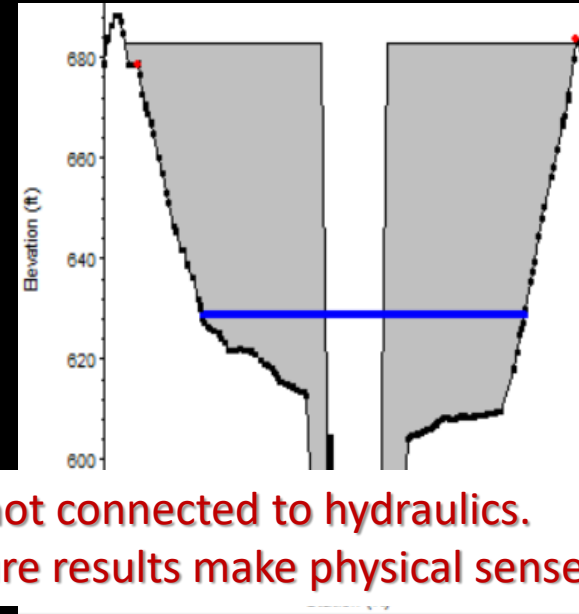
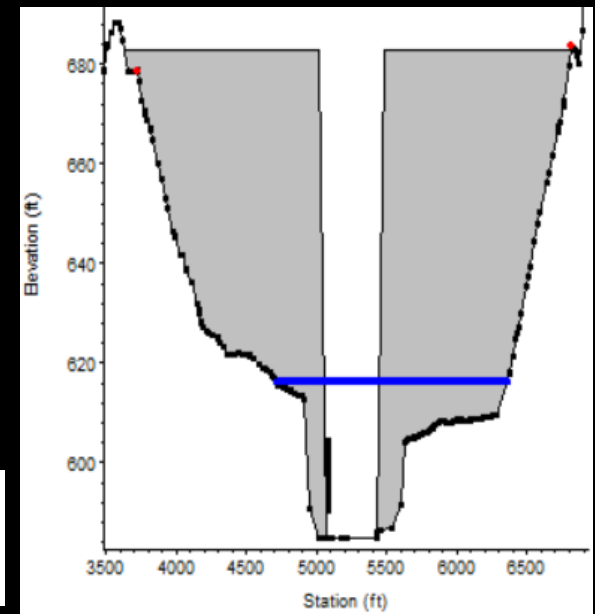
# This Simulation Continues to Widen for High $\Delta$ Head and Velocities

Breach  
Progression  
Ends Here

$\Delta$  Head and  
Velocity  
Still High

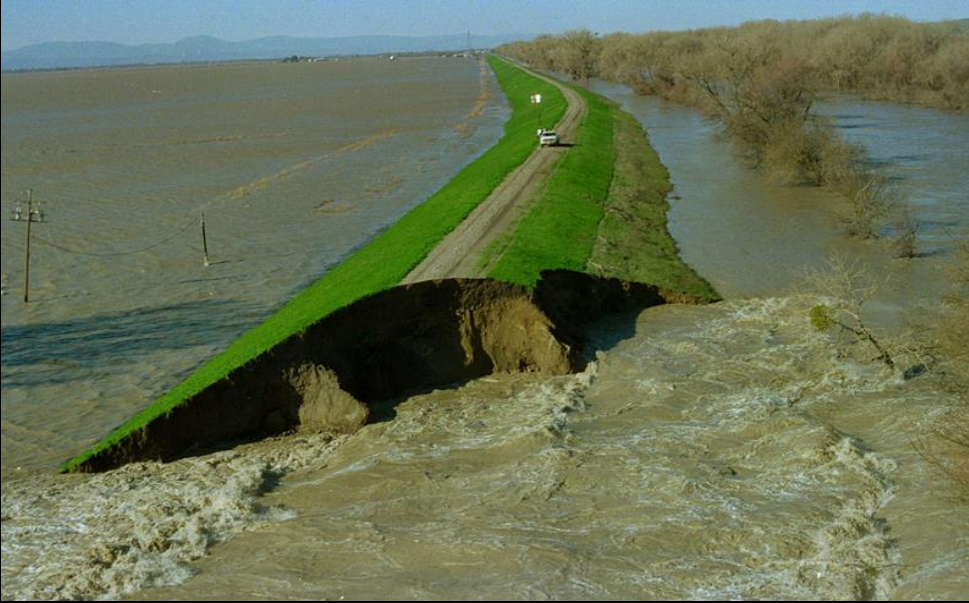
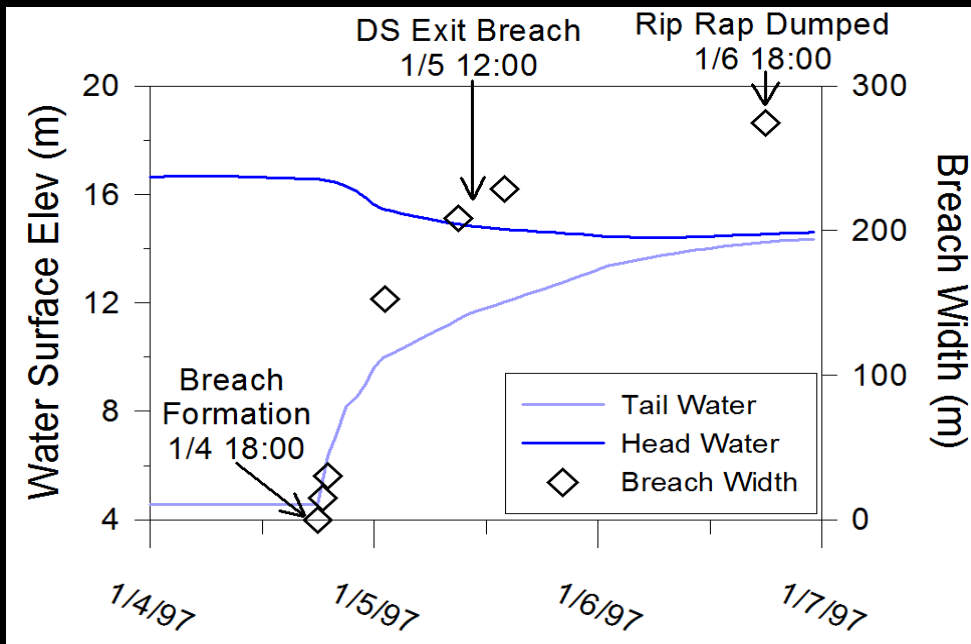
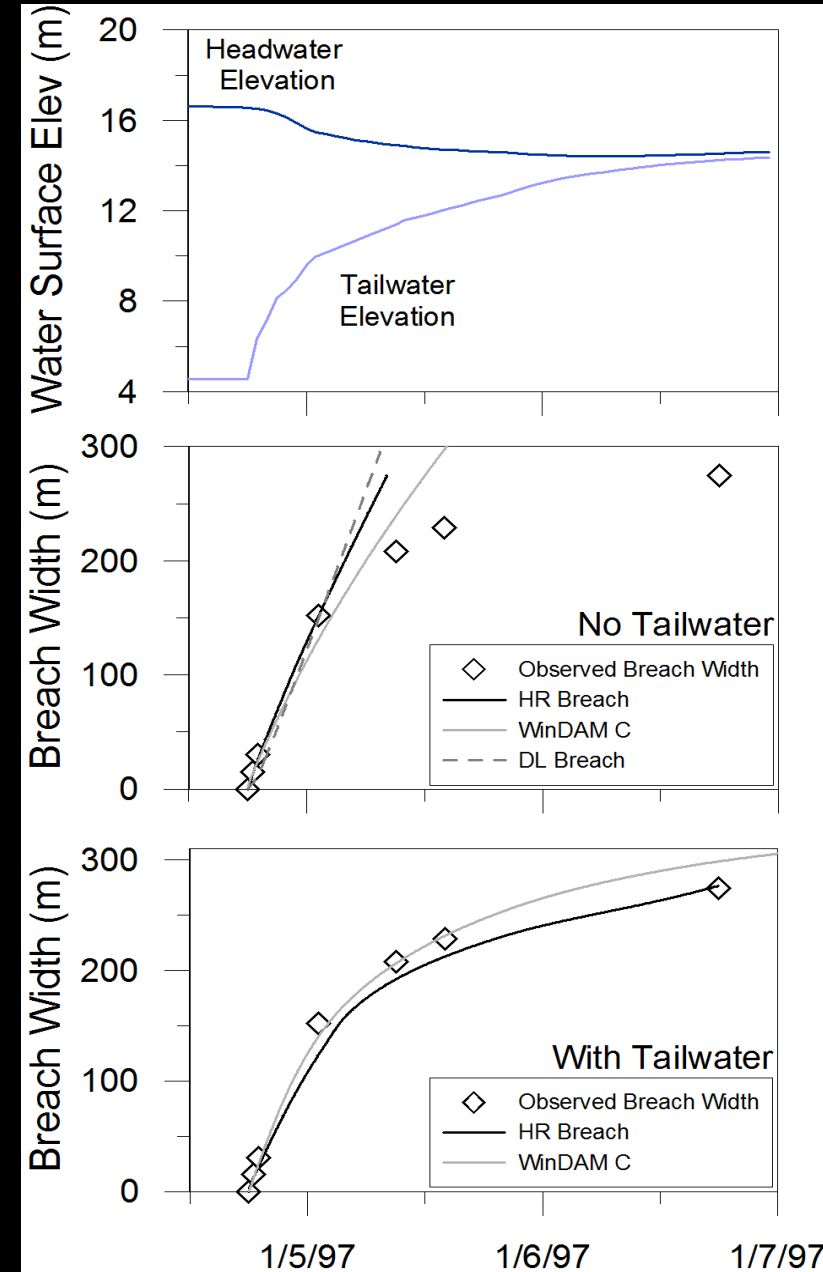
# Sutter Bypass Levee Breach

From: Risher, P. and Gibson, S. (2016) "Applying Mechanistic Dam Breach Models to Historic Levee Breaches," Proceedings FloodRisk 2016.

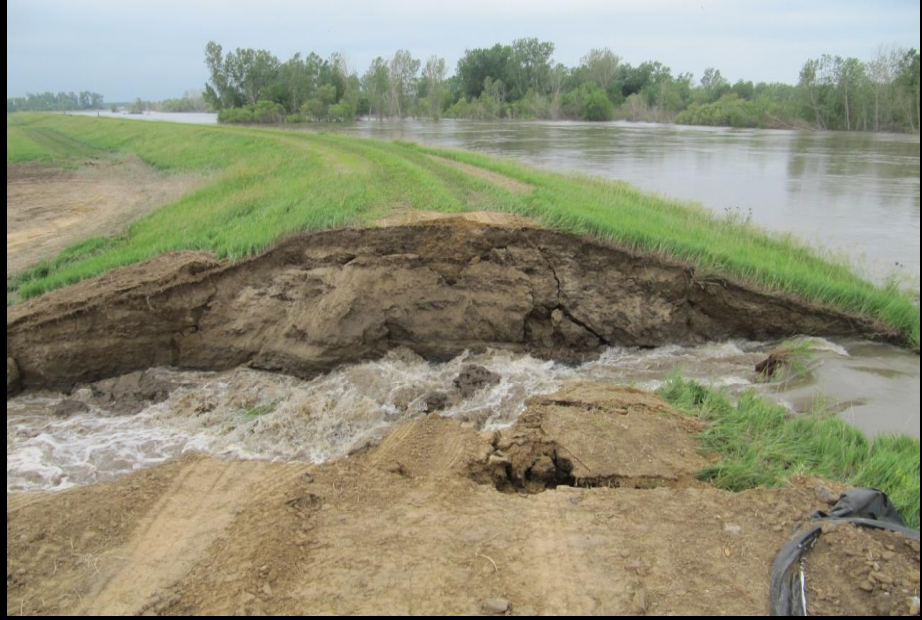
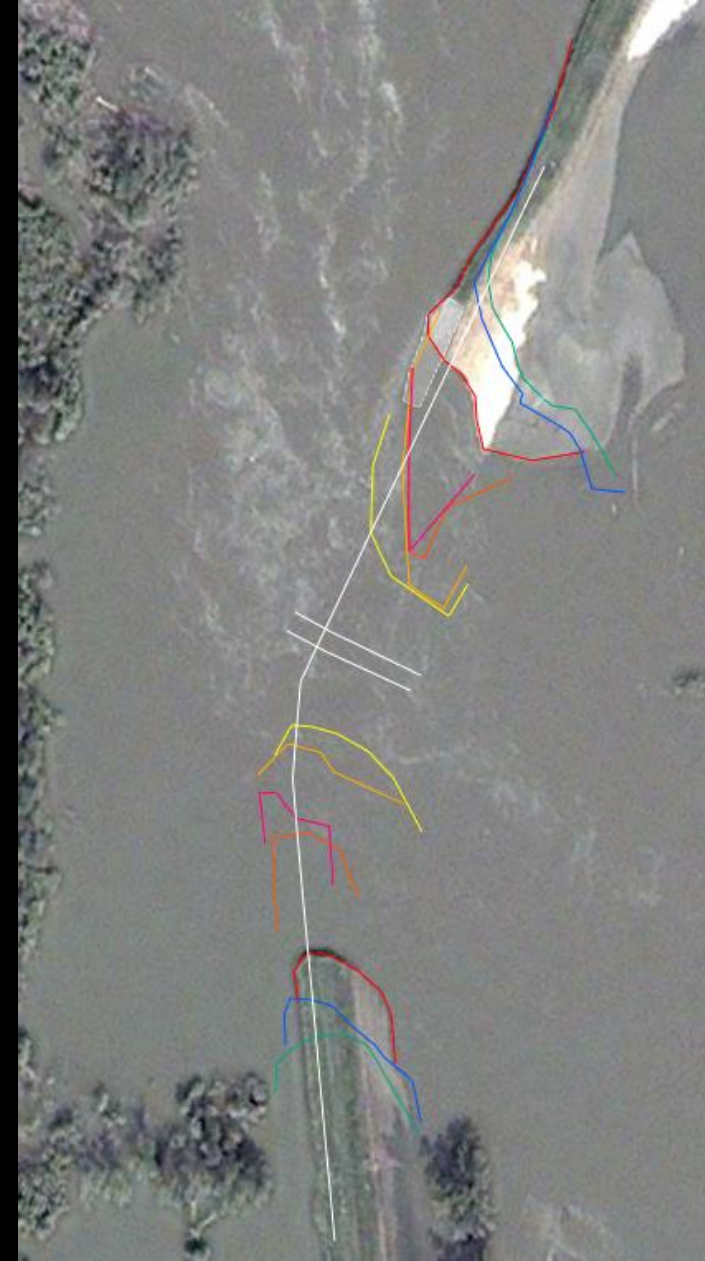
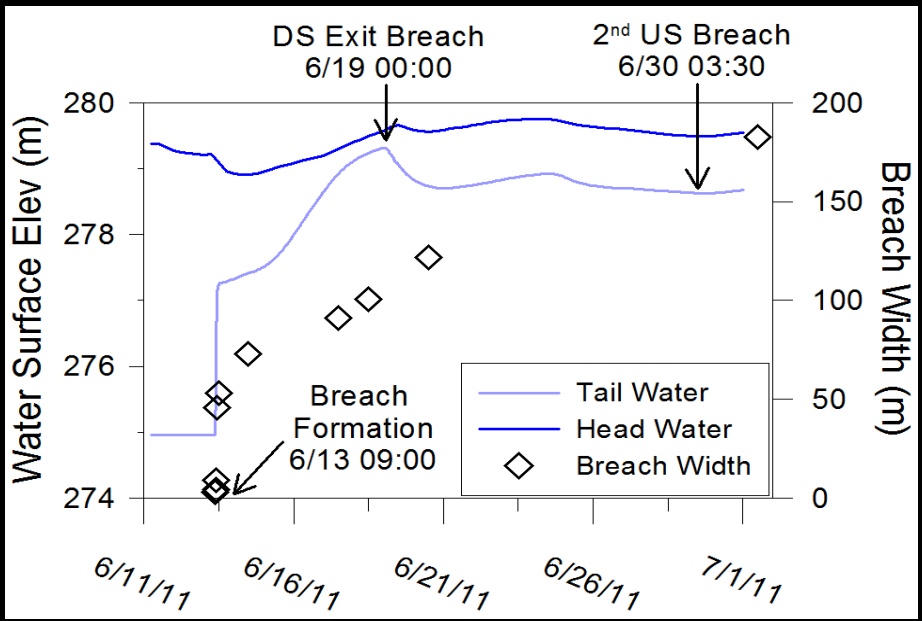
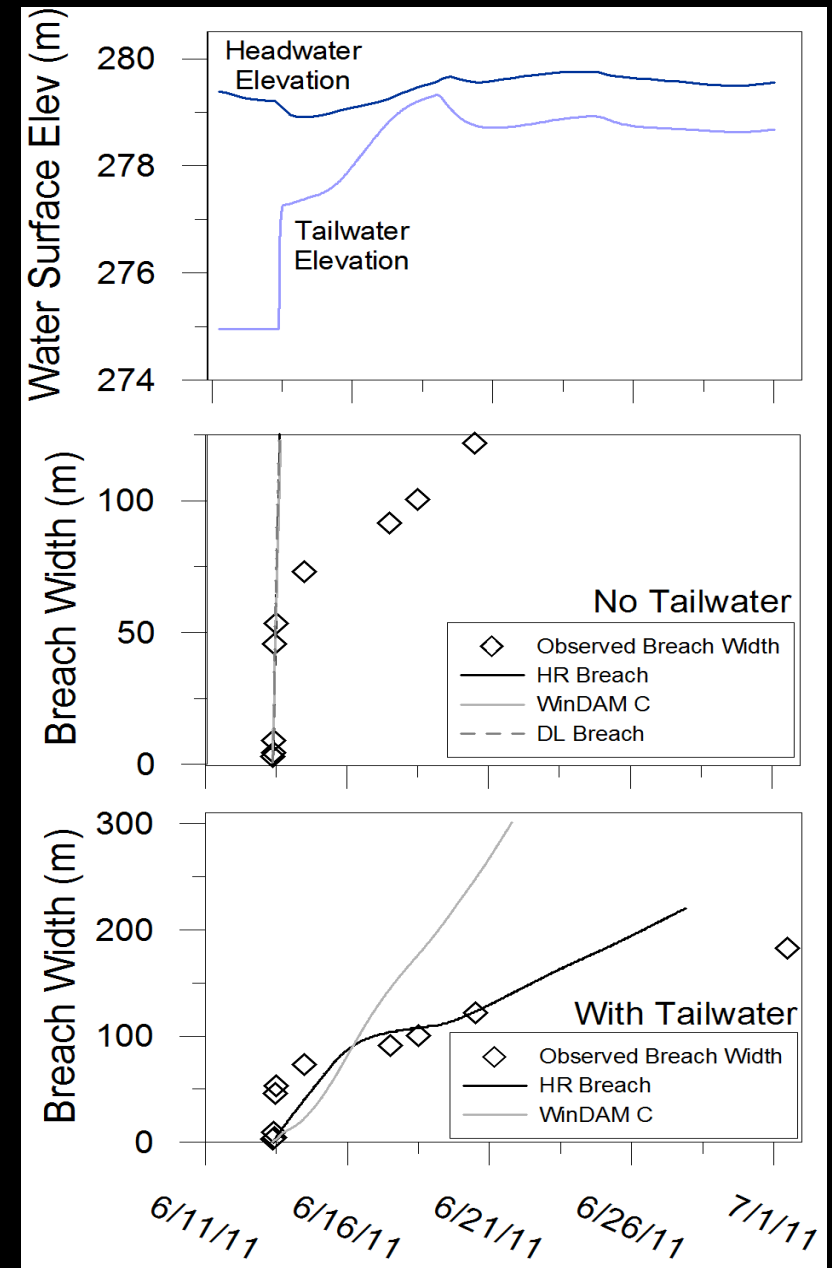
# Hamburg Breach (Missouri River)

From: Risher, P. and Gibson, S. (2016) "Applying Mechanistic Dam Breach Models to Historic Levee Breaches," Proceedings FloodRisk 2016.

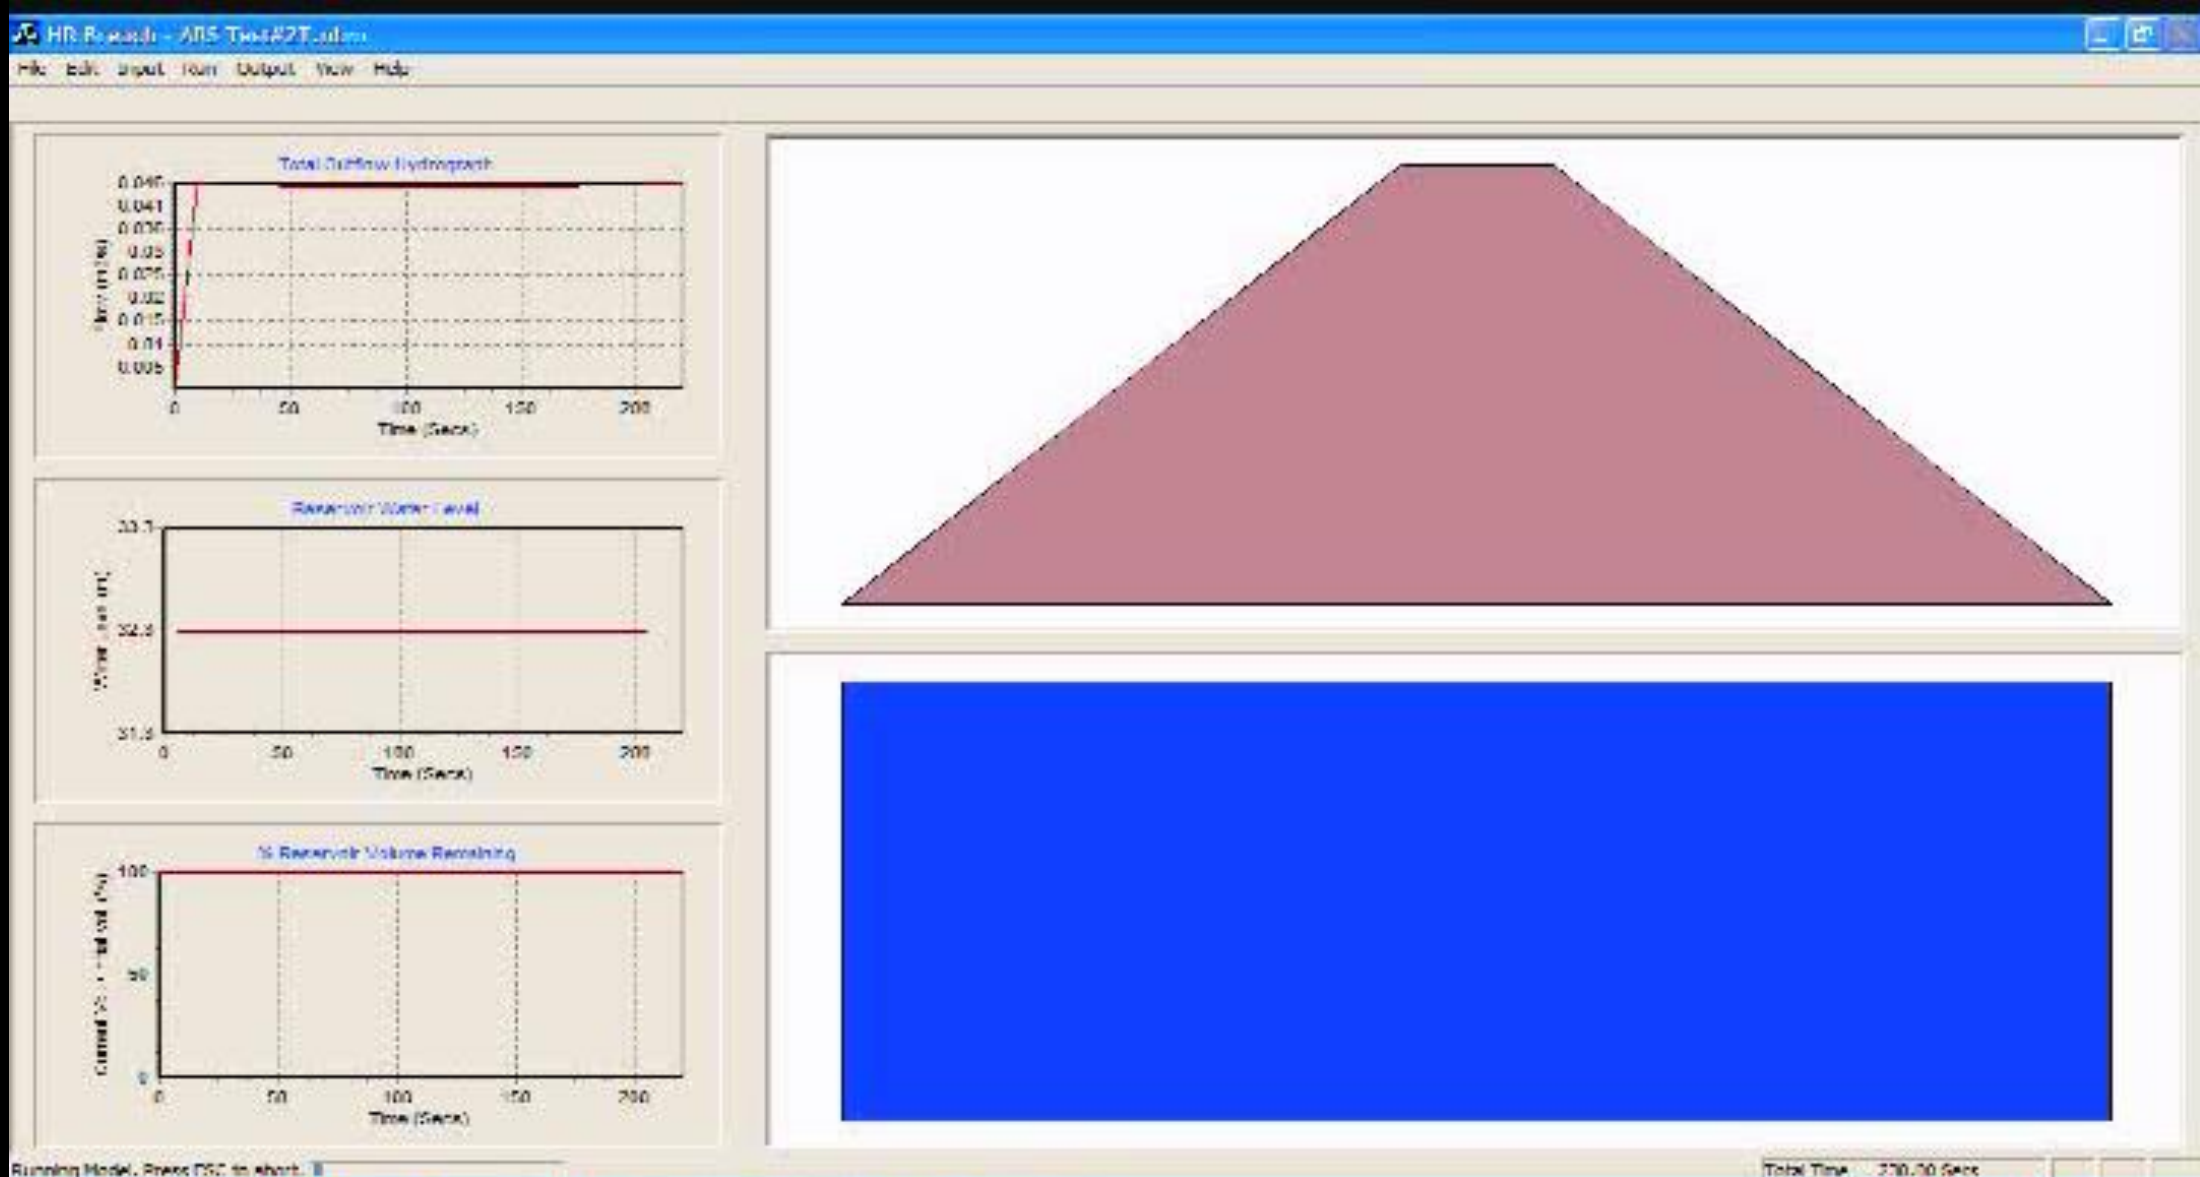
# HR BREACH

- Erosion through homogeneous or simple composite dams
- Channel erosion, head cutting and side slope instability + piping
- Storage routing with quasi-steady hydraulics thru the breach

- HR BREACH Model [http://www.floodsite.net/html/HR\\_Breach\\_Model.htm](http://www.floodsite.net/html/HR_Breach_Model.htm)
- MacDonald, T. C., and Langridge-Monopolis, J. (1984), "Breaching Characteristics of Dam Failures," ASCE J. Hydraulic Engineering, 110(5), 567-586,

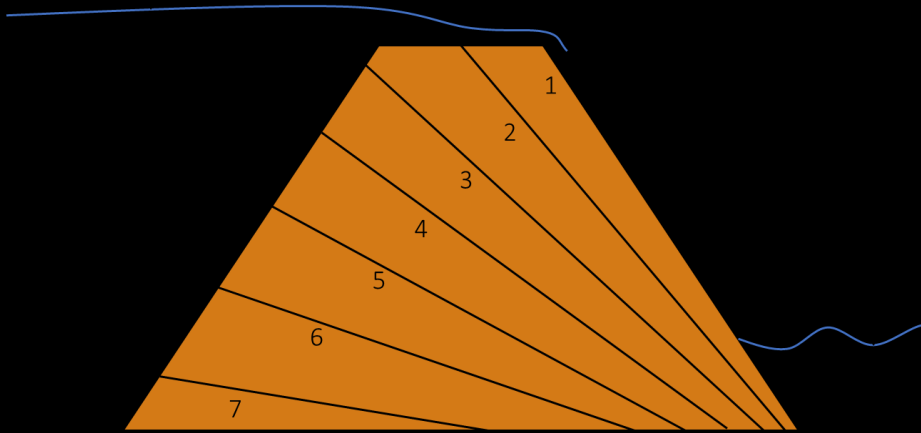
Surface Erosion

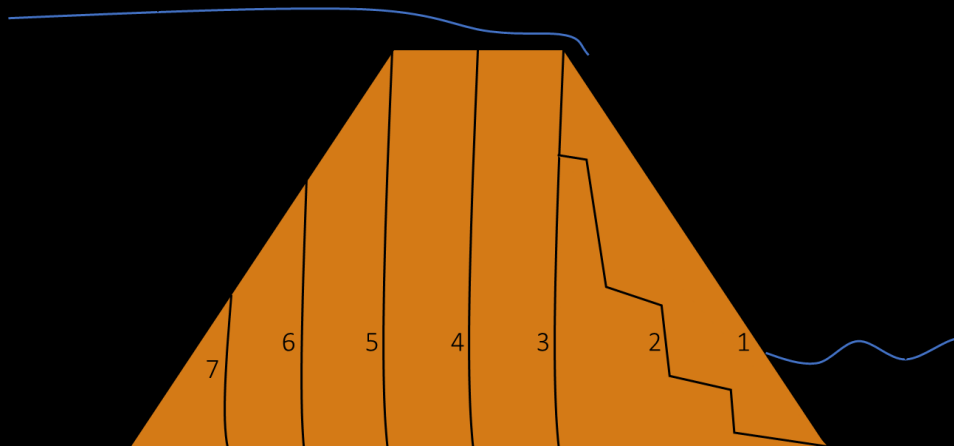
Headcut Erosion

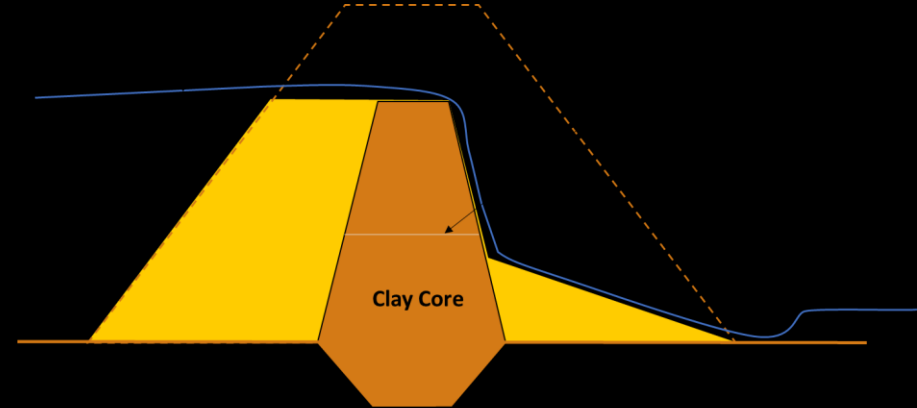
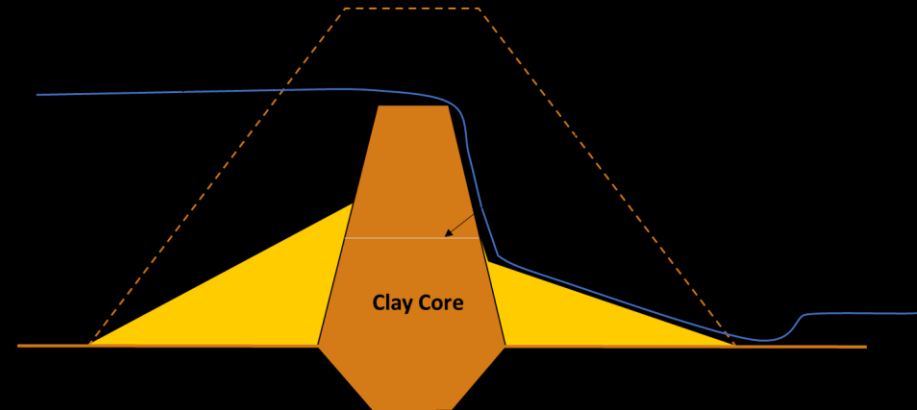
Composite (Zoned) Structure

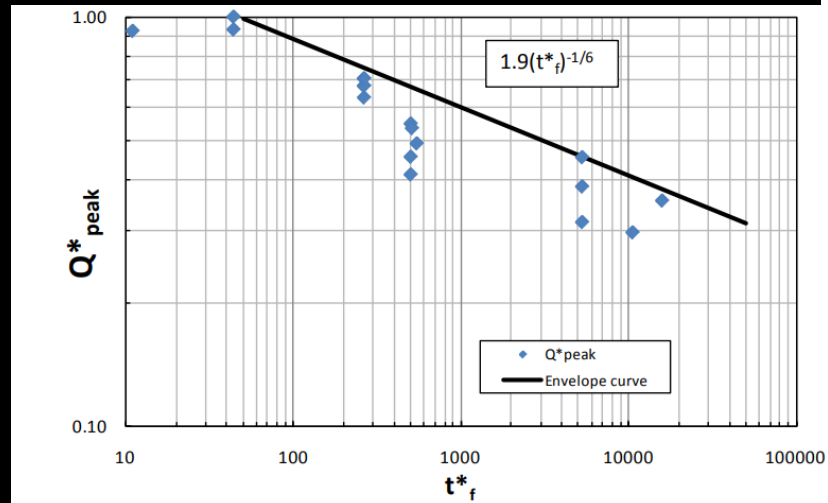
Figure 28. — Dimensionless peak discharge as a function of dimensionless breach development time.

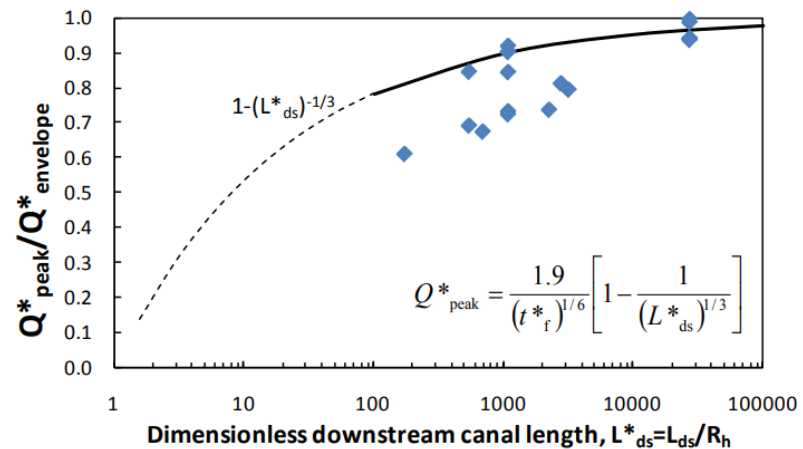
Figure 29. — Effect of downstream canal reach length on peak breach outflow.
