# *Sustainable Rivers Program*

## Oxbow Restoration Planning Report Des Moines River below Saylorville Lake Rock Island District

January 2020

Compiled by Rock Island District, U.S. Army Corps of Engineers

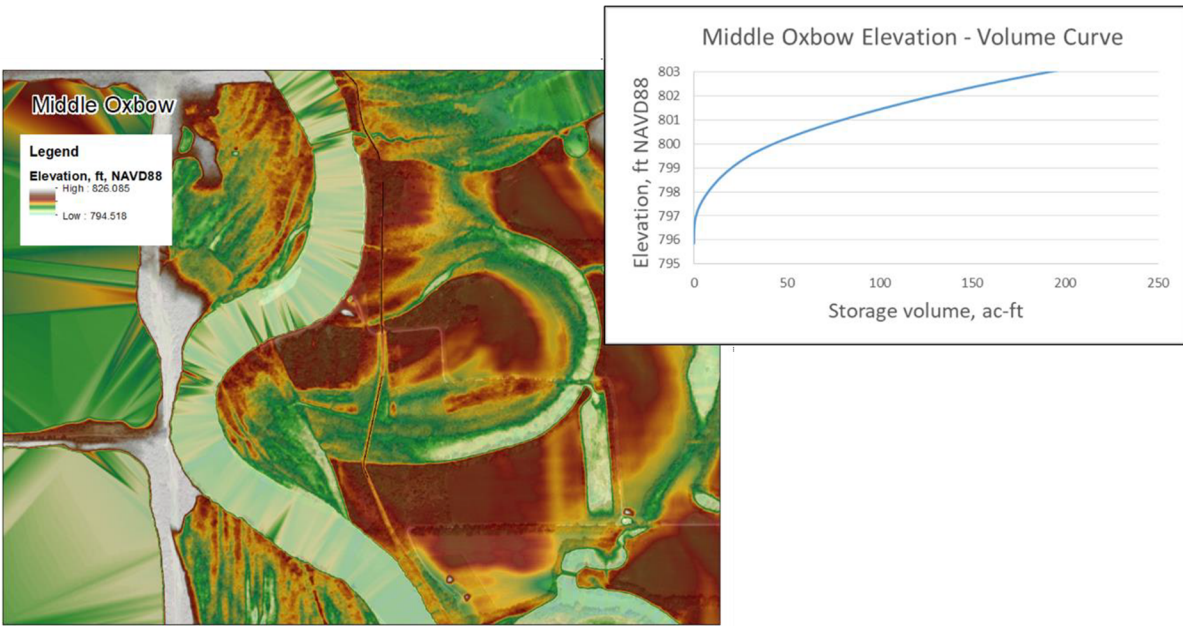
Figure 2: LiDAR data and elevation - volume curve for middle oxbow.

**Hydraulics & Hydrology:** The State of Iowa collected Light Detection and Ranging (LiDAR) land surface elevation data for Polk County in April 2008. Elevation – volume curves were approximated for each oxbow (Figures 1-3). These curves can be used to estimate storage potential at various elevations for each oxbow (assuming sufficient loading and containment of water). Curves were delineated for individual oxbows, rather than the entire corridor.

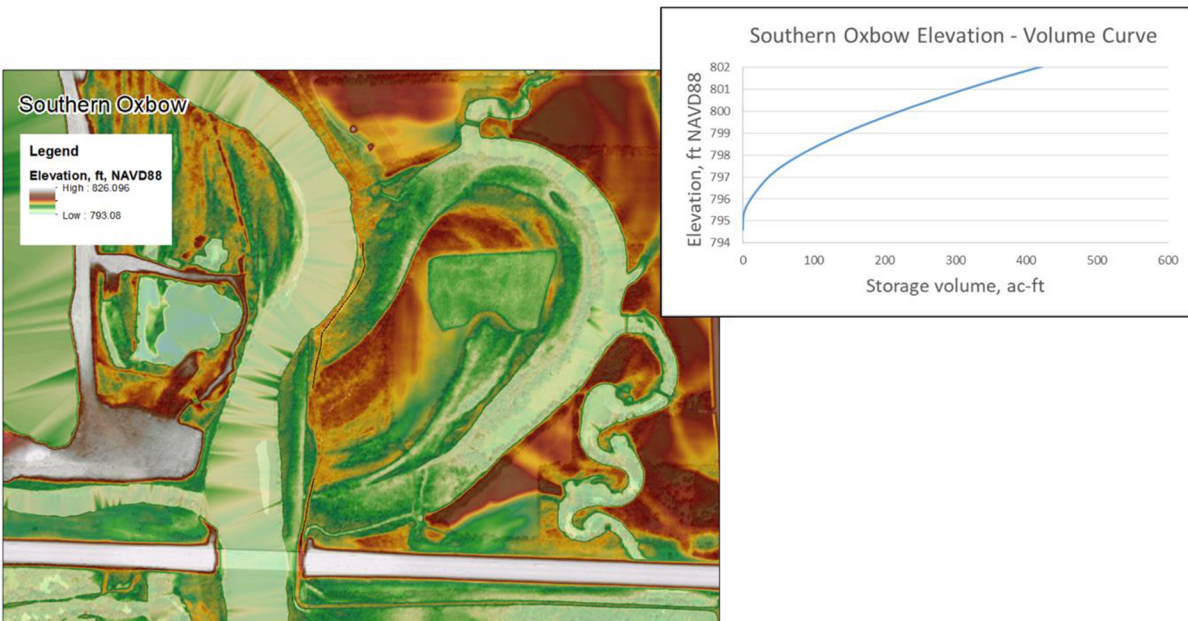
Figure 3: LiDAR data and elevation - volume curve for southern oxbow.

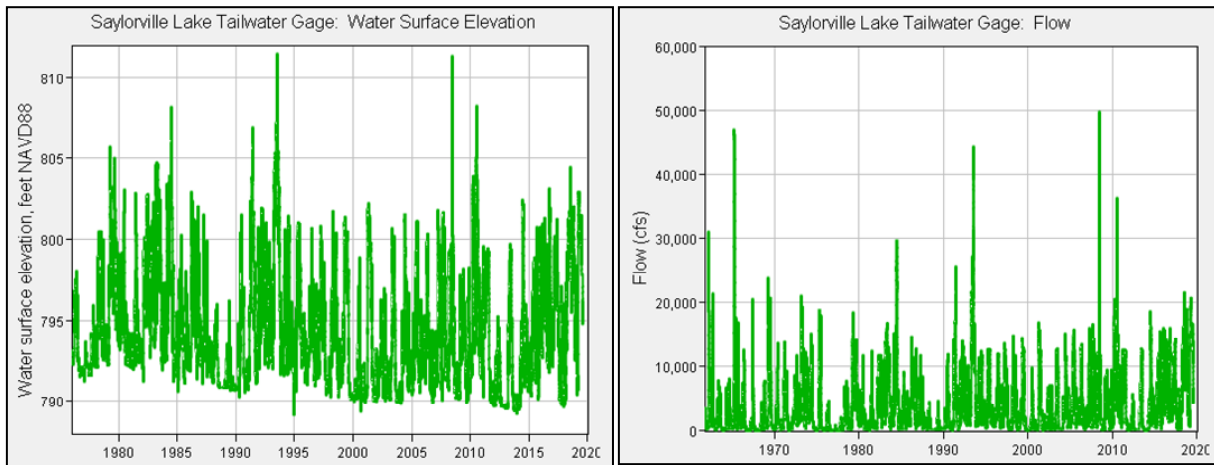
Figure 5: Period of record water surface elevation (left) and flow (right) at Saylorville Lake tail water gage. *FEMA Flood Insurance Study Profile: The regulatory 1% annual chance exceedance water surface profile for the Des Moines River in the project area is available in FEMA Flood Insurance Study #19153CV002A for Polk County, Iowa (effective February 2019).*

Saylorville Lake Tail Water Gage: The Saylorville Lake tail water gage is located on the Des Moines River at NW 66<sup>th</sup> Avenue, immediately upstream of the project area. It is approximately 2.4 miles from the gage to Interstate 80, the downstream boundary of the project area (Figure 4). Water surface elevation and flow data is available at this gage (Figure 5).

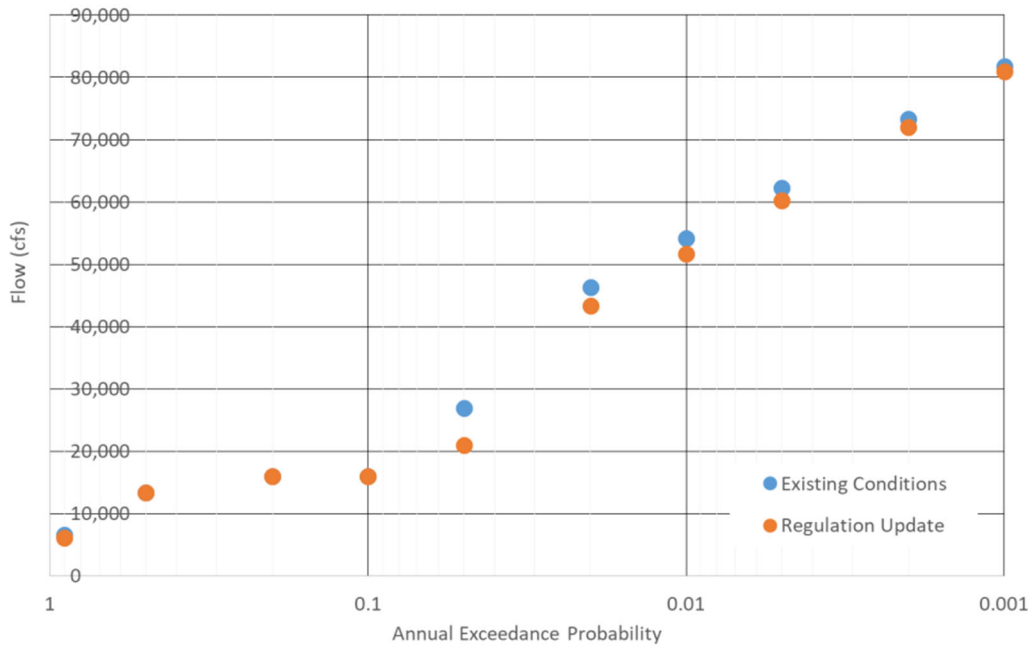
Saylorville Regulated 1-Day Annual Maximum Flow Frequency Curve  
 Below Saylorville Dam  
 Des Moines River Basin Master Reservoir Regulation Manual Feasibility Report

Figure 7: Annual flow frequencies computed for before (“existing conditions”) and after (“regulation update”) Des Moines River Basin Master Regulation Manual Update (2019).

Des Moines River Basin Master Regulation Manual Update: The Des Moines River Basin Master Regulation Manual update was effective February 2019 (<https://www.mvr.usace.army.mil/About/Offices/Programs-and-Project-Management/Des-Moines-River-Water-Control-Plan-Update/>). At Saylorville, operations will be similar to those enacted through temporary deviations authorized and implemented 2016 – 2019. Compared to the period of record, larger flow releases may occur sooner and for a longer period of time. The impact of the regulation update on annual flow frequencies was investigated during the feasibility study. A decrease in peak flows is expected for less frequent events (Figures 6-7).

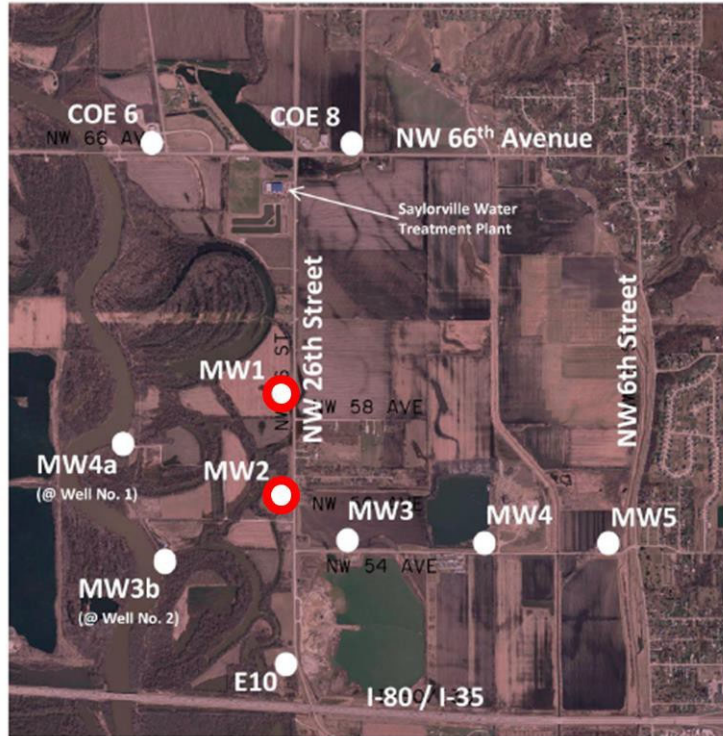
Figure 9: Locations of Des Moines Water Works groundwater monitoring wells (“Saylorville Habitat Monitoring Program”, 2014 – 2015).

Groundwater levels: As a condition of the use of federal land for drinking water collector wells, Des Moines Water Works monitored groundwater levels in the oxbow corridor from 2010 to 2015. Locations of monitoring wells are shown (Figure 9). Because sites MW4a and MW3b are directly adjacent to pumping activity, sites MW1 and MW2 are most appropriate for observing ambient groundwater levels. At these locations, groundwater elevations were generally found to exceed 791 feet (datum not provided) between October 2014 and October 2015 (Figure 10). Overall, from 2010 to 2015, groundwater levels were found to be strongly impacted by the operation of Saylorville Lake and the water surface elevation of the Des Moines River (“Saylorville Habitat Monitoring Program”, 2014 – 2015).

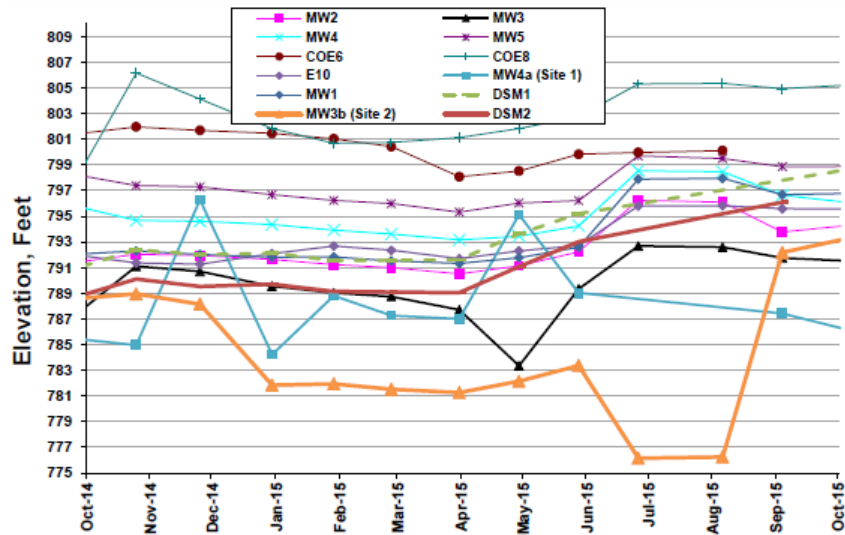
Figure 10: Observed groundwater elevations between October 2014 and October 2015 for locations shown in Figure 9. Sites MW1 and MW2 are most appropriate for observing ambient groundwater levels (“Saylorville Habitat Monitoring Program”, 2014 – 2015).

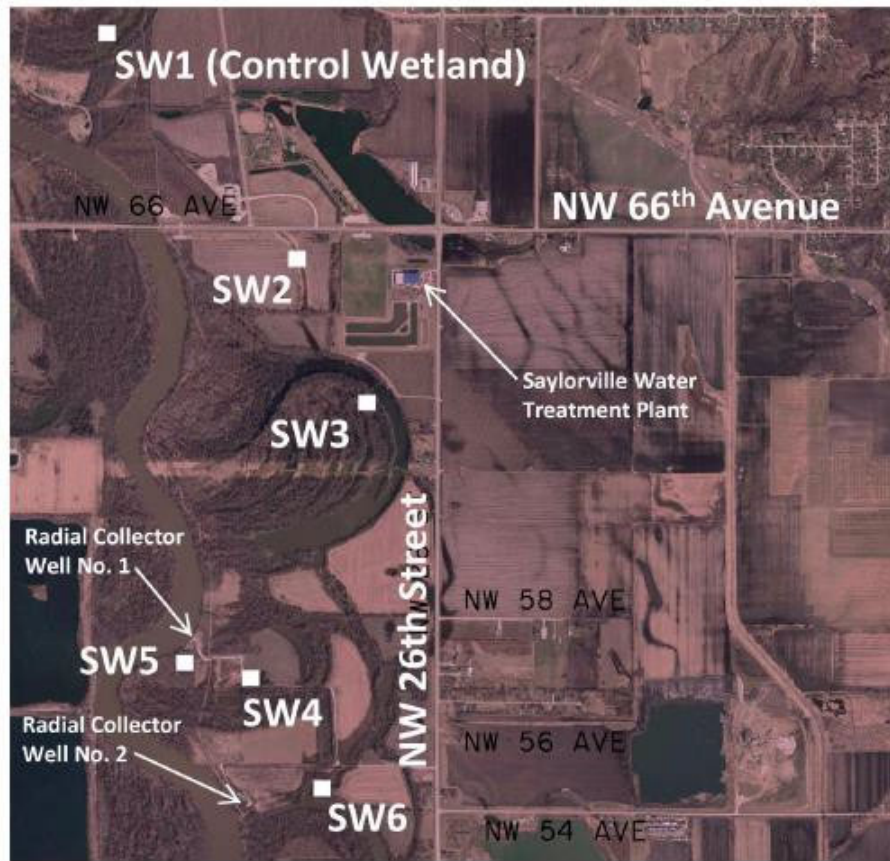
*Figure 11: Locations of Des Moines Water Works surface water monitoring sites (“Saylorville Habitat Monitoring Program”, 2014 – 2015).*

Surface water levels: Des Moines Water Works also monitored surface water levels in the oxbow corridor from 2010 to 2015. Monitoring locations are shown (Figure 11). At these locations, water levels above the surface and in the first 24 inches below the surface are shown (Figure 12). Overall, from 2010 to 2015, surface water levels were found to be strongly impacted by the operation of Saylorville Lake and the water surface elevation of the Des Moines River (“Saylorville Habitat Monitoring Program”, 2014 – 2015).

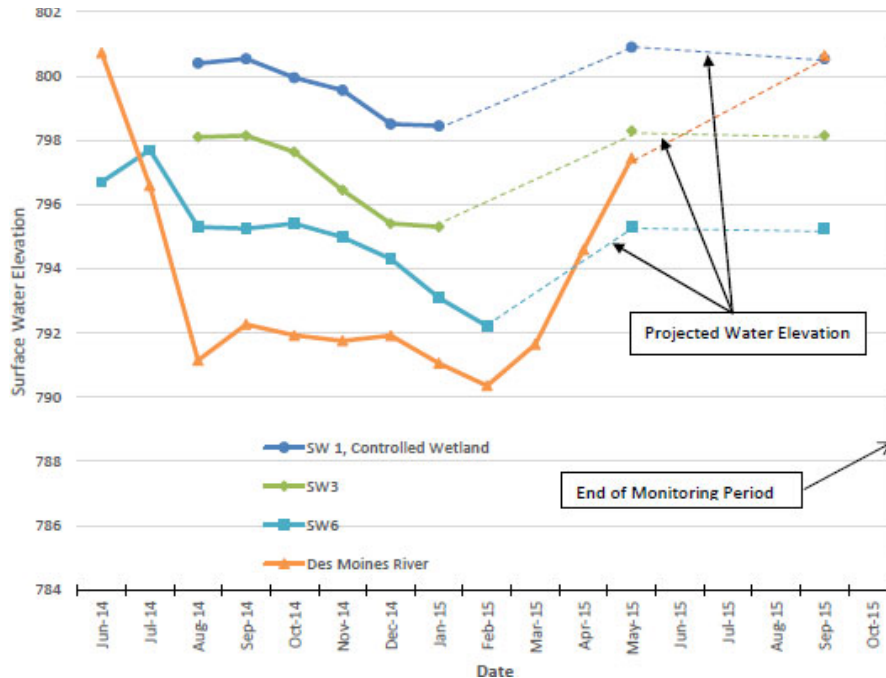
Figure 12: Observed surface water elevations (above ground and less than 24 inches below ground) between October 2014 and October 2015 for locations shown in Figure 11. Water was not present for dates not shown in plot. Dotted line represents period where monitoring conducted, but water is assumed to have been present. No data is shown for sites where water level was greater than 24 inches below ground (“Saylorville Habitat Monitoring Program”, 2014 – 2015).

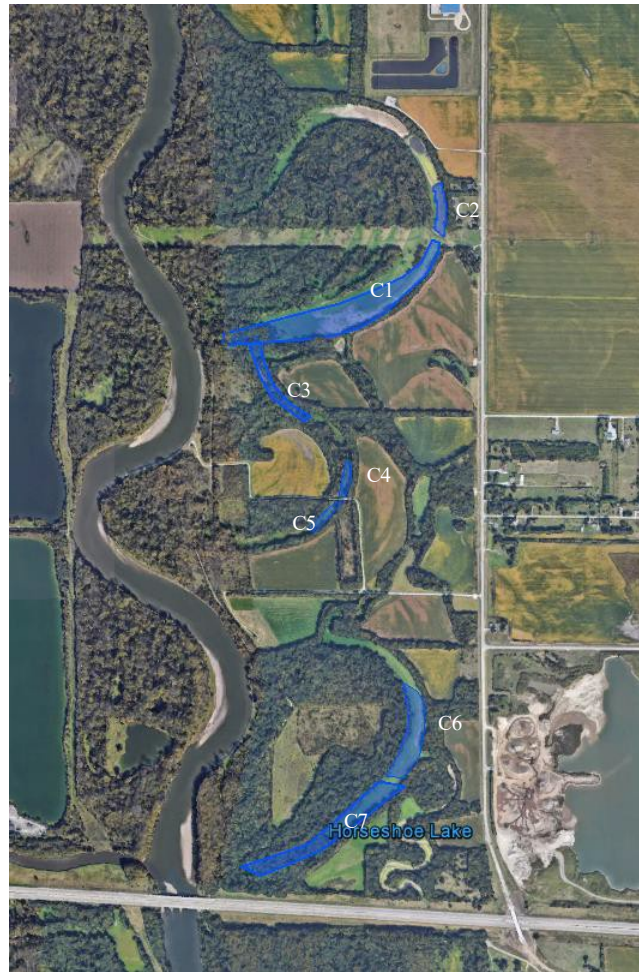
*Figure 13: Identified oxbow locations for excavation to create deeper lake-like conditions for purposes of water storage, overwintering fish habitat, and greater habitat diversity.*

A desired goal of the project is to increase connectivity of the oxbows. This can be further achieved through excavation in the natural path of the oxbows or historic channel path. By maintaining and improving this historic path, the oxbows are greater able to utilize gravity as a means of transporting water within the oxbows. Recognizing demands on management staff and increasing the operability of the system by minimizing structures where possible and utilizing features that require little day-to-day maintenance was a factor considered by the team. Figure 13 indicates key areas identified in the workshop as potential excavation areas.

USACE staff has the ability to manipulate water levels through their partnership with Des Moines Water Works in the center oxbow, allowing for the management of duck habitat. By connecting north and center oxbow there may be further opportunities for USACE to manipulate water elevations. Cut 3 identified in Figure 13 initiates this connection. The design alternative explored for excavation in these areas includes a shelf at the diversion from the north oxbow to prevent water from draining out of the north oxbow at low flow times and ensuring enough depth remains in the north oxbow to provide overwintering habitat. This option serves as a spillway for the north oxbow into the center oxbow.

Approximate cost to excavate on site material is \$20 per cubic yard of material excavated. Incidental costs included in this unit price are removal of material and placement of excavated material. Opportunities to decrease unit cost are to utilize placement sites close in proximity to the removal area. Additionally work performed in house or through partners of the project would generally generate a lower rate than work performed by a contractor. See Table 3 for approximate costs of excavation at the various locations identified in Figure 13.

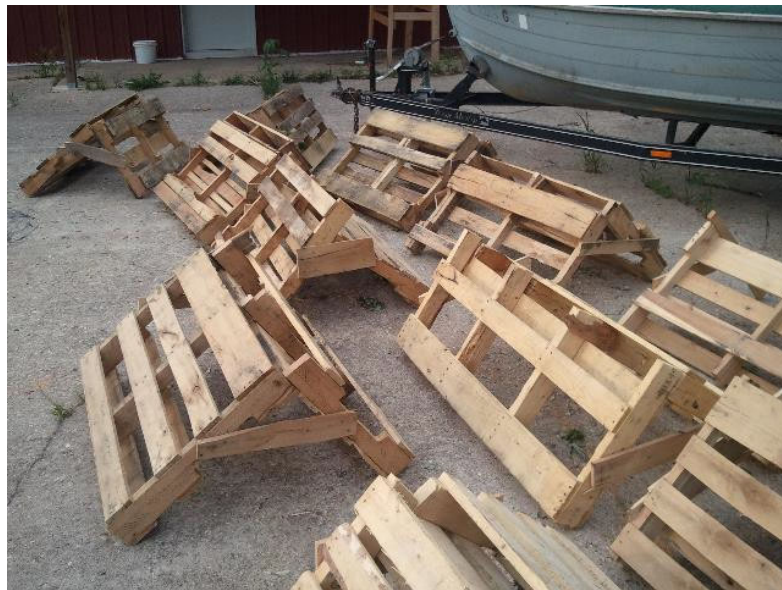
*Figure 14: Fish Habitat Pallet Structures (USACE photo).*

Several options are available to provide species specific fish habitat in the north oxbow. One option would be pallet structures (Figure 14). These can be cubes or other shaped structures to attract panfish and largemouth bass. One factor to keep in mind with structures such as these is the necessity of proper anchors. These structures can also present boating hazards and may need to be in secluded areas or sections of the oxbow that wouldn't receive boat traffic or public access. Simpler alternatives for fish habitat could include anchored felled trees or rock (Figure 15). These features are often little to no cost to the stakeholder as materials such as pallets can be obtained for free and trees that fall naturally can be found on site. The north oxbow excavation areas provide several opportunities for fish habitat.

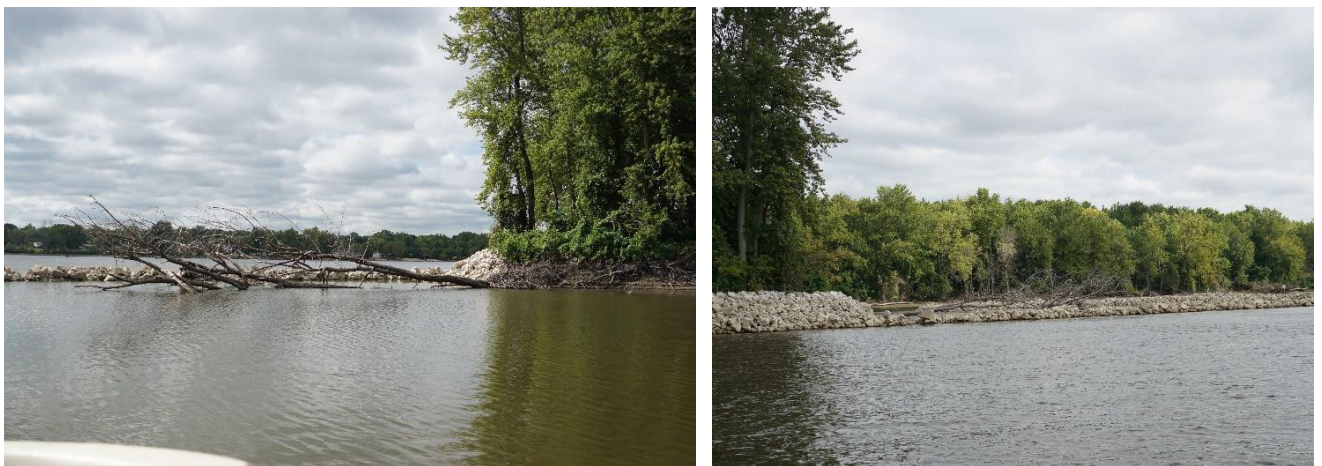
*Figure 15: Anchored Felled Tree at Beaver Island HREP (USACE photos).*

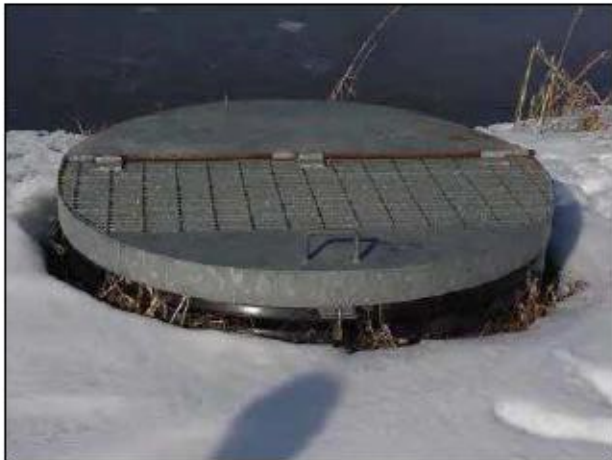
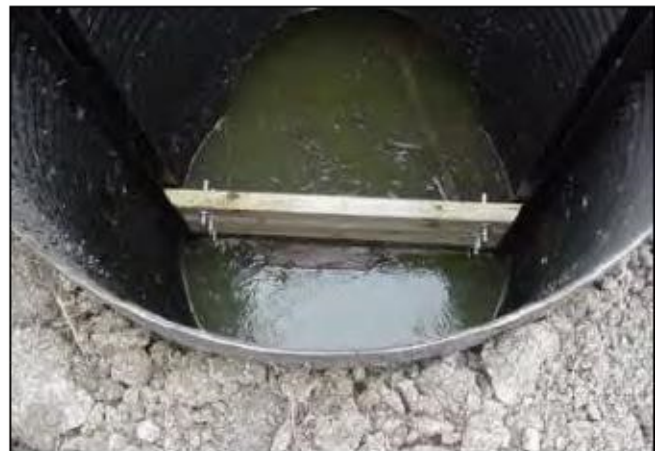
Figure 17: Culvert with Stoplog Structure at Banner Marsh HREP.  
[https://www.mvr.usace.army.mil/Portals/48/docs/Environmental/EMP/HREP/EMP\\_Documents/Design%20Handbook%202012/05\\_Waterlevel\\_Management.pdf](https://www.mvr.usace.army.mil/Portals/48/docs/Environmental/EMP/HREP/EMP_Documents/Design%20Handbook%202012/05_Waterlevel_Management.pdf) (USACE photos).

Cost estimates were based off of Corp HREP projects (Figure 17) and scaled to current dollars. ([https://www.mvr.usace.army.mil/Portals/48/docs/Environmental/EMP/HREP/EMP\\_Documents/2012%20UMRR%20EMP%20Environmental%20Design%20Handbook%20-%20FINAL.pdf](https://www.mvr.usace.army.mil/Portals/48/docs/Environmental/EMP/HREP/EMP_Documents/2012%20UMRR%20EMP%20Environmental%20Design%20Handbook%20-%20FINAL.pdf))

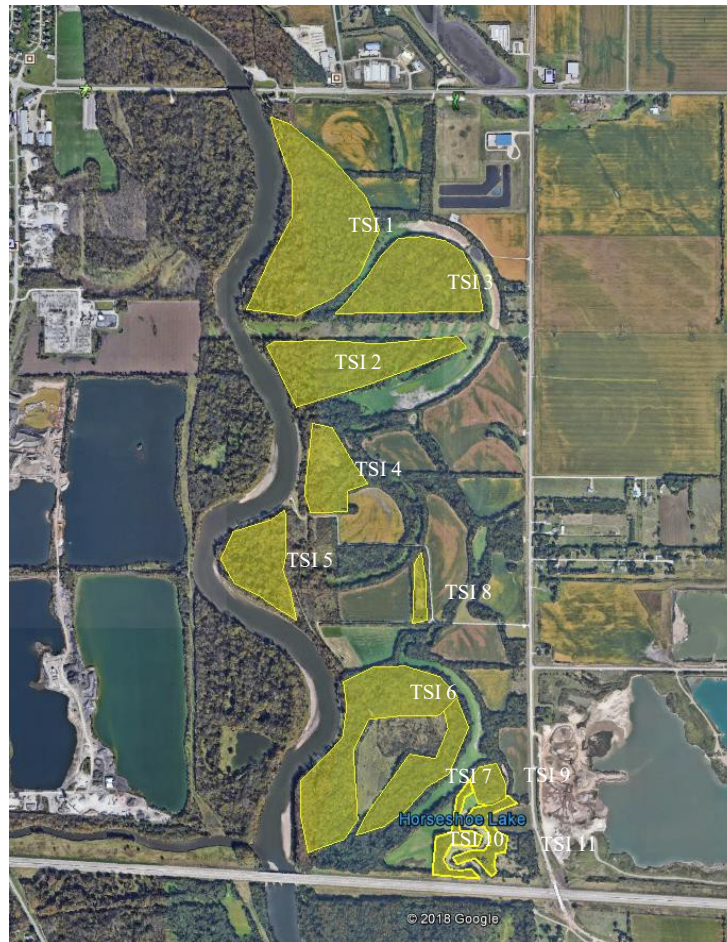
*Figure 18: Suitable locations identified as timber stand improvement (TSI 1–11) areas and used as the basis for quantities and cost estimates for restoration.*

Operations Division at Saylorville Lake has already undertaken tree plantings and timber stand improvement projects near the oxbows in some locations. However, opportunities still exist to increase the quality of the habitat available in the area and convert current forested areas to more natural oak savannahs. Figure 18 shows several key areas that were identified as possible locations for timber stand improvements during the workshop.

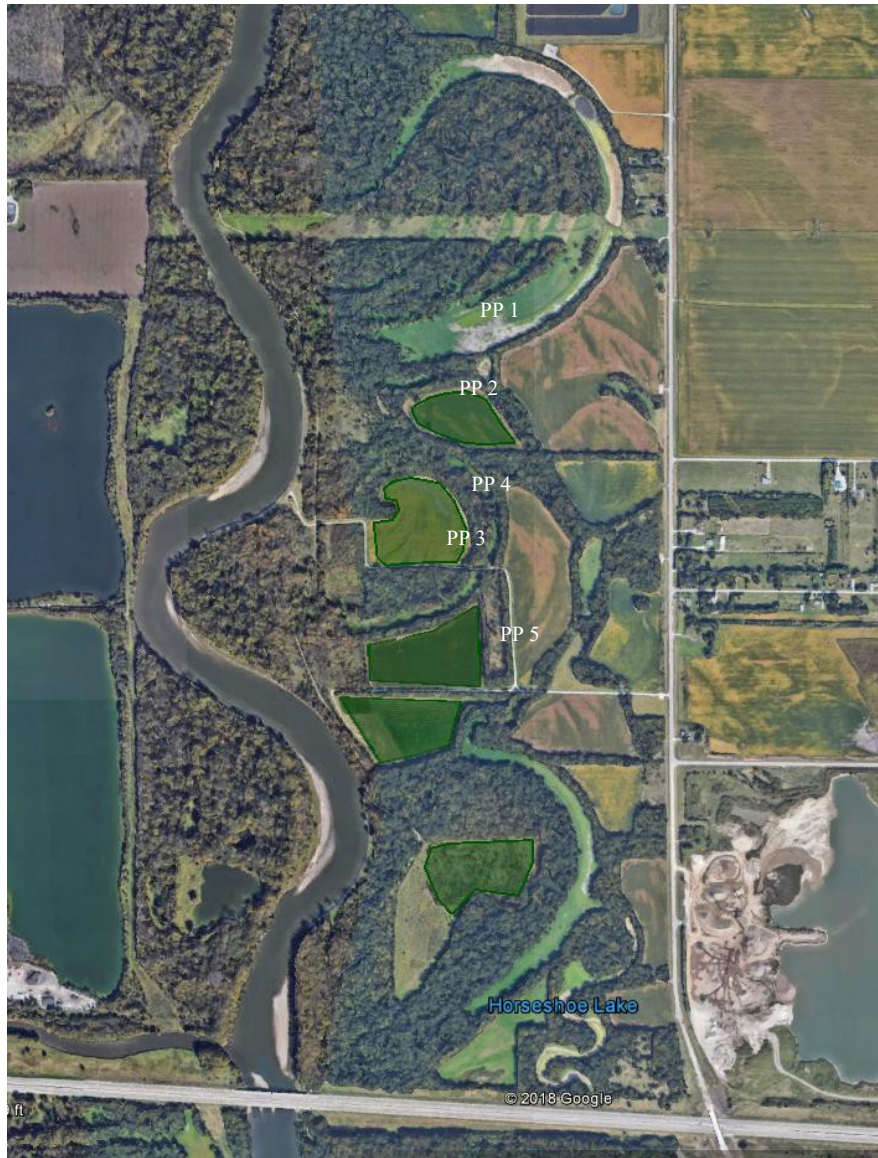
*Figure 19: Suitable locations identified as prairie habitat restoration areas (PP 1-5) and used as the basis for quantities and cost estimates for restoration (Table 6).*

Another key goal identified by the stakeholders is to increase the acreage of prairie within the USACE and Iowa DNR managed land directly surrounding the oxbows. Potential future prairie planting locations are show in Figure 19. These planting would require some adjacent leased farmland to be converted. This land use change offers many benefits such as a decrease in high nutrient run-off and an increase in natural habitat.

The areas identified in Figure 19 indicate the larger areas selected as possible prairie planting areas during the workshop. However, additional locations that could provide increased benefits would be between the oxbows and leased farmland. Small sections in these areas could serve as buffer strips for remaining farmland in the area. Buffer strips decrease nutrient, pathogen and sediment loads into the oxbows.

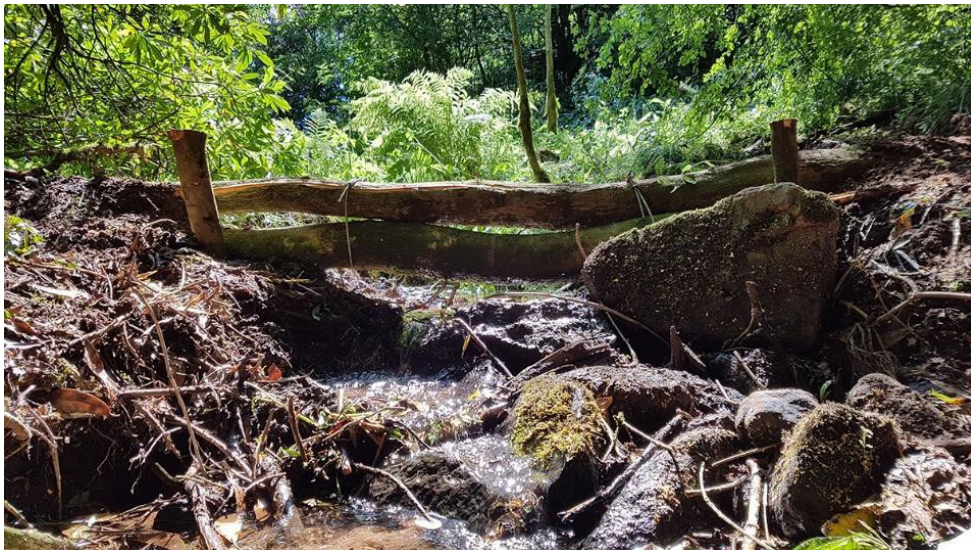
*Figures 21-22: Photo examples of run-off attenuation structures (i.e., leaky dams). These structures can have significant impacts on flood peaks in small to medium events. They also provide numerous ancillary benefits including water level manipulation, increased residence time of water within the system, sediment capture, and water quality improvements (USACE photos).*

Another feature to be considered is the addition of run-off attenuation structures (i.e., leaky dam; Figures 21-22). This feature uses engineering with nature principles such as minimal management requirements and natural construction materials (i.e. felled trees). This could be utilized in sections of the oxbow that are draining at an above desired rate. However, one considerations would be the potential to sediment in causing the dam to no longer leak and altering its design function. Leaky dams could be minimal to no cost if put in place by Operations staff.

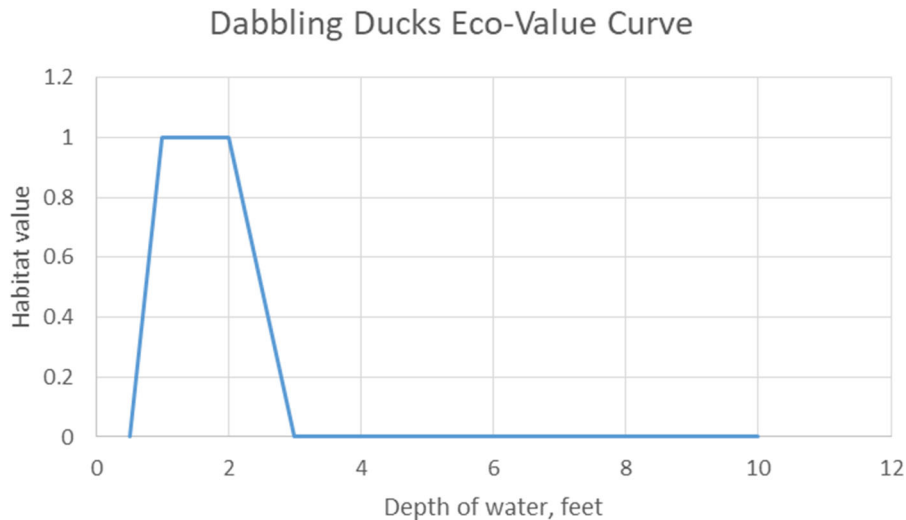
Figure 23: Ecological relationship used in the HEC-EFM analysis for dabbling ducks. Graph shows habitat value as depth of water changes.

**Dabbling ducks:** Habitat value was assigned to each cell of the HEC-RAS model grid according to Figure 23 for each individual day during the Fall months (September 1<sup>st</sup> – November 30<sup>th</sup>). It is assumed that ideal habitat for dabbling ducks is 1-2 feet, but some value can be attained in the 0.5 – 3 foot range.

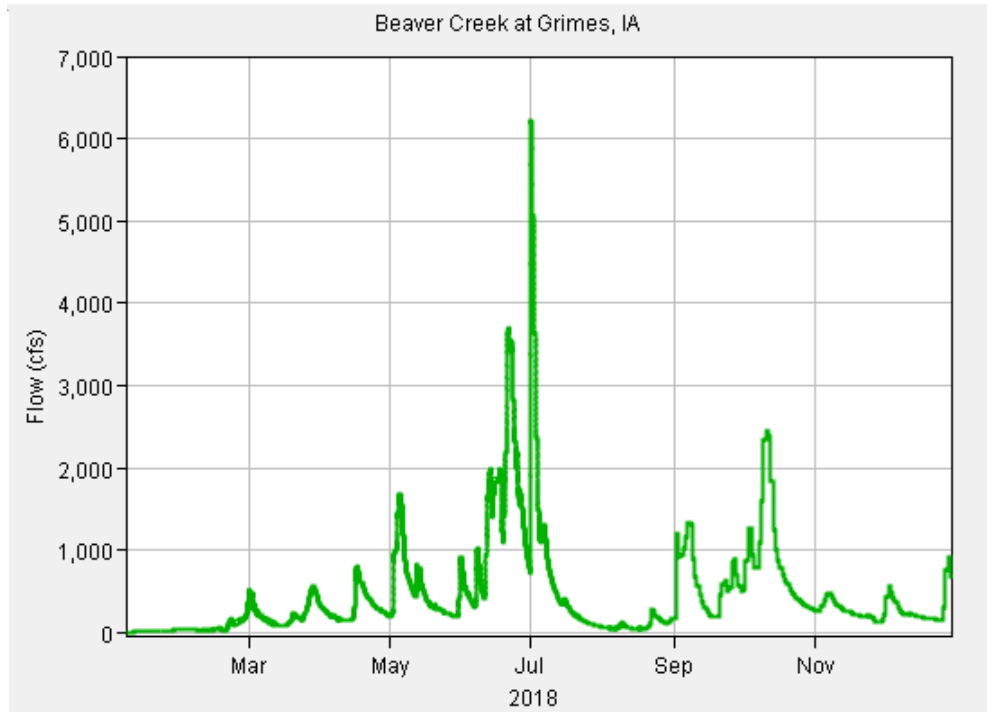
Figure A2: Flow hydrograph, Beaver Creek at Grimes, IA.

**HEC-RAS boundary conditions:** Normal depth (slope = 0.0009) were specified as the downstream boundary condition for this model. Flow hydrographs were specified for Beaver Creek and the Des Moines River using data from Beaver Creek at Grimes, IA (Figure A2) and Des Moines River at Saylorville, IA (Figure A3) gages, respectively. In future modeling efforts in this area, it could be beneficial to extend the study area downstream approximately two models and use the Des Moines River 2<sup>nd</sup> Ave. gage water surface elevations as the downstream boundary condition.

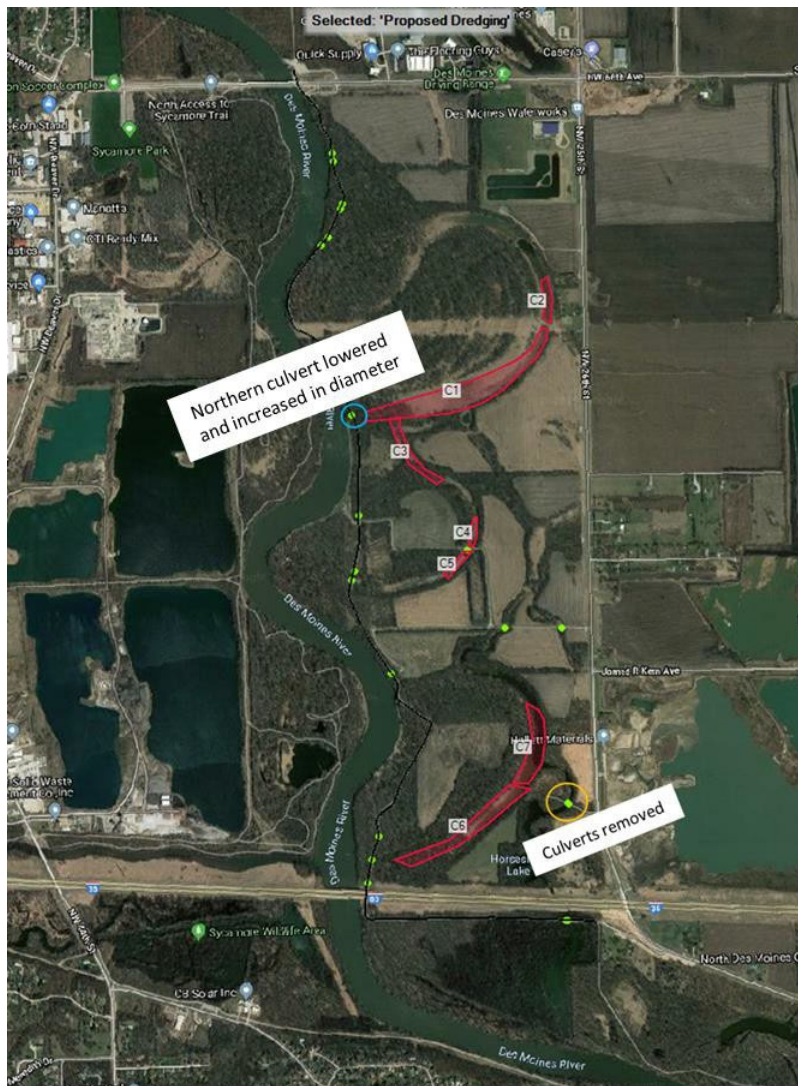
Figure A6: Selected plan – changes to existing condition 2D HEC-RAS model geometry. Red polygons show proposed dredge cuts added to model terrain. Blue circle shows culvert to be lowered and increased in diameter. Orange circle highlights two culverts to be removed.

**Changes to existing condition:** The main report (see Section 4: Preferred Restoration Design) suggests a potential plan for restoration of the Oxbows. To model hydraulic impacts of the proposed design, boundary conditions and computational settings were not changed. However, the following changes were made to the existing conditions geometry (Figure A6):

- Dredge cuts (4 – 13 feet deep) were added to the model terrain (locations shown in red).
- The culvert at the downstream end of the north oxbow (circled in blue) was lowered from an invert elevation of 796.75 feet NAVD88 to 794 feet NAVD88. The diameter of this culvert was increased from 3.5 feet to 6 feet.
- The two culverts in the road crossing east of the south oxbow (circled in orange) were removed.
